# INSPECTION REPORT

For the Property at:  
**6266 SKY-VIEW DRIVE**  
PARK CITY, UT 84098

Prepared for: SAMPLE REPORT  
Inspection Date: Wednesday, September 21, 2016  
Prepared by: Mathew Stouffer

RE: Report No. 6398, v.5  
6266 Sky-View Drive  
Park City, UT  
84098

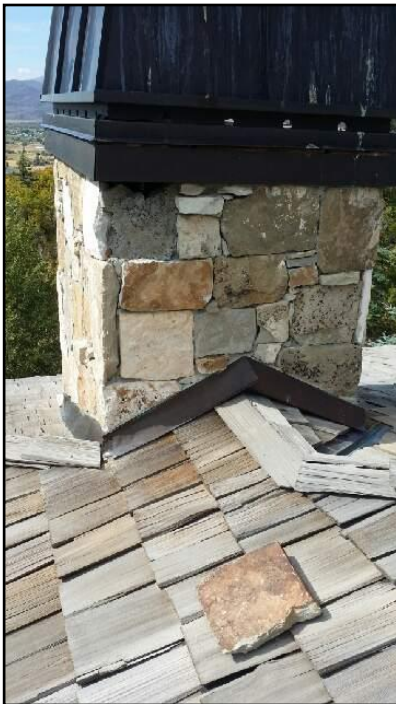
1. • The weather cap is missing on the west vent termination, spark arrestors are missing on the three flue terminations within the south chimney shroud and the termination in the southwest chimney, and various stones around all three chimneys are detaching from the chimneys. Furthermore, copper flashing around the southwest and west chimneys is poorly installed, there are gaps around the flashings, and the flashings have been faced nailed. Repair is recommended.

*Detached stones*

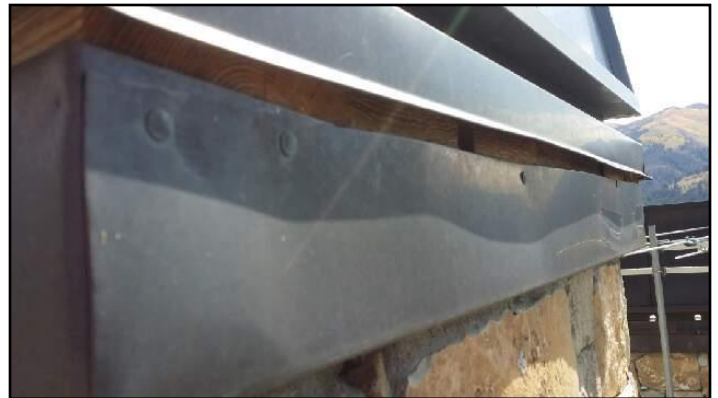
*Gap in flashing*

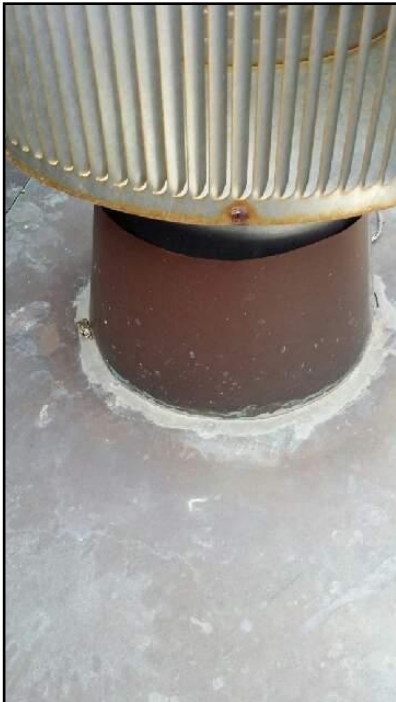
Gaps

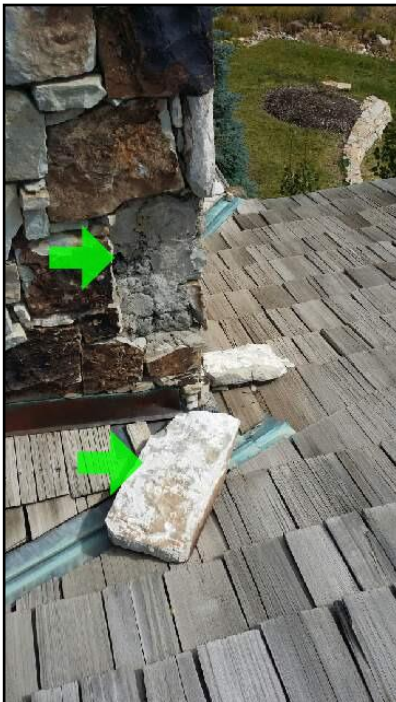
Detached stones

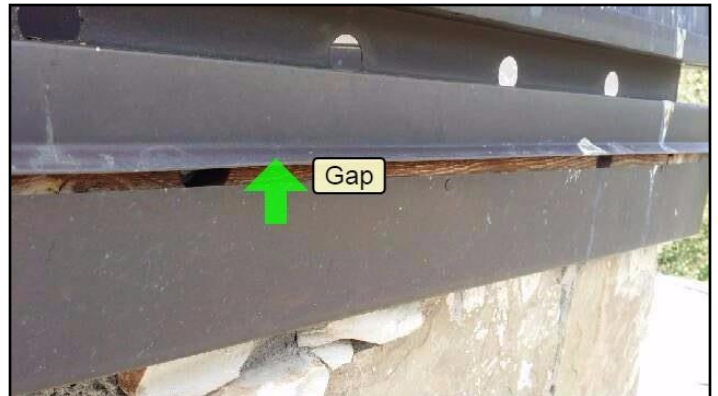
Gaps

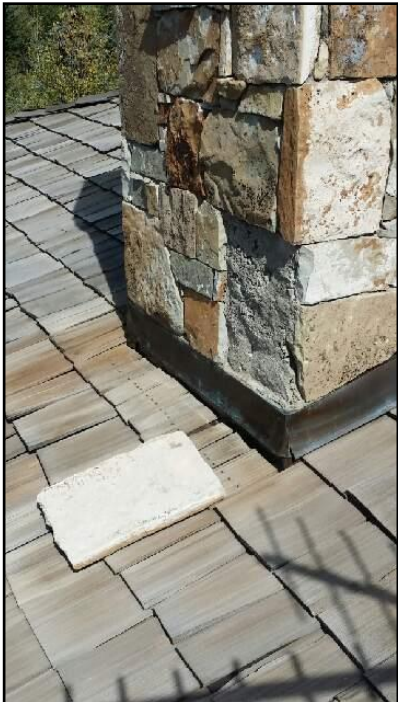
*Detached stone*

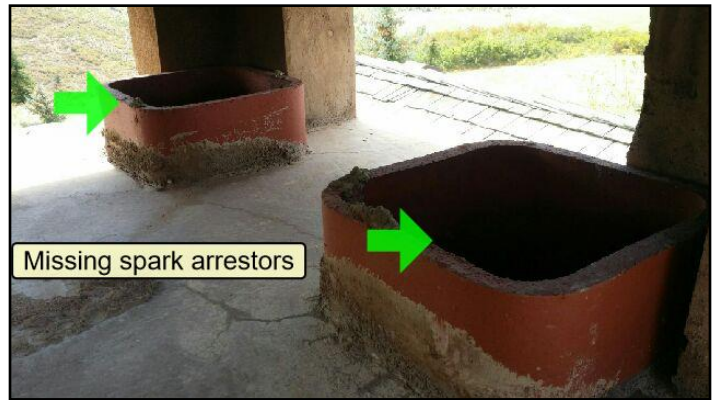
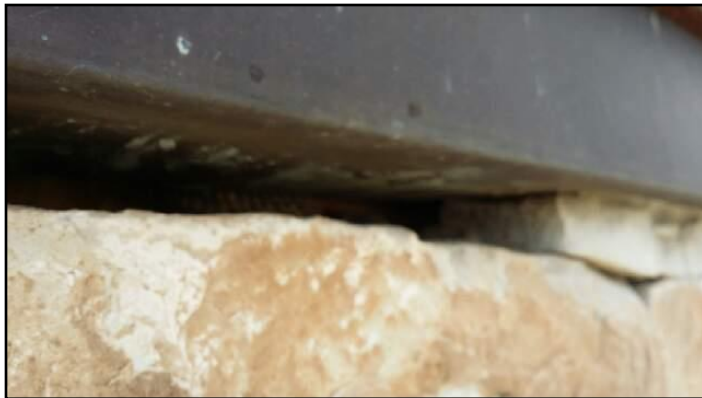
*Gap*

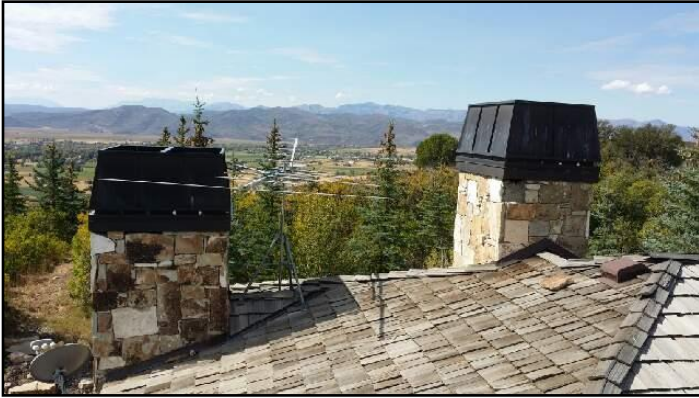
Areas noted

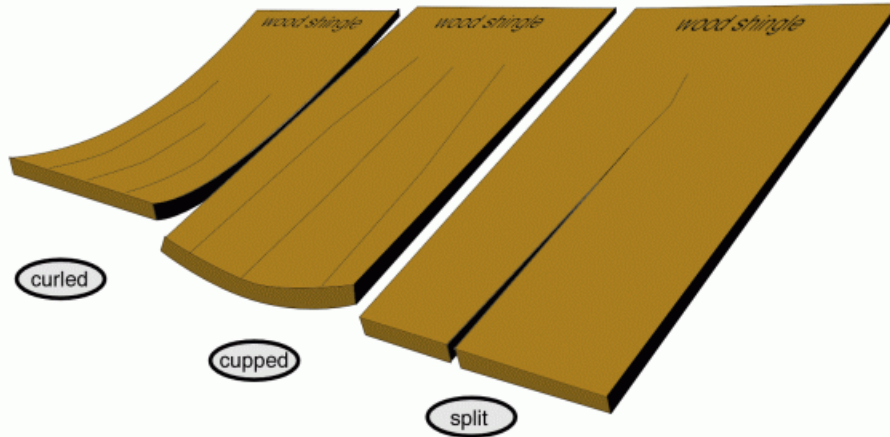
The home is equipped with a wood shake roof. According to industry standards and averages, wood shake roofing typically has a 15 to 22 year life span in this area. Loose shakes, damaged shakes, splitting and UV burn through are present on various aspects of the roof. Based on age, condition and average life expectancy for cedar shake roofing in this area, the roof is nearing the end of its useful life span. Additional evaluation by a roofing contractor is recommended to provide a bid for maintenance, remaining useful life, and replacement cost.

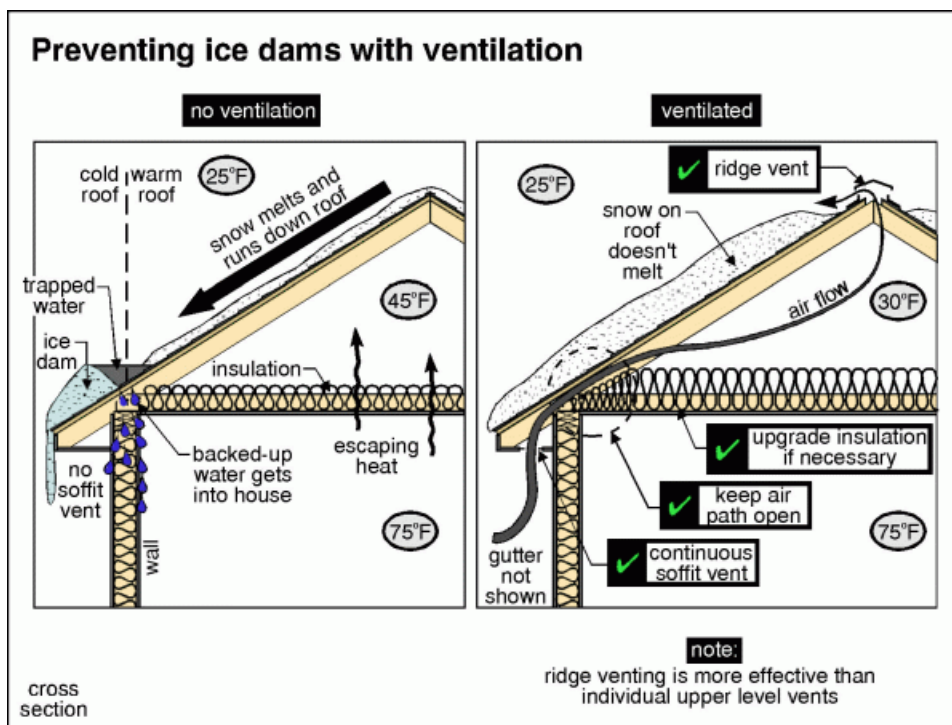
Due to the amount of snow received in this area, you may want to consider installation of heat tape throughout the roof eaves and valleys, in particular in the valleys.

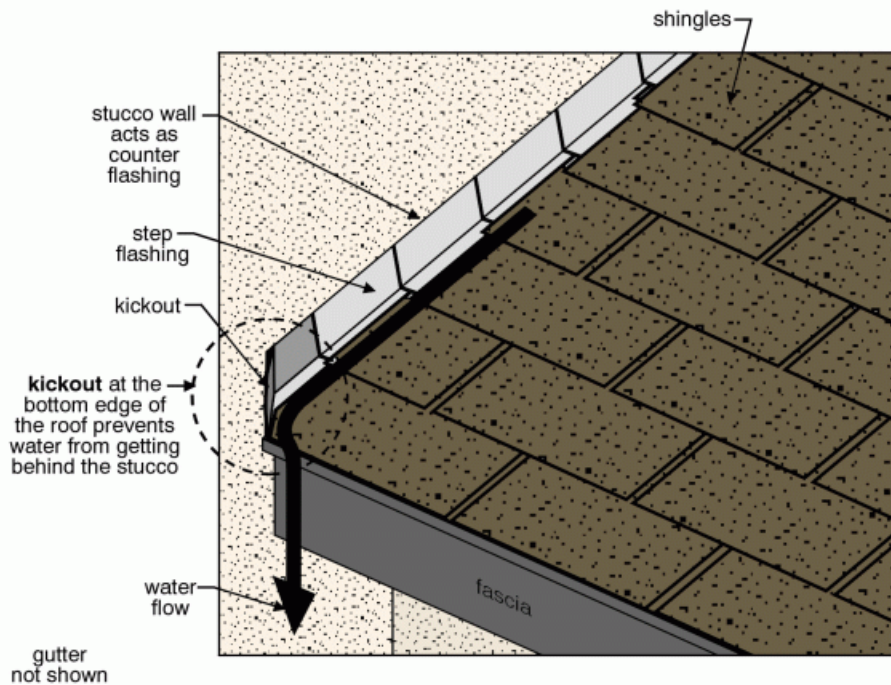
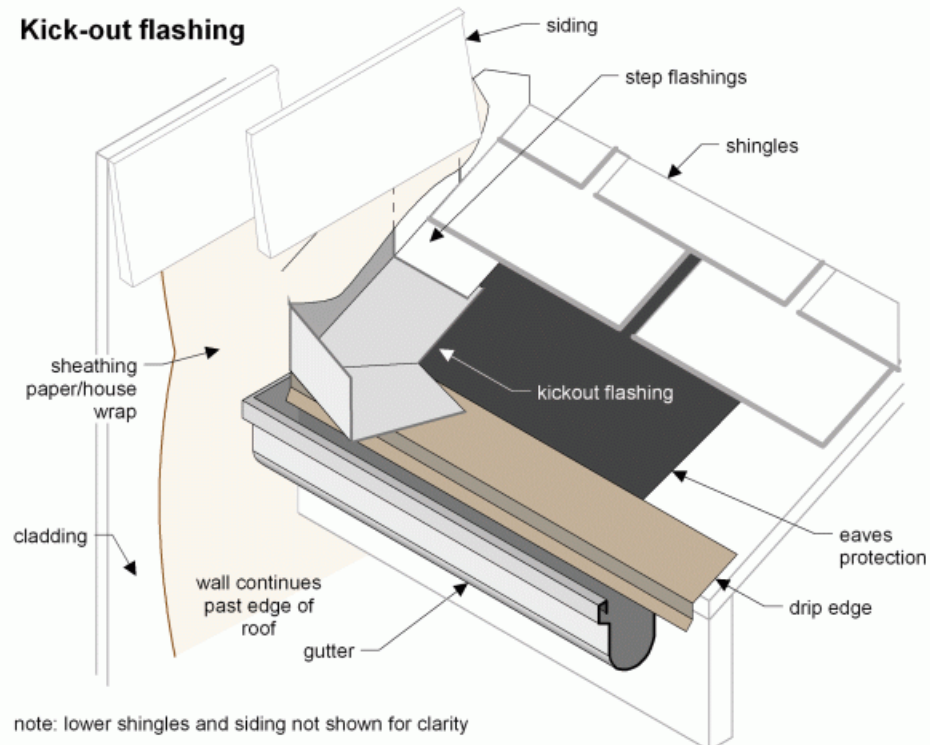
A kick out flashing is missing at the southwest roof wall intersection along the chimney.

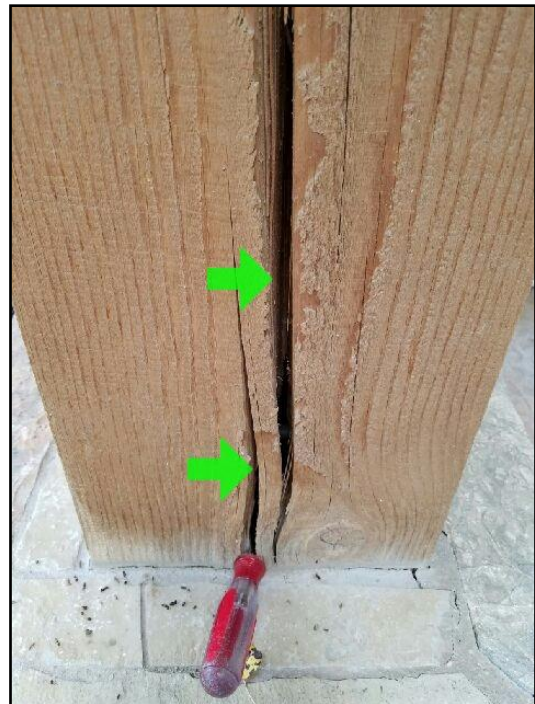
Checking

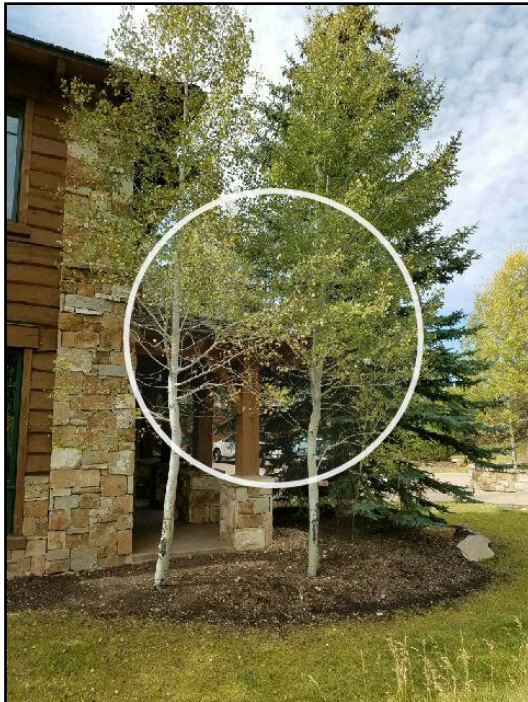
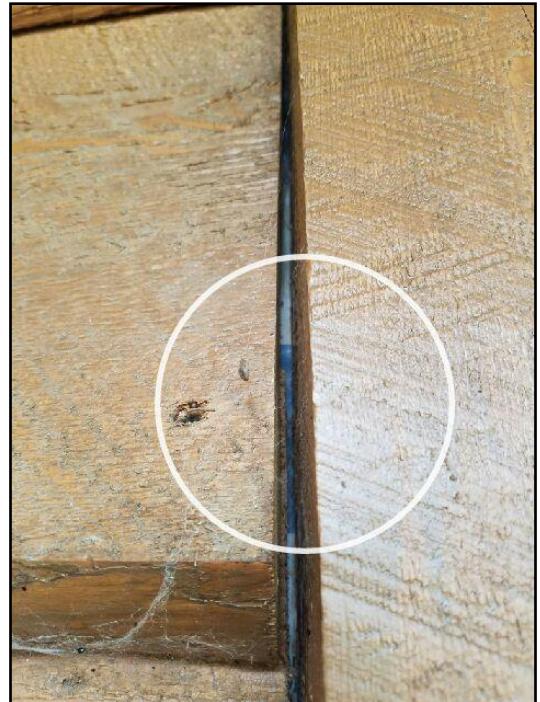
Gaps

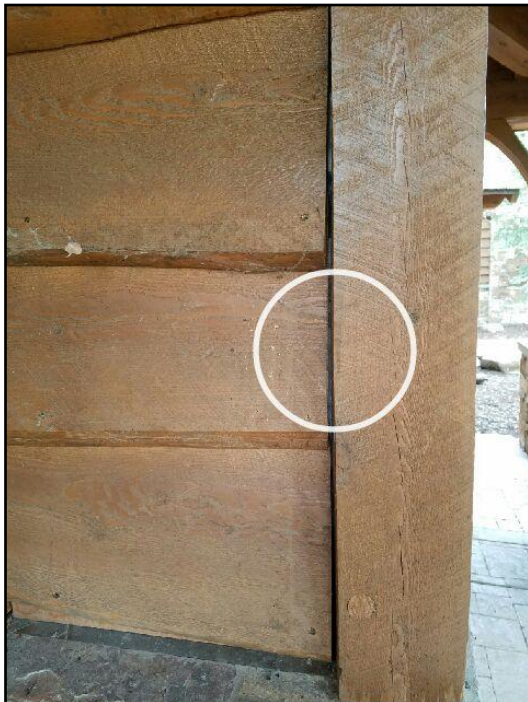
Gaps

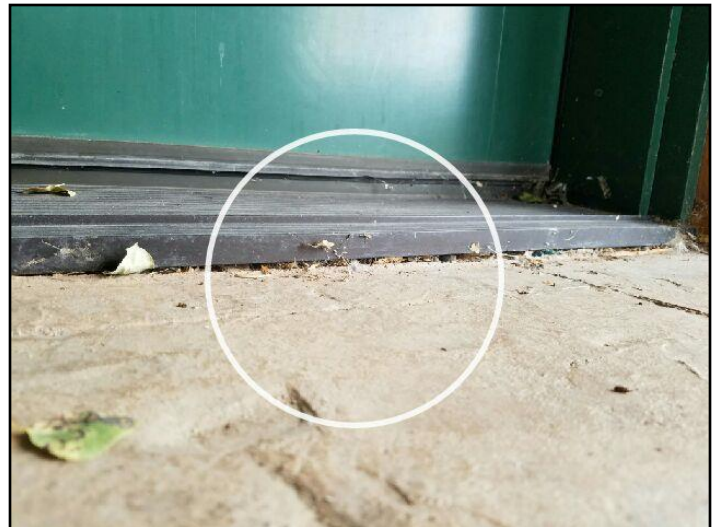
Gap

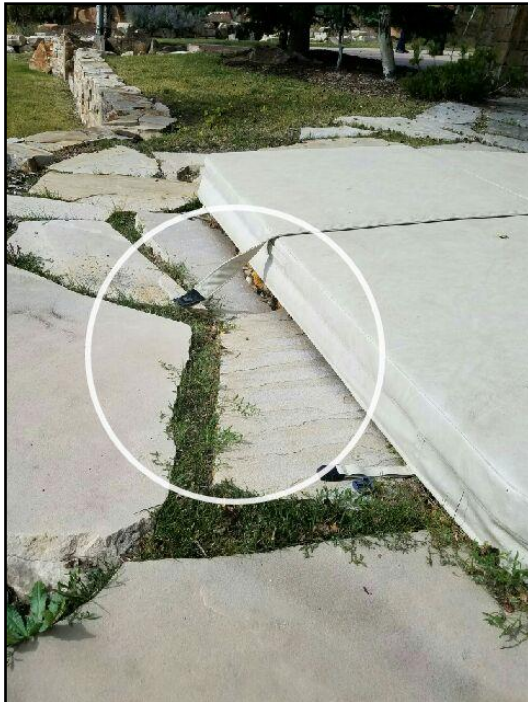
*Settlement*

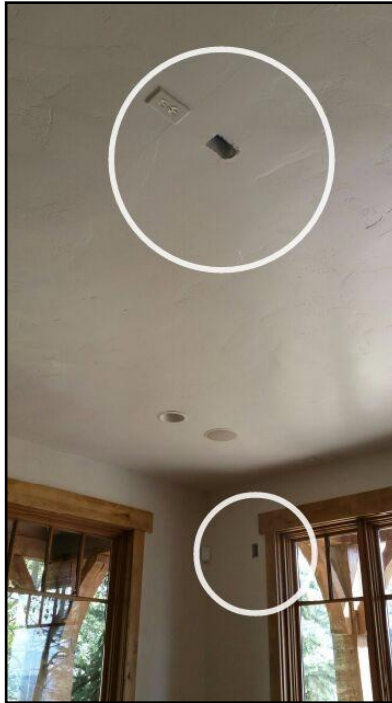
**Location:** Bonus Room

**13.** • Minor incomplete electrical work appears to be present in the bonus room.

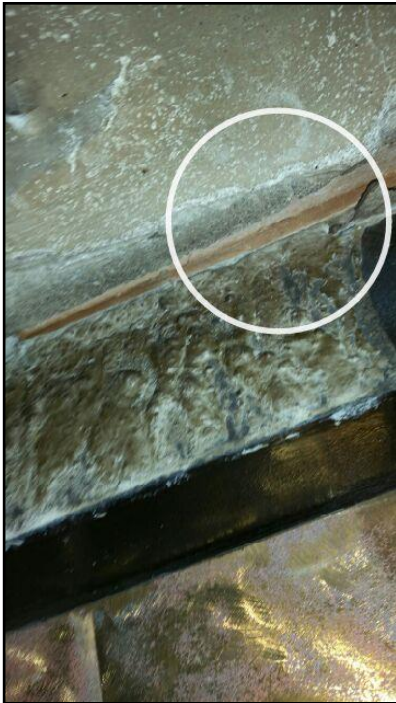
**Location:** Master Bedroom

There are combustible materials present within the fireplace of the master bedroom. Repair is needed. Strand board is not intended to be present within the firebox of a wood burning fireplace.

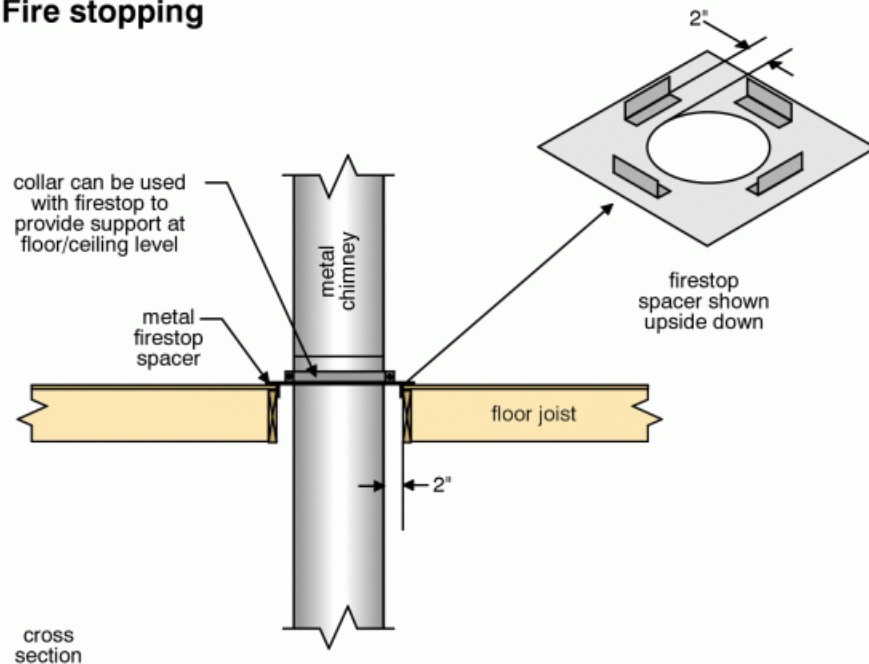
Missing fire stopping

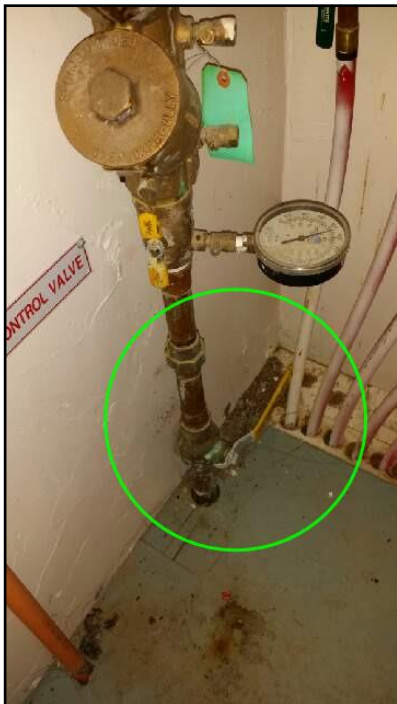
**Location:** Fire Suppression System

The system was shut off. Service is needed.

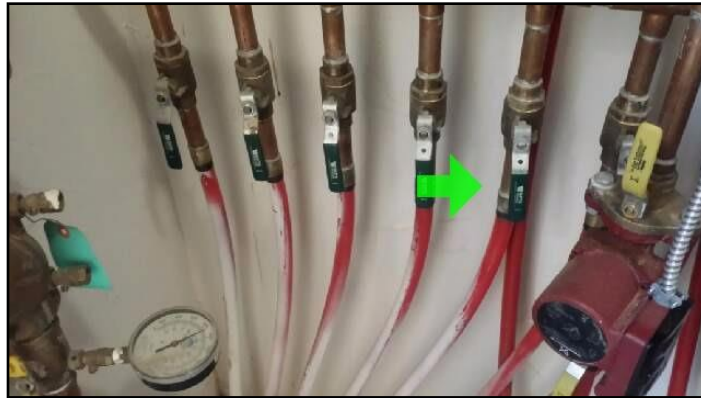
**Location:** Interior

**35. Condition:** • [Various fittings on water lines and radiant lines in the home may be involved in a class action lawsuit.](#) Fittings marked with F 1807 may be manufactured by Zurn and are alleged to have higher failure rates. Visible fittings in the home appeared to be in good condition, with the exception of corrosion noted on one of the manifolds in the crawlspace.

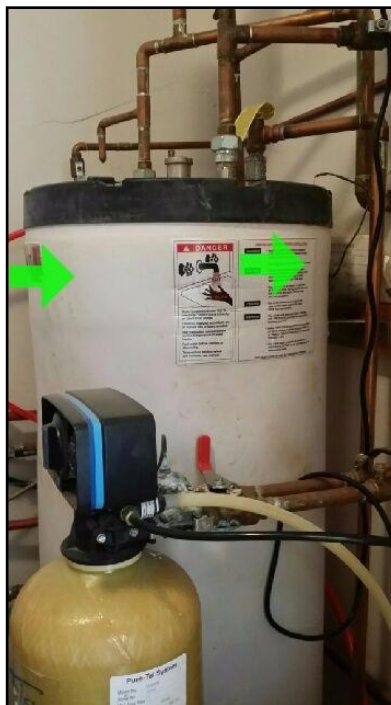
**Location:** Utility Room

**37. Condition:** • Seismic strapping is missing on the water heater tank/tanks. Strapping is recommended on the upper and lower third of the tank.

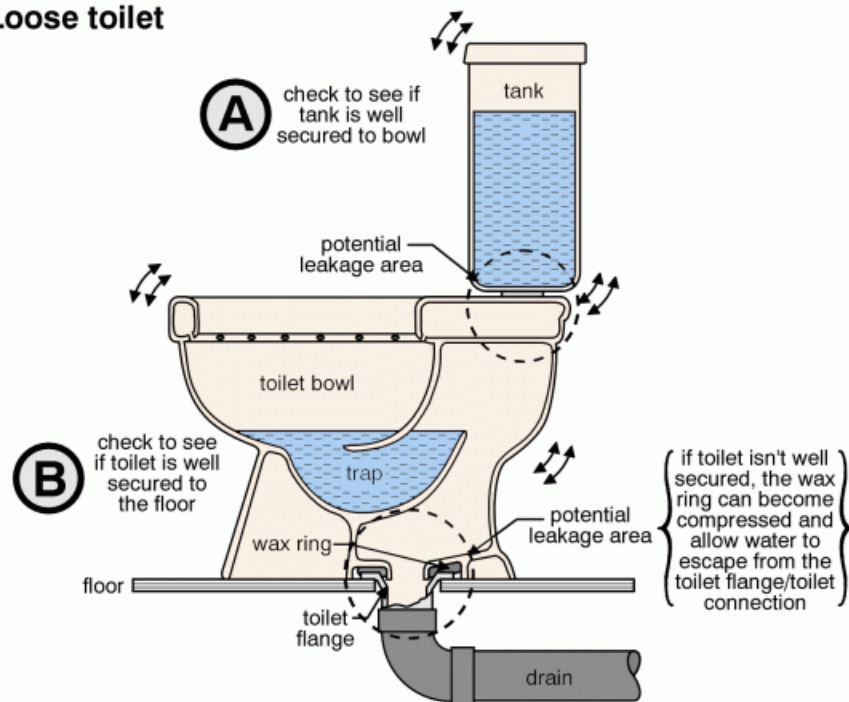
**Location:** Various Aspects Of The Interior First Floor

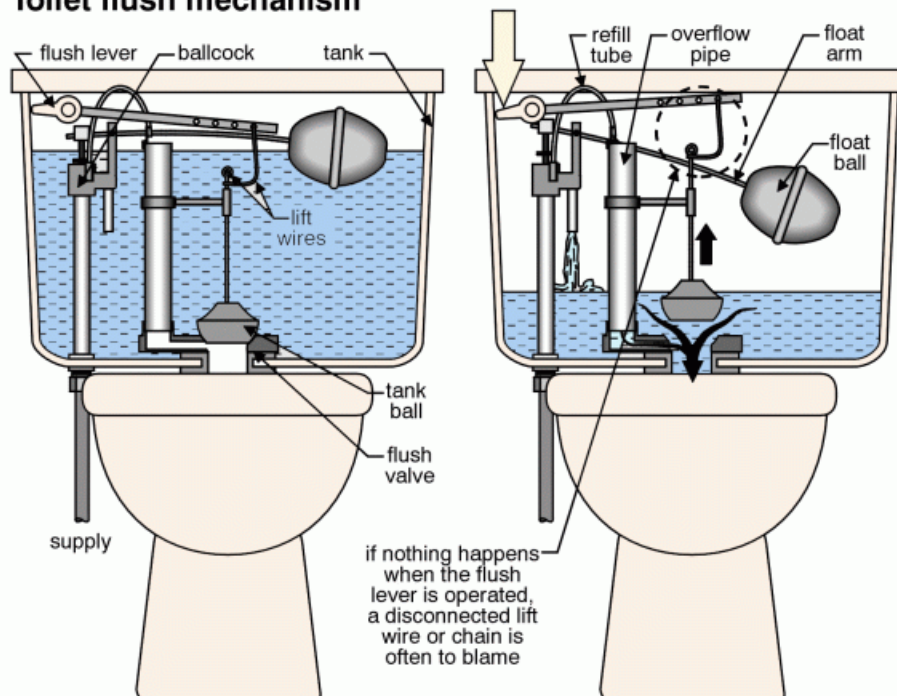
**Location:** Northwest Second Floor Bathroom

### 41. Condition: • [Running continuously](#)

## Toilet flush mechanism

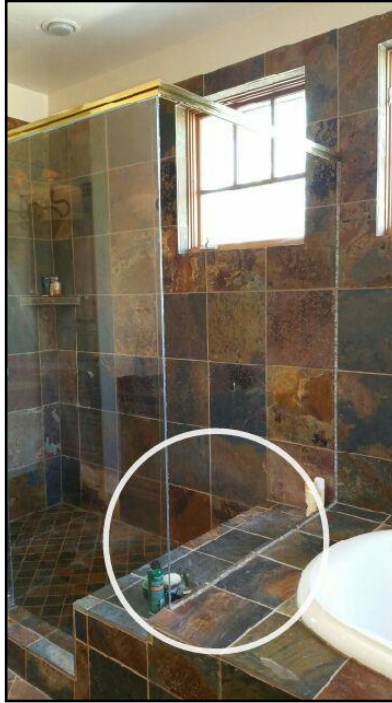
**Location:** Northwest Second Floor Bathroom

**42. Condition:** • The glass on the east aspect of the shower enclosure of the northwest second floor bathroom has been broken and is missing.

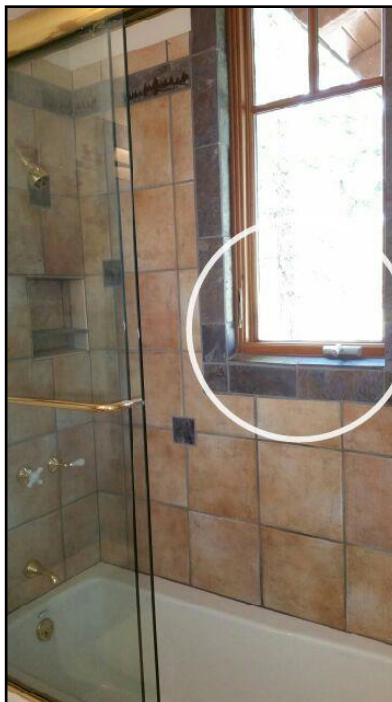
**Location:** Northeast First Floor Bathroom

**43. Condition:** • There is an unprotected window located in the shower enclosure of the northeast first floor bathroom.

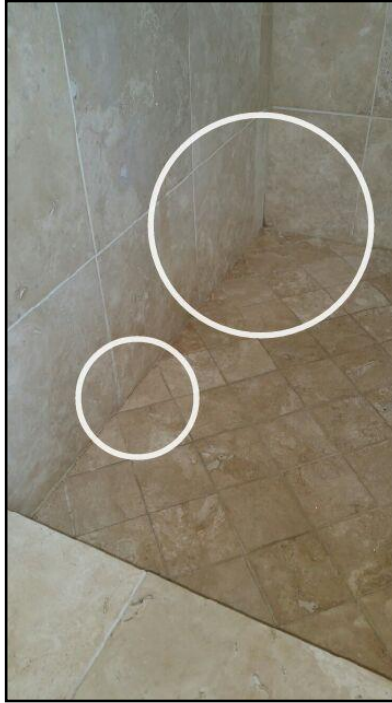
**Location:** Hallway Bathroom

**44. Condition:** • [Caulking loose, missing or deteriorated](#)

Deterioration of the grout is present in the shower enclosure in the master bathroom. Furthermore, it is suggested that a doorstop should be installed for the glass shower door.

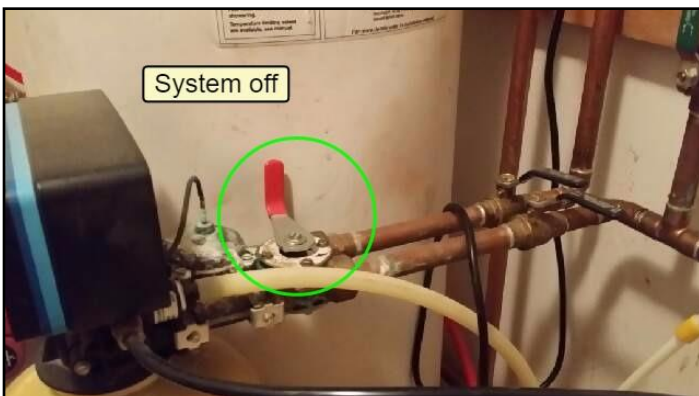
**Location:** Water Treatment

**46. Condition:** • Reverse osmosis systems, water softeners or filters are beyond the scope of a home inspection. You may want to determine the last date of service and service accordingly.

Furthermore, the water softener was off, and this unit is original. Water softener typically have 10 to 15 year useful lifespans. The system may need to be replaced. Two of the filters have been removed from the RO system in the utility room as well.

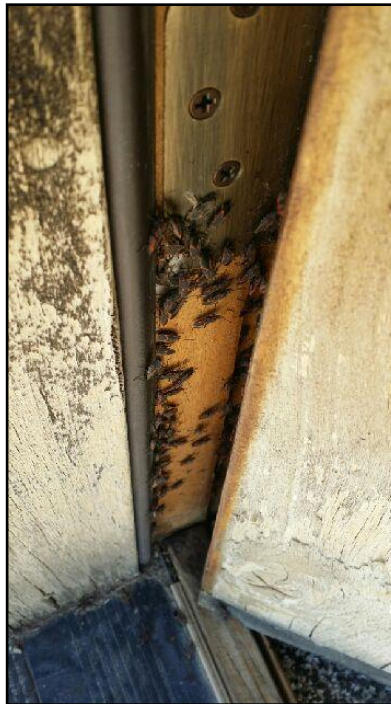
**Location:** Interior

**48.** • Common in homes in Utah and typically not considered to be destructive. Box elder bugs are present around multiple aspects home. Service by a pest-control contractor is recommended.

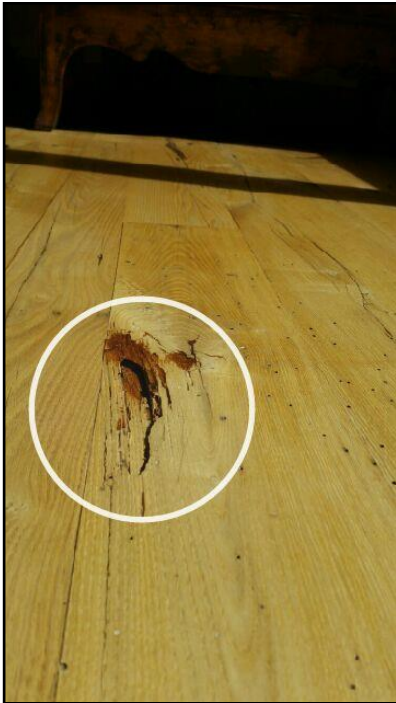
**Location:** Master Bedroom, Interior

**51. Condition:** • The wood floor is faded likely due to U/V exposure.

There is damage present to the wood floor in the master bedroom and small areas in the room have been patched.

*Fading*

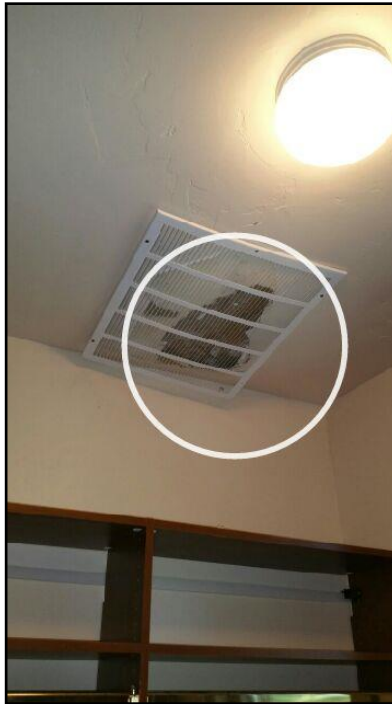
**Location:** Master Bedroom

**52. Condition:** • Water damage due to previous ice damming is present in the ceiling of the master bedroom closet.

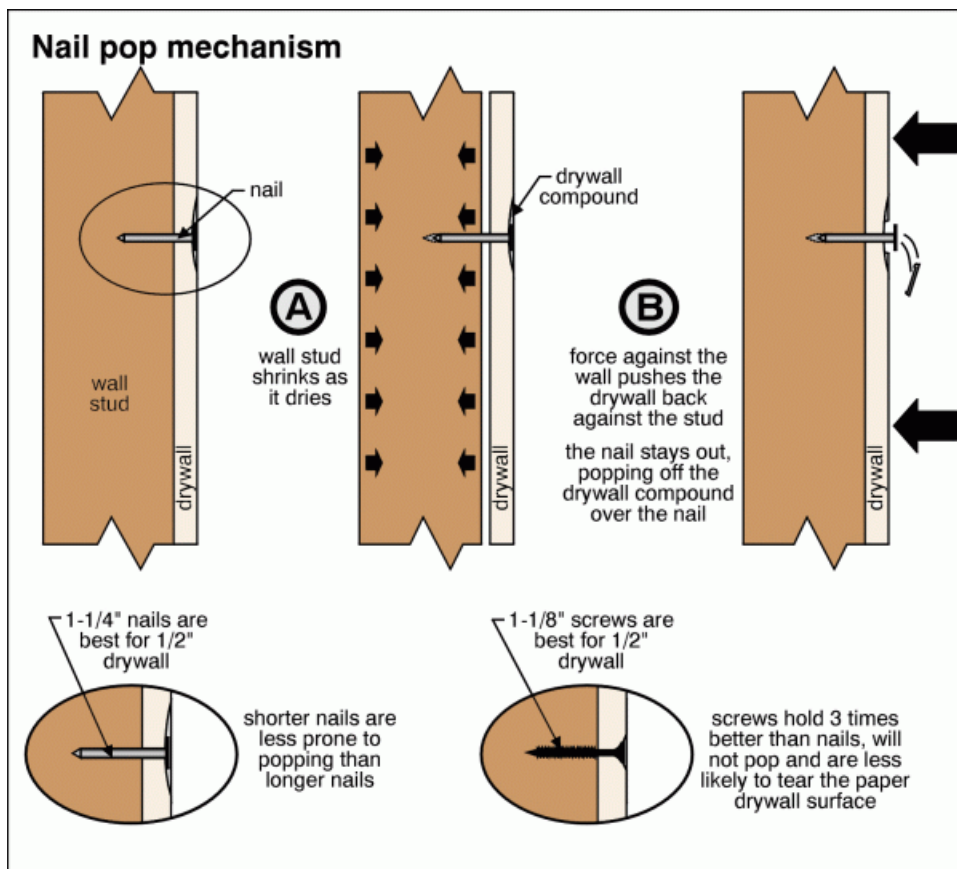
**Location:** Various Aspects Of The Interior

**54. Condition:** • [Nail pops](#)

Nail pops are present in multiple aspects of the ceilings in the second floor. This may be related to inadequate ventilation in the attic.

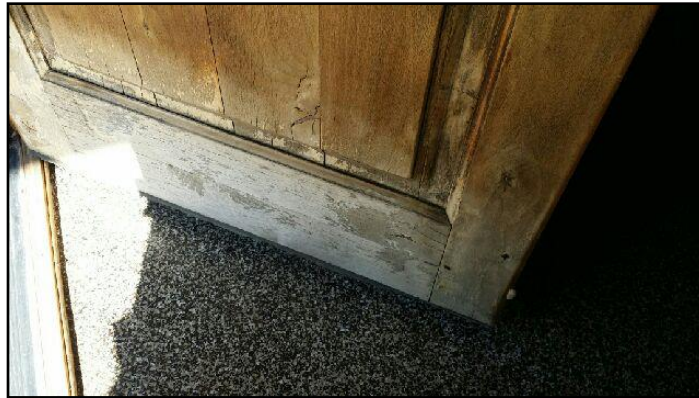
**Location:** West First Floor Garage

**57. Condition:** • Weather and UV damage are present along with two exterior doors on the west wall of the garage. These doors do not appear to be rated for exterior exposure.

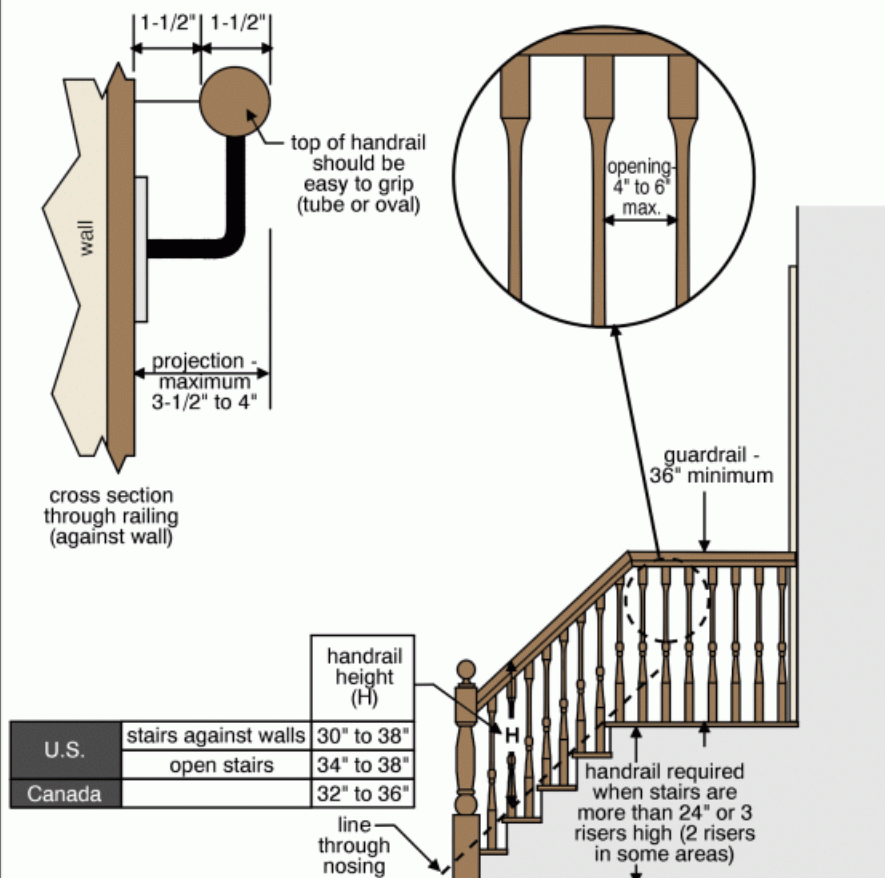
**Location:** North Second Floor

### 58. Condition: • [Missing](#)

A handrail is missing along north primary staircase.

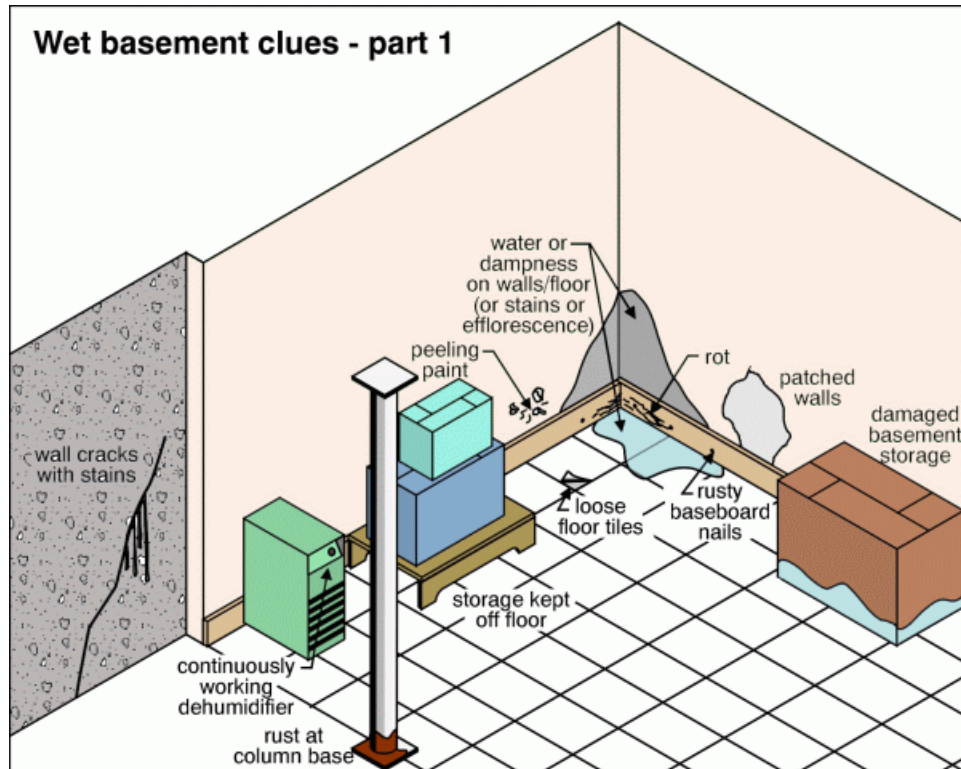
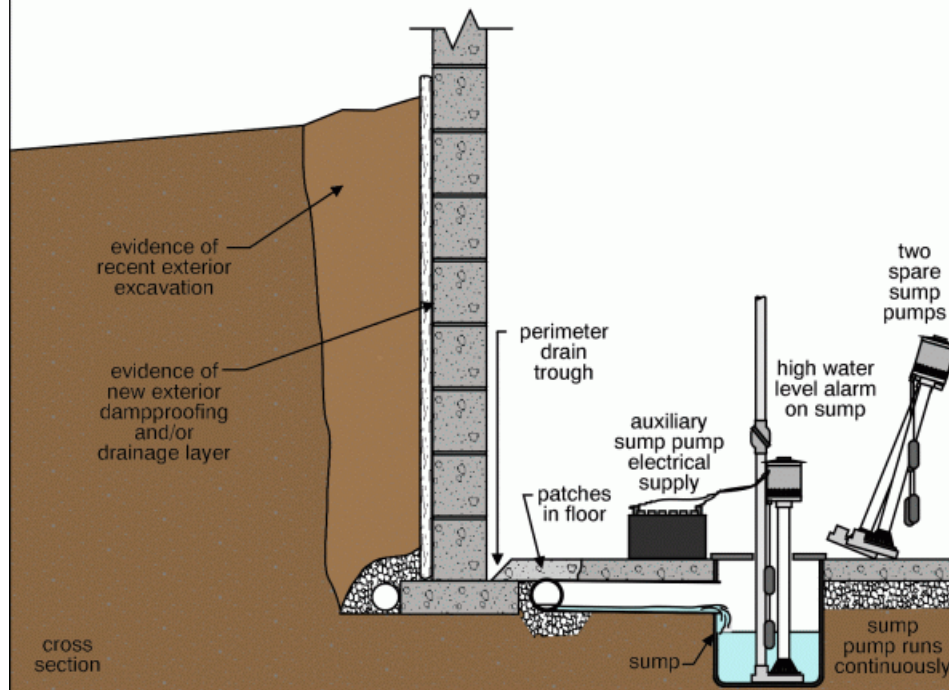
**Location:** Crawl Space

### 59. Condition: • [Water marks](#)

Moisture staining is present on the vapor retarder and high water marks are present throughout the crawlspace likely caused by moisture penetration. Additional evaluation by a contractor specializing in crawl space drainage is recommended to determine if installation of sump pumps are needed.

Signs of moisture

*Moisture staining*
