# YOUR Inspection Report

1000 Just Built Rd  
Simpsonville, KY 40069

Thursday, February 15, 2018

RE: Report No. 1031, v.2  
1000 Just Built Rd  
Simpsonville, KY  
40069

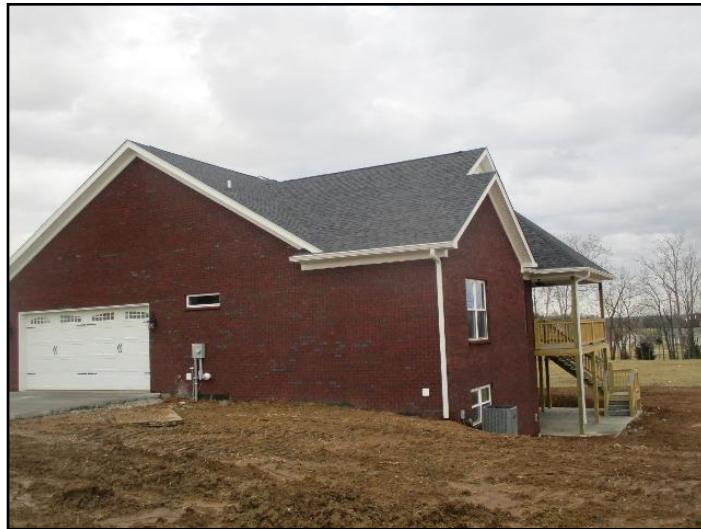
3. Away from building

The front and right side of the house drains towards the building and the left and rear side of the house slopes away from the building. Recommend rechecking the final grade to assure all drainage will be diverted away from or around the house.

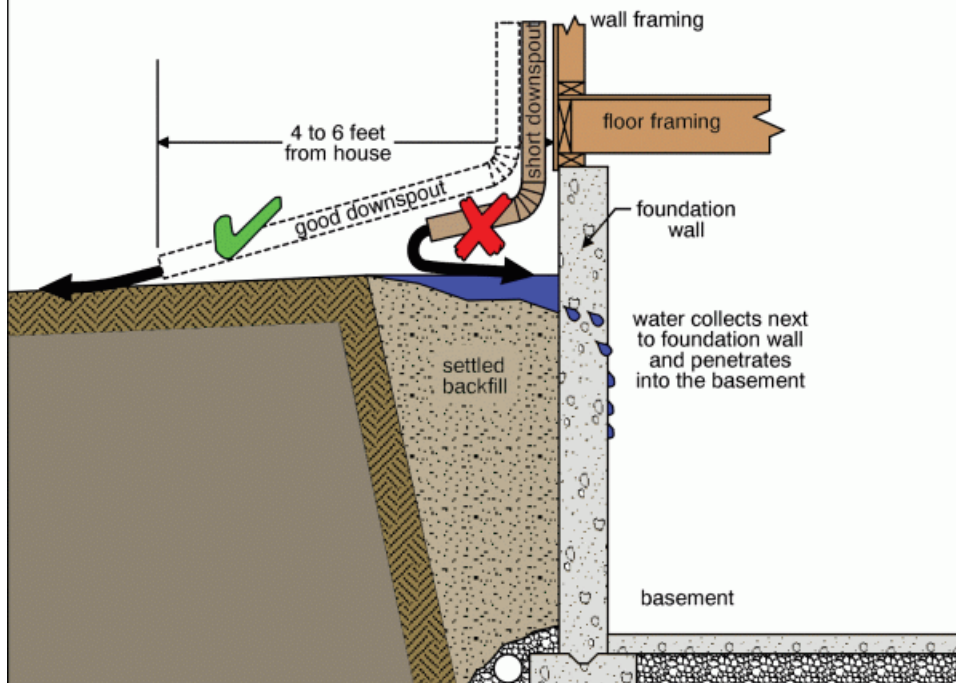
## Downspout extension too short

**1. Condition:** • [Should discharge 6 feet from building](#)

**Implication(s):** Chance of water damage to contents, finishes and/or structure
