Your Inspection Report

42 Kawaihani Circle
Kihei, HI 96753

INSPECTION DATE:
Tuesday, October 8, 2019

RE: Report No. 1012
42 Kawaiiani Circle
Kihei, HI
96753

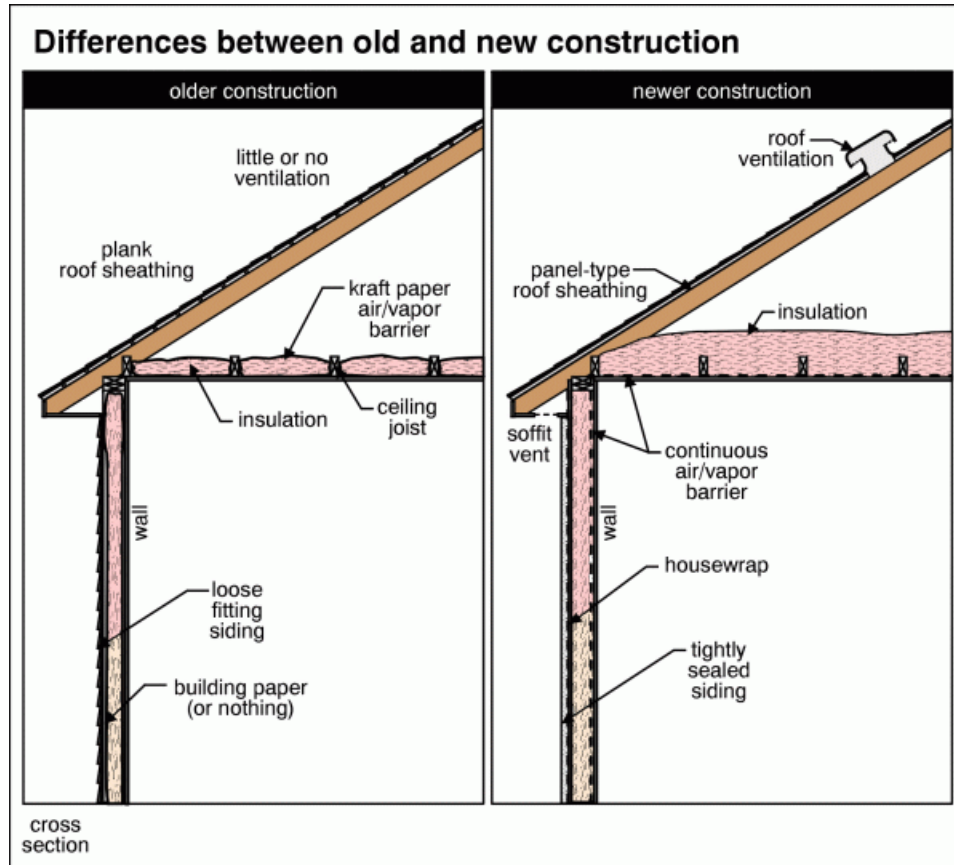
Location: Attic

Implication(s): Chance of condensation damage to finishes and/or structure | Increased heating and cooling costs | Reduced comfort
