# YOUR Inspection Report

123 Home Sweet Home Lane  
Louisville, KY 40212

Wednesday, August 23, 2017

RE: Report No. 1005, v.6  
123 Home Sweet Home Lane  
Louisville, KY  
40212

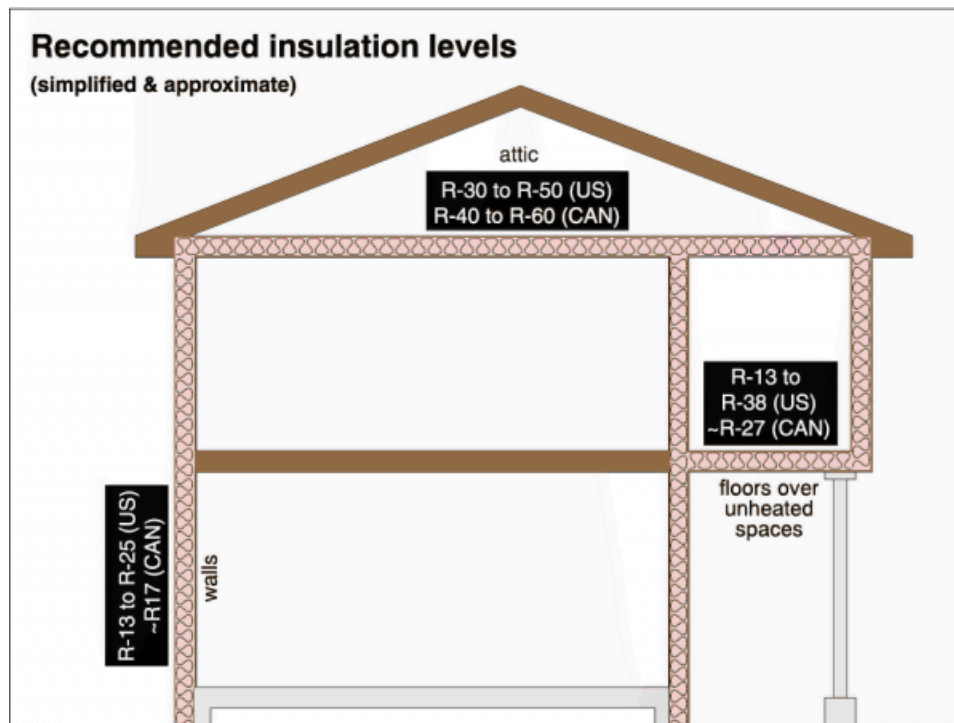
Implication(s): Increased heating and cooling costs

Task: Have evaluate by a qualified contractor
