YOUR INSPECTION REPORT

FOR THE PROPERTY AT:
23 Durie Street
Toronto, ON M6S 3E5

INSPECTION DATE:
Wednesday, March 4, 2020

RE: Report No. 2617, v.2
23 Durie Street
Toronto, ON
M6S 3E5

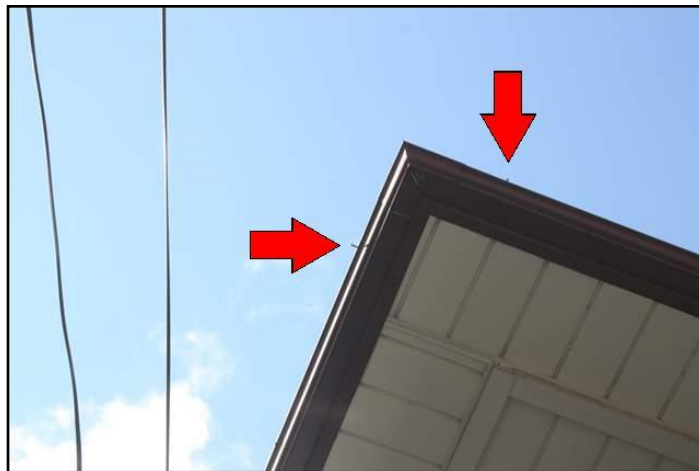
1. Example

Condition: • Aging - Wear and tear noted. Fasteners loose in some areas

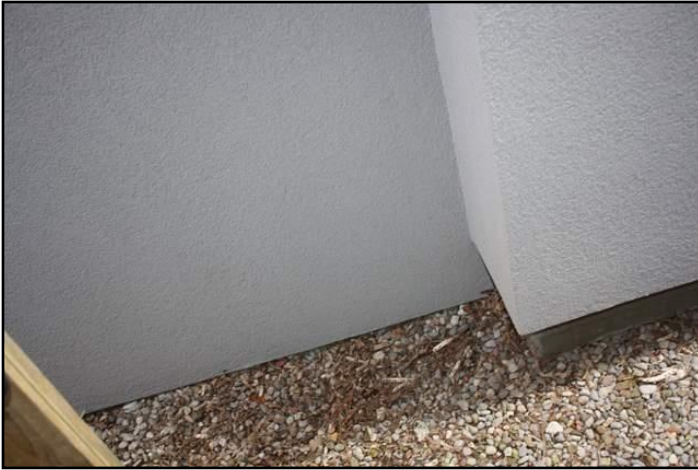
9. Too close to grade

Condition: • [Too close to grade](#)

Implication(s): Chance of water damage to contents, finishes and/or structure | Material deterioration

Time: As Needed

Cost: Consult with EIFS Contractor when necessary
