Your Inspection Report

123 West Drive
Your Town, LA 70000

INSPECTION DATE:
Thursday, June 8, 2017

Report No. 1004, v.3

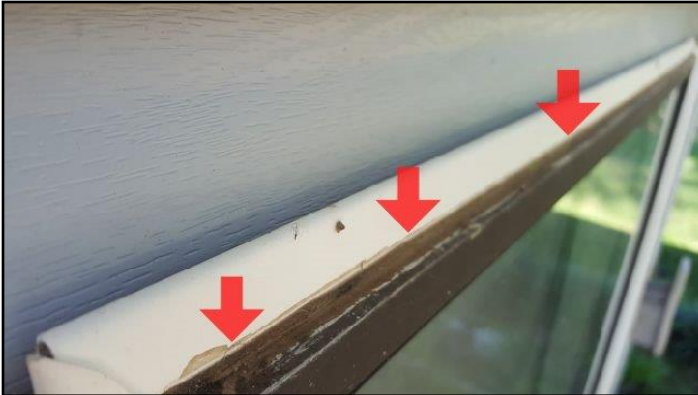
17. Condition: • [Ineffective](#)

Implication(s): Chance of water damage to contents, finishes and/or structure

Ineffective

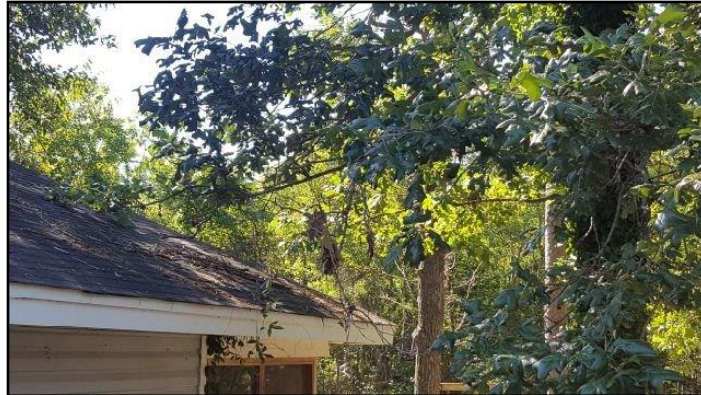
18. Condition: • [Trees or shrubs too close to building](#)

Implication(s): Chance of water damage to contents, finishes and/or structure | Chance of pests entering building | Material deterioration

Trees or shrubs too close to building

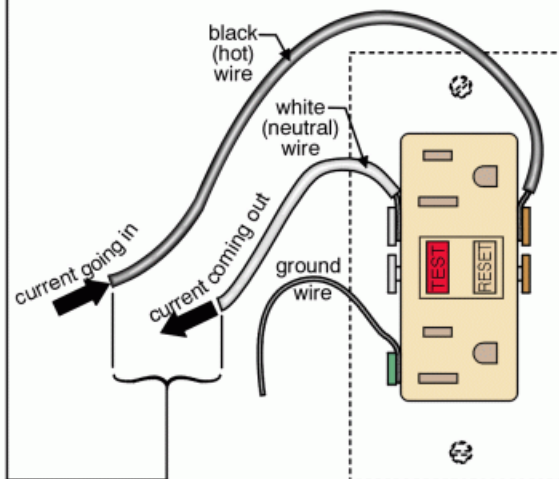
note:

if the GFI is in the panel, the entire circuit will be shut down

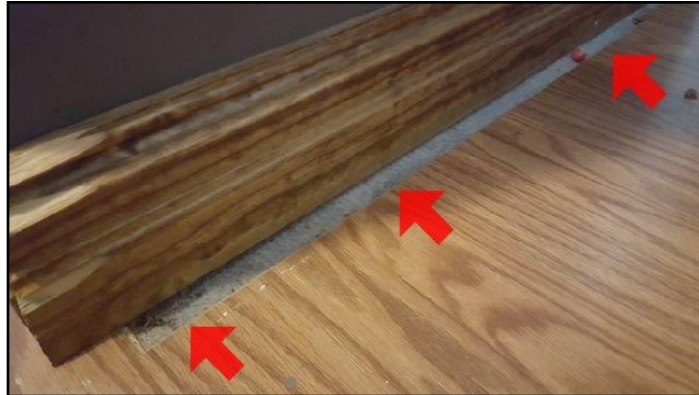
37. • Opening in the flooring

Location: Throughout Living Room, Hall

Gap
