# INSPECTION REPORT

For the Property at:  
**2581 SAMPLE WAY**  
NORCROSS, GA 30071

Inspection Date: Thursday, September 3, 2020

RE: Report No. 1019, v.2  
2581 Sample Way  
Norcross, GA  
30071

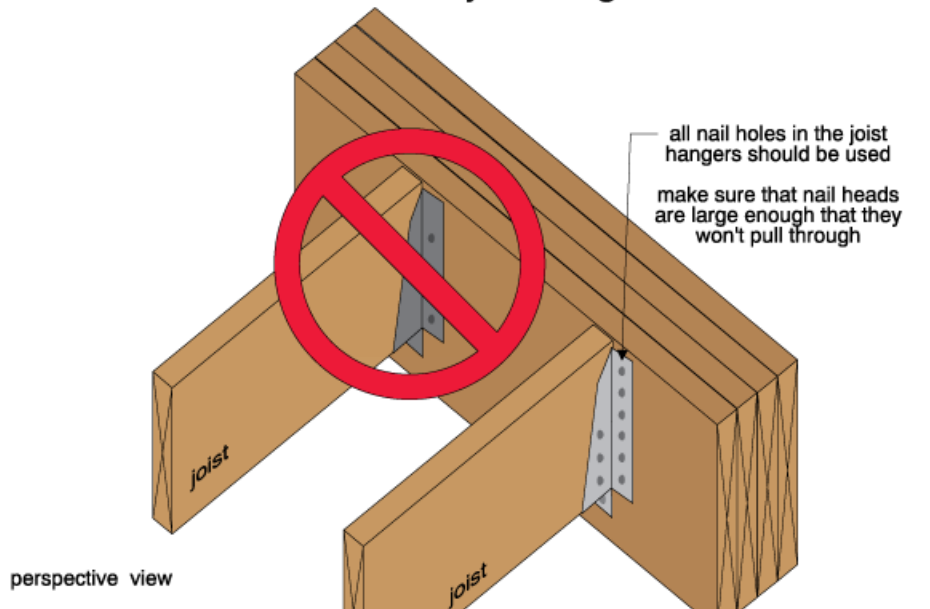
**Location:** Stair landings

**Condition:** • [Poor end bearing, joist hanger connections](#)

Recommend adding missing joist hangers to joists underneath stair landings to ensure proper support.
