YOUR INSPECTION REPORT

FOR THE PROPERTY AT:
231 Fairview Avenue
Toronto, ON M6P 3A6

INSPECTION DATE:
Thursday, February 26, 2026

RE: Report No. 9054
231 Fairview Avenue
Toronto, ON
M6P 3A6

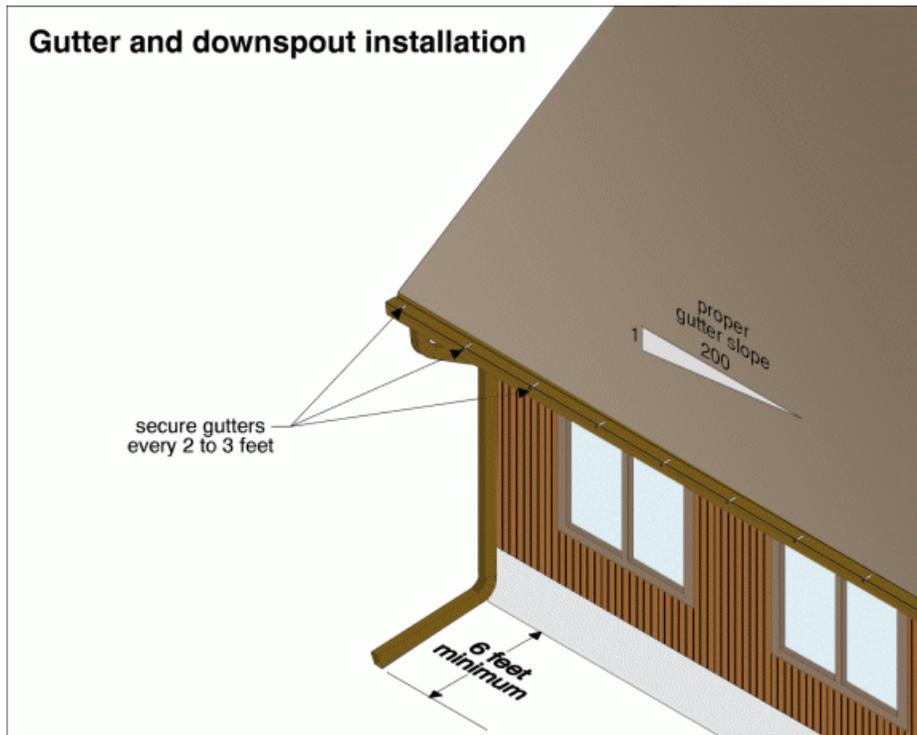
4. Missing example

Condition: • [Missing](#)

No gutter is installed along the right side roof overhang. Shingles extend beyond the roof edge and are beginning to sag at the eave. Installation of a gutter is recommended to improve roof edge support and control roof runoff.

Implication(s): Chance of water damage to structure, finishes and contents

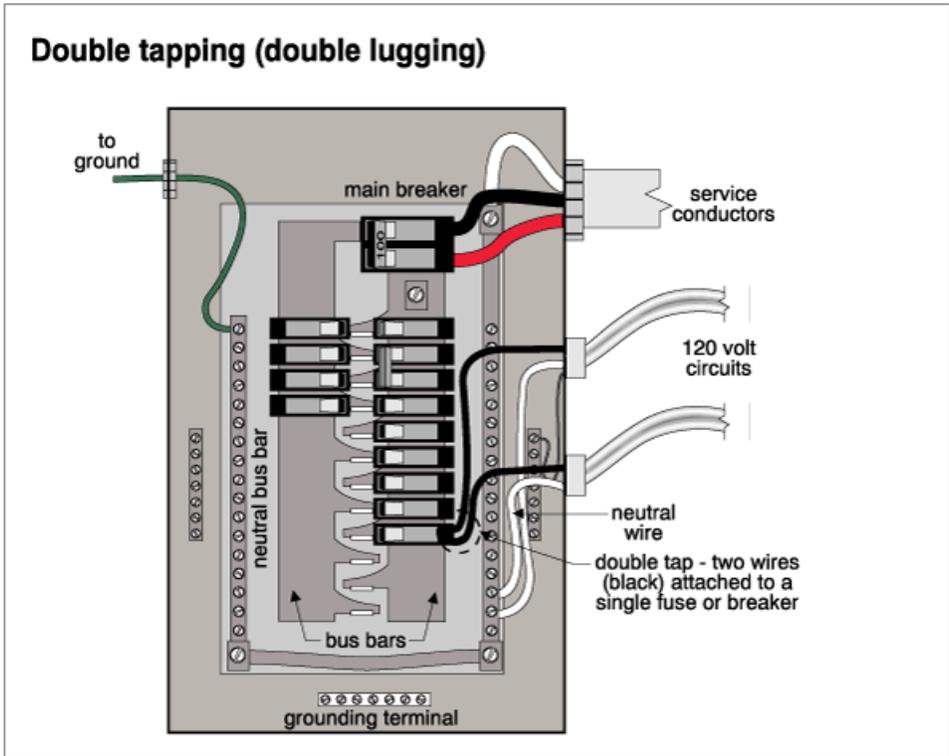
- Condition:** • [Double taps](#)
Implication(s): Fire hazard
Location: Various Basement Panel
Task: Correct
Time: As Soon As Possible
Cost: Minor

13. Double taps

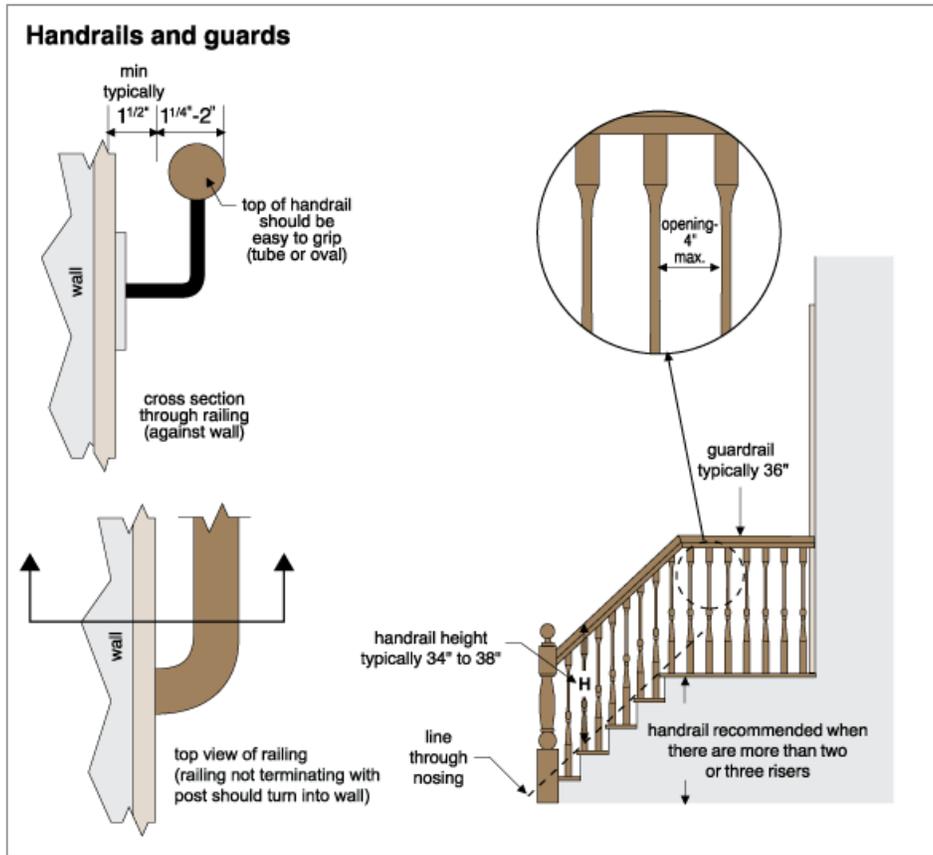
STAIRS \ Guardrails

Condition: • [Too low](#)
