# YOUR INSPECTION REPORT

139 Gilmour Avenue  
Toronto, ON M6P 3B2

INSPECTION DATE:  
Thursday, March 15, 2018

RE: Report No. 2243  
139 Gilmour Avenue  
Toronto, ON  
M6P 3B2

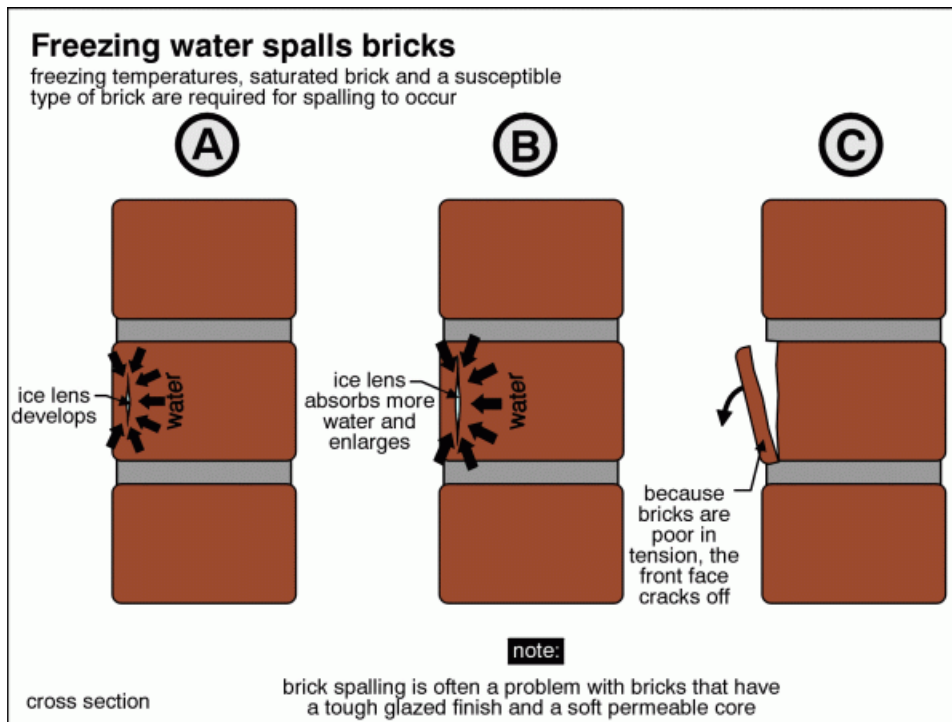
12. Spalling

**Condition:** • [Spalling](#)

Spalling/ masonry deterioration noted at various areas. Repair / Replace / Tuck point masonry. This is regular maintenance for a home of this age.

**Task:** Repair

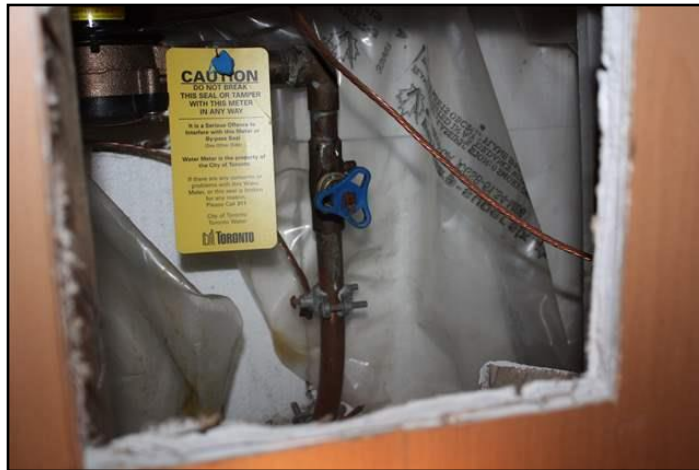
30. Basement

Main water shut off valve at the:

• Basement
