# HOME INSPECTION REPORT

PREPARED FOR:  
TOM LATHROP

INSPECTION DATE:  
Wednesday, March 3, 2021

RE: Report No. 1080  
4147 Cedar Hill Road  
Victoria, BC  
V8N 3C2

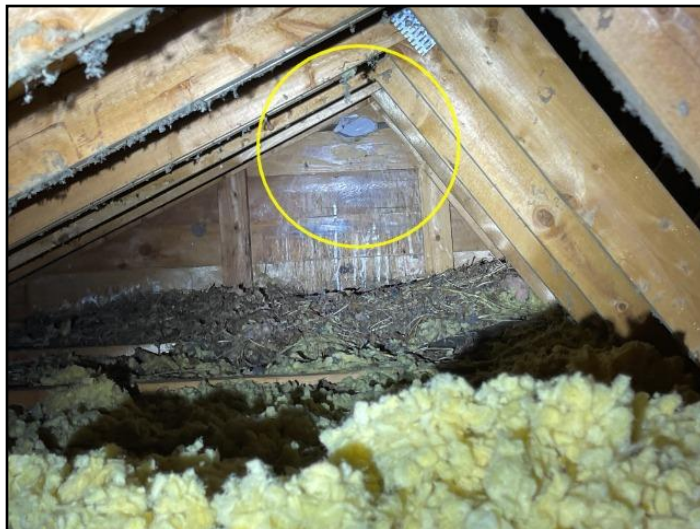
**Condition:** • There is a hole in the north gable / soffit.

Birds have been nesting in the attic - repair / seal opening.
