# **Your Inspection Report**

# 254 Windermere Ave Etobicoke, ON

**INSPECTION DATE:** Friday, April 21, 2017

RE: Report No. 57777, v.5 254 Windermere Ave Etobicoke, ON

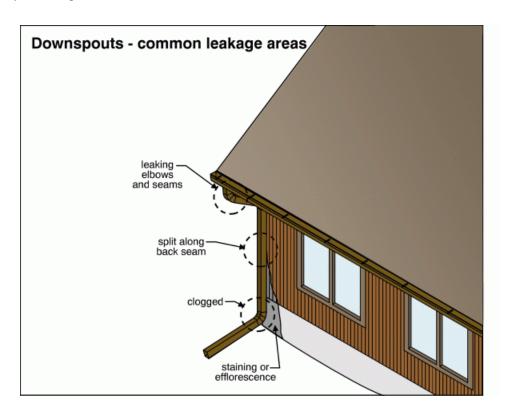
**Condition:** • Damage

Minor damage noted. Also, the downspout configuration from dormer to lower gutters should be improved.

Implication(s): Chance of water damage to contents, finishes and/or structure

**Location**: Exterior **Task**: Replace

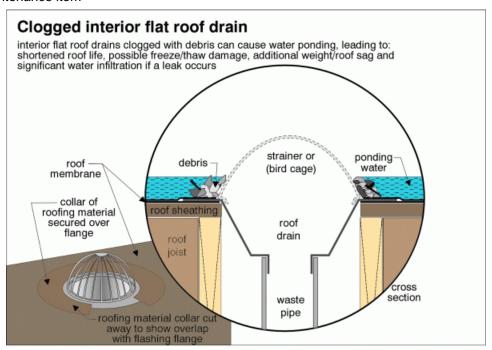
Condition: • Clogged

Implication(s): Chance of water damage to contents, finishes and/or structure

Task: Clean

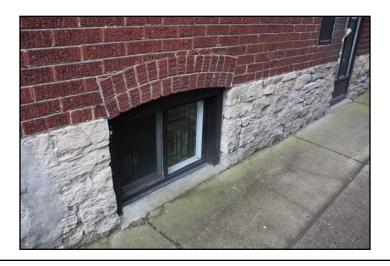
Condition: • Caulking missing or ineffective

Implication(s): Chance of water damage to contents, finishes and/or structure

Implication(s): Potential for water leakage / damage

Location: Various Exterior Task: Monitor / Improve Time: Unpredictable

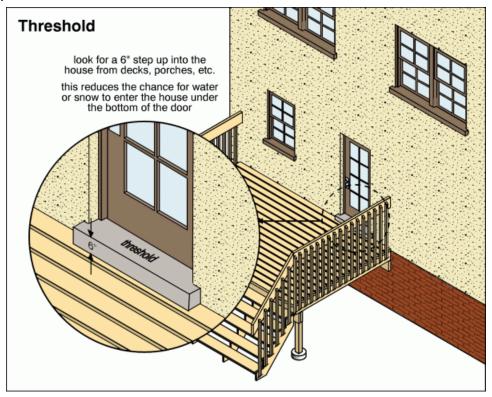
Condition: • Threshold - too low Location: Exterior South Side Task: Monitor / Improve
