your INSPECTION REPORT

888 Volcano Drive
Oahu, HI

RAM Inspections

RE: Report No. 1002, v.2
888 Volcano Drive
Oahu, HI

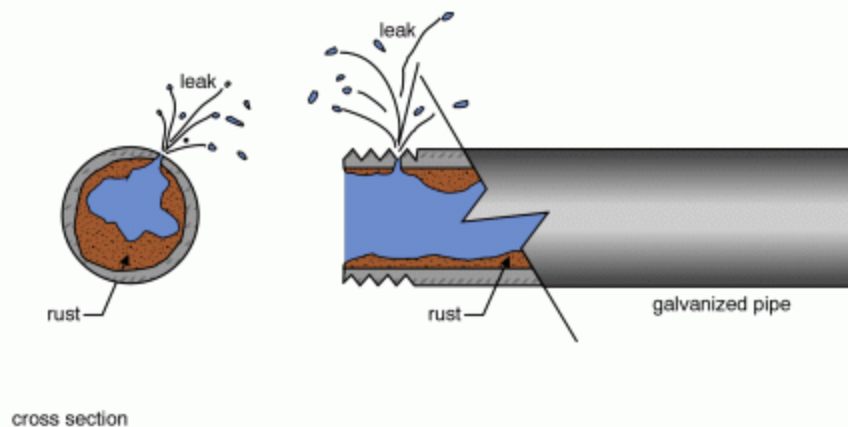
rusting of galvanized pipe can greatly reduce water pressure and will eventually cause leaks as rust creates holes in the pipe walls

problems are likely to occur soonest on pipes carrying hot water, horizontal pipes and at threaded (thinner) sections
