Your Inspection Report

51 Skylark Rd
Toronto, ON M6S 4M5

INSPECTION DATE:
Tuesday, April 7, 2026

RE: Report No. 96754, v.2
51 Skylark Rd
Toronto, ON
M6S 4M5

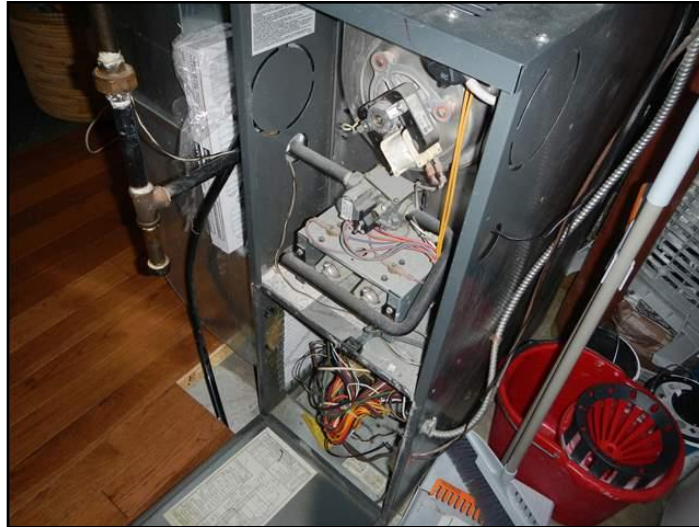
Furnace

Condition: • Near end of life expectancy

Although the furnace is close to the end of its life, continue to use and maintain the unit until it fails. Be prepared to replace the furnace at any time.

Task: Replace

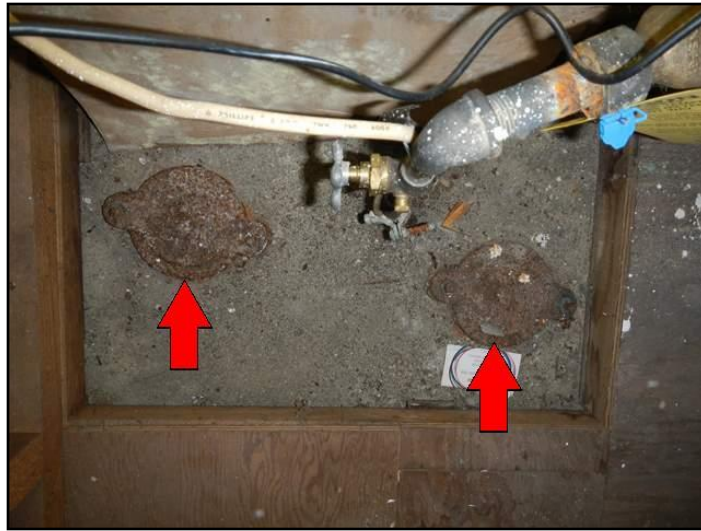
Cast iron

Condition: • The cast iron waste piping is near the end of its normal life expectancy and is prone to rusting through or splitting. Replacement may be required in the near future.

Task: Replace
