# YOUR INSPECTION REPORT

67 Westholme Avenue  
Toronto, ON M6P 3B9

INSPECTION DATE:  
Friday, January 11, 2019

RE: Report No. 2390, v.2  
67 Westholme Avenue  
Toronto, ON  
M6P 3B9

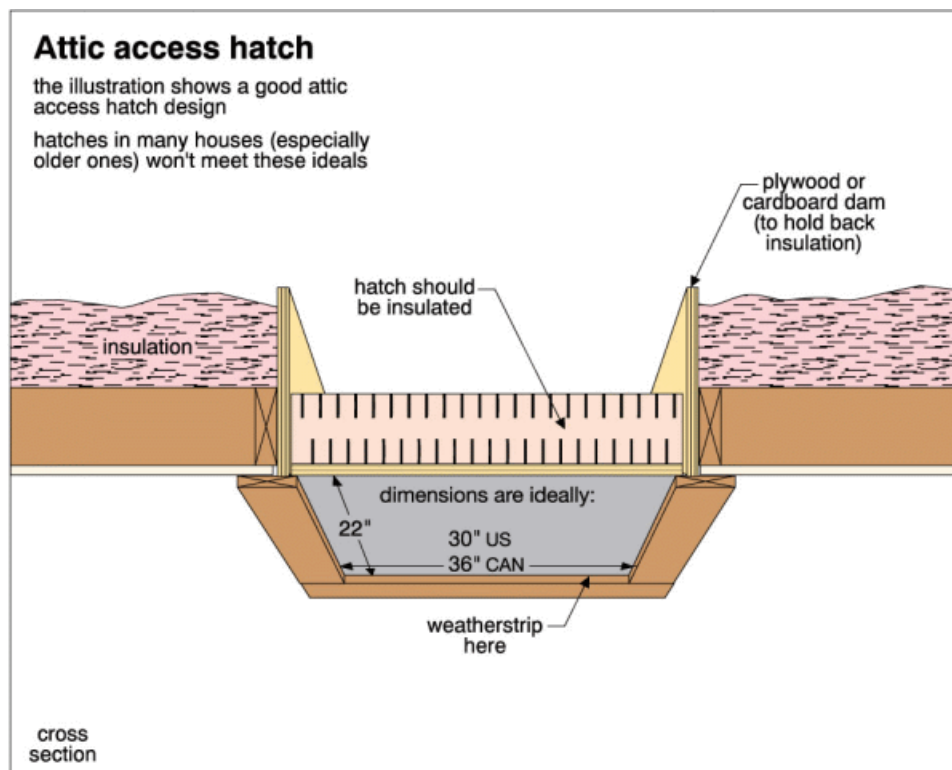
**Condition:** • [Inaccessible](#)

The attic hatch is sealed shut, therefore we could not observe the attic space. Provide larger access and inspect attic for issues with structure, insulation, water damage, vermiculite asbestos, and mold.

**Task:** Provide access and inspect

**Time:** Less than 1 year

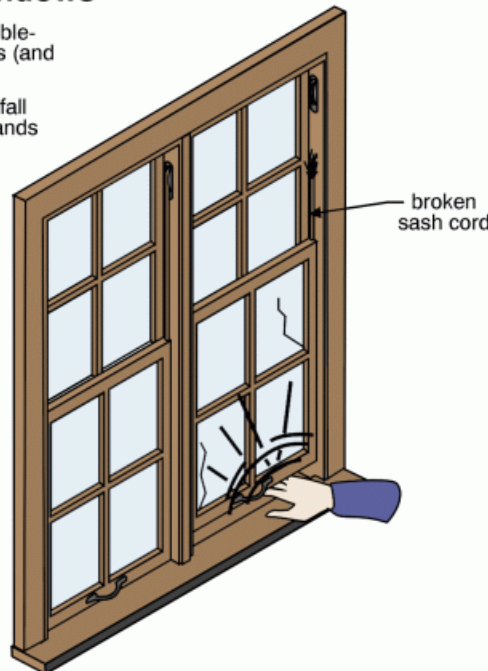
be careful when operating double-hung and single-hung windows (and also self-storing storms)

if they're defective, they could fall unexpectedly - injuring your hands and/or the window

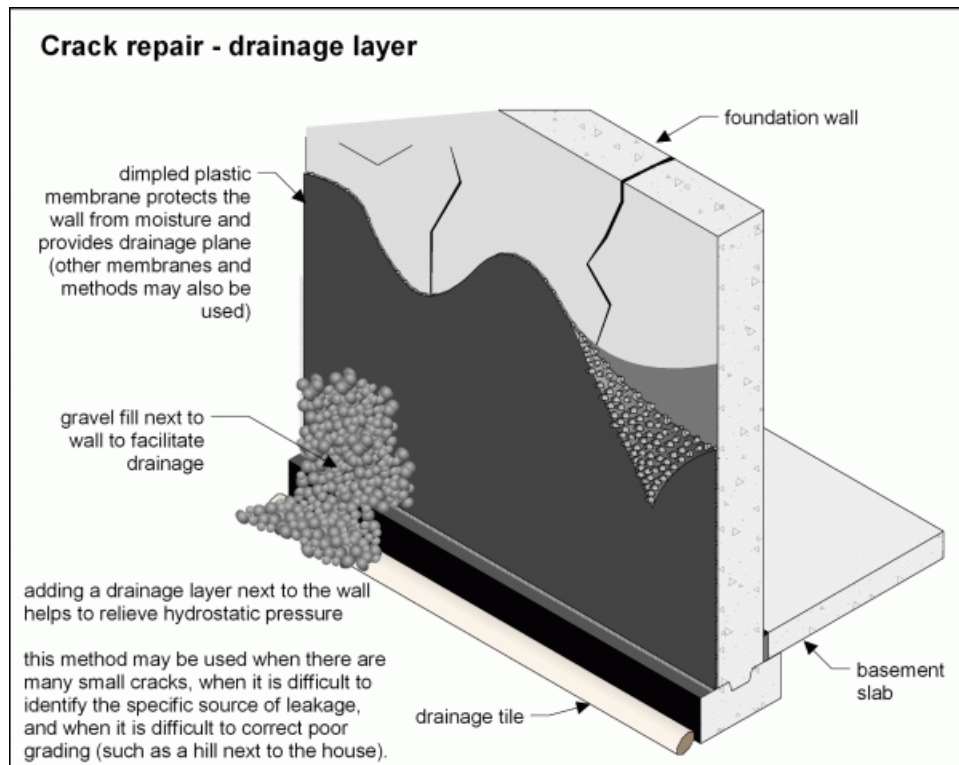
**Location:** Basement

**Task:** For Your Information
