YOUR INSPECTION REPORT

54 Albani St.
Etobicoke, ON

INSPECTION DATE:
Tuesday, August 15, 2017

RE: Report No. 2150
54 Albani St.
Etobicoke, ON

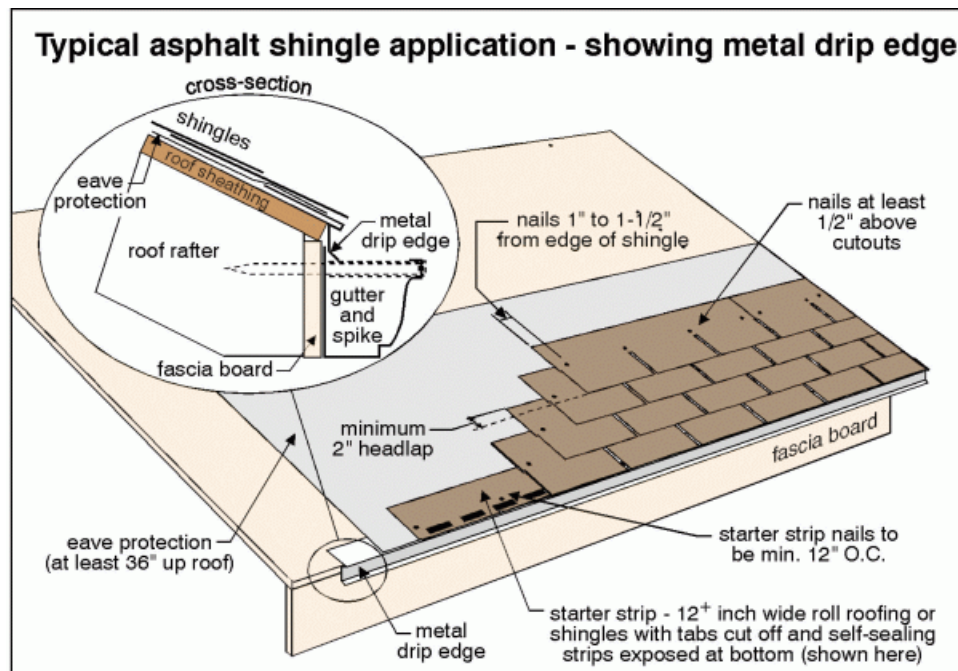
Condition: • [Exposed fasteners](#)

Implication(s): Chance of water damage to contents, finishes and/or structure

Time: Less than 1 year

Cost: Minor Regular maintenance item

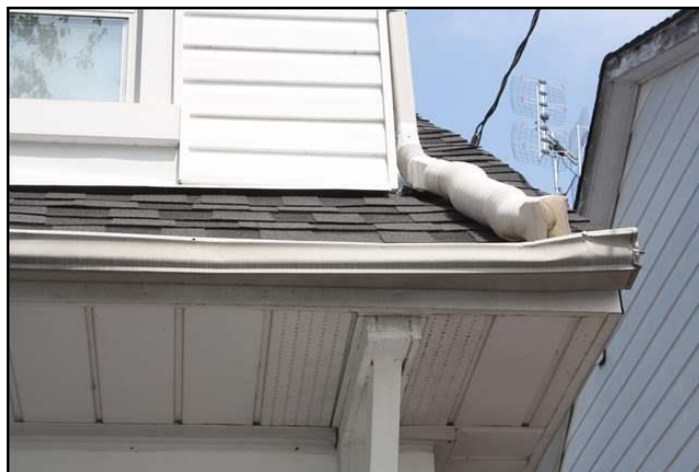
2. Example

Condition: • Damage

Task: Repair or replace

Time: Less than 1 year

Cost: Regular maintenance item \$5 to \$10 per linear foot to replace

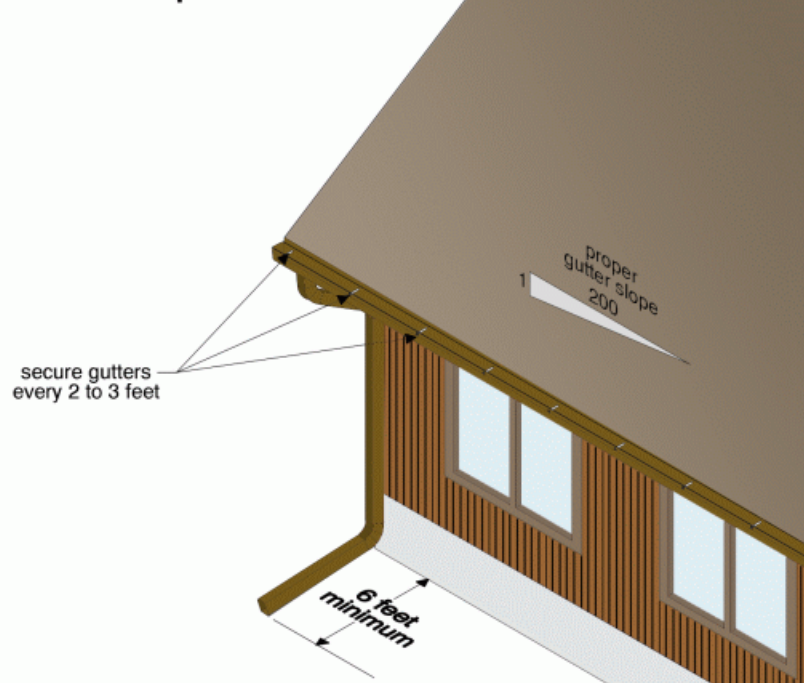
Condition: • [Should discharge 6 feet from building](#)

Cost: Minor

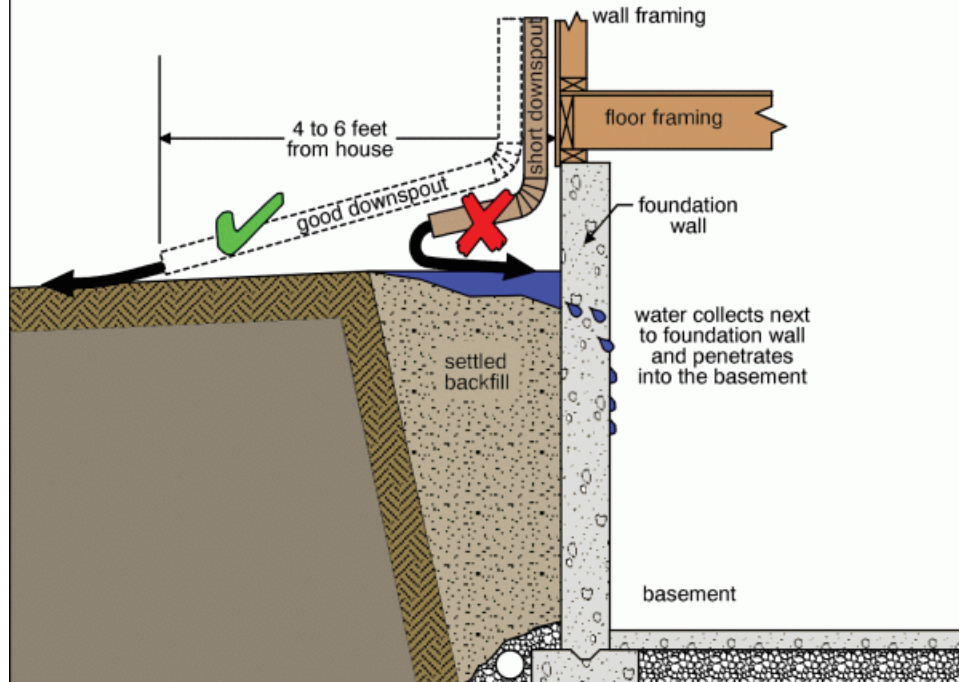
Downspout extension too short

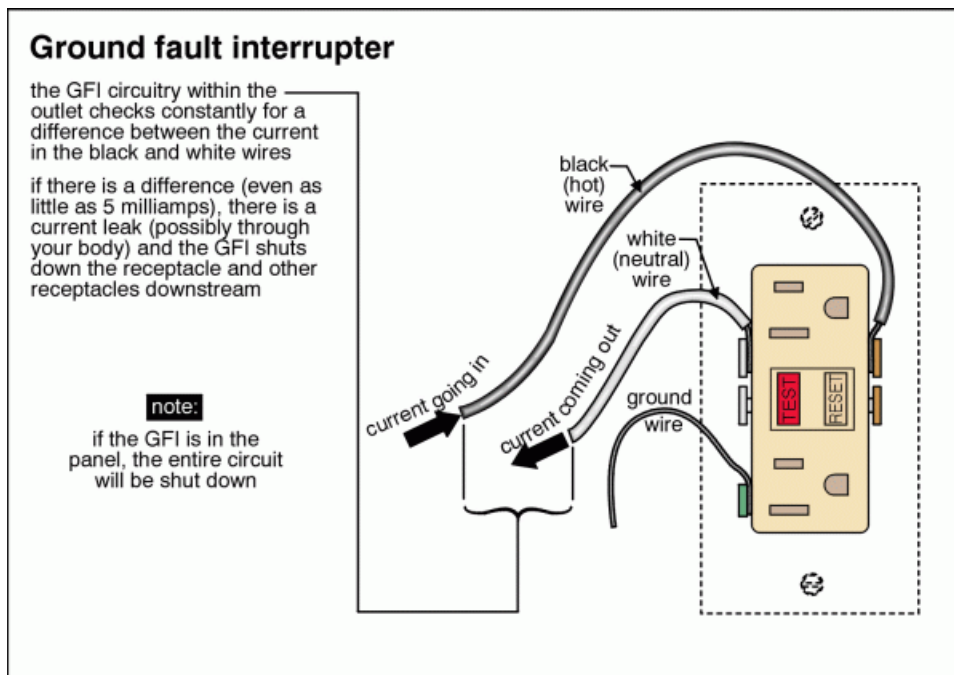
Condition: • [Missing](#)

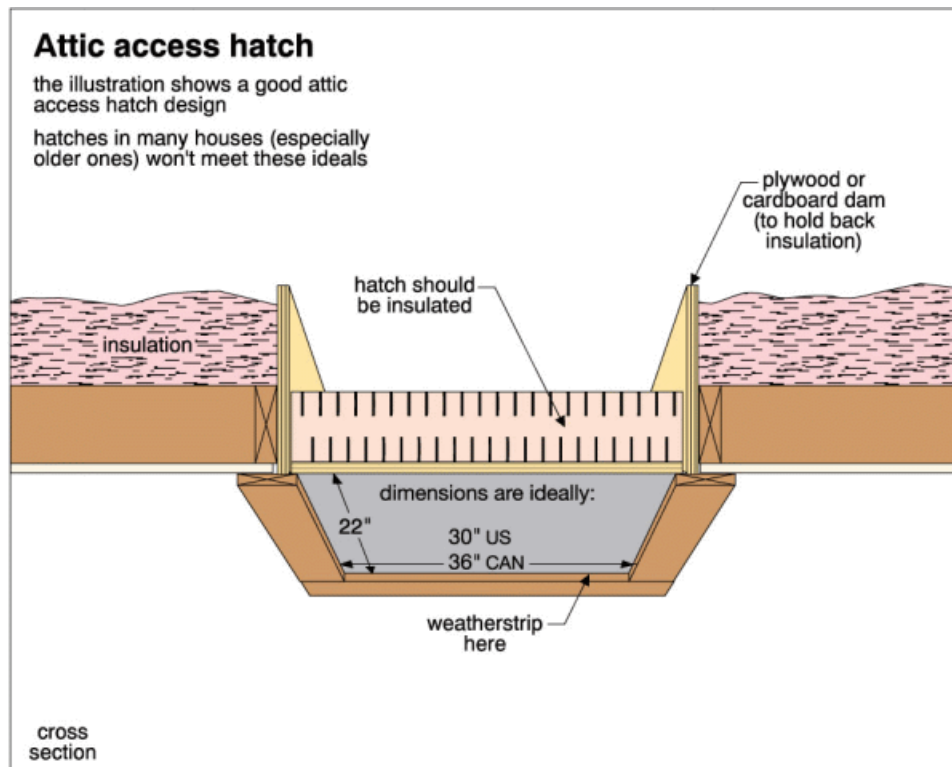
Condition: • [Inaccessible](#)

The attic hatch opening was too small, therefore we could not observe the attic. Attics are important areas. Provide larger access and inspect attic for issues with structure, insulation, water damage, vermiculite asbestos, and mold.

Task: Increase hatch opening and inspect

Time: Immediate

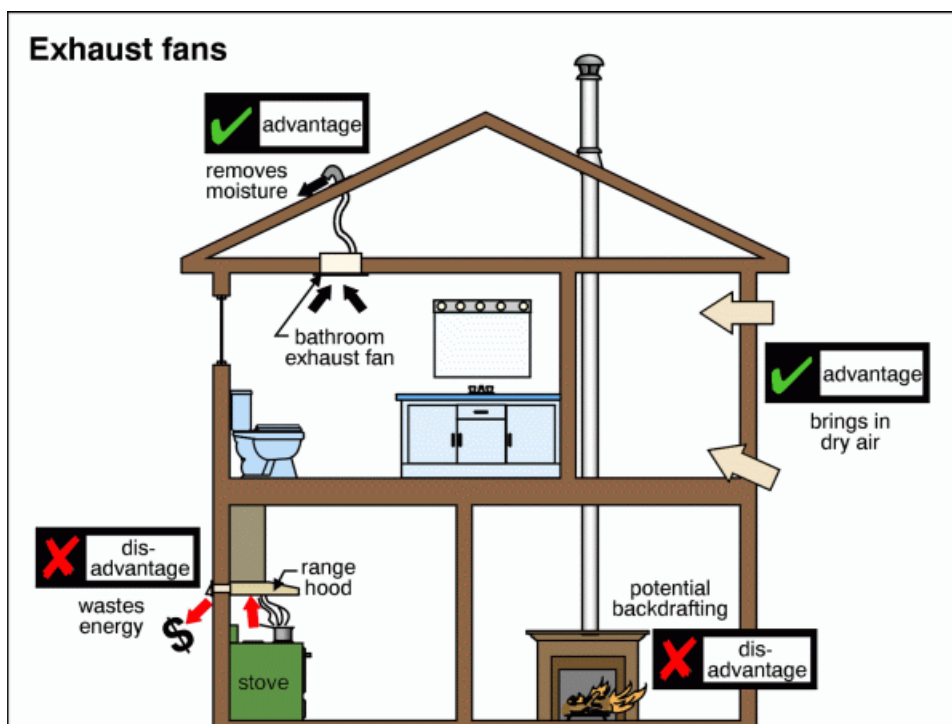
Condition: • [Missing](#)

Time: As Soon As Possible

Cost: \$300 - \$600

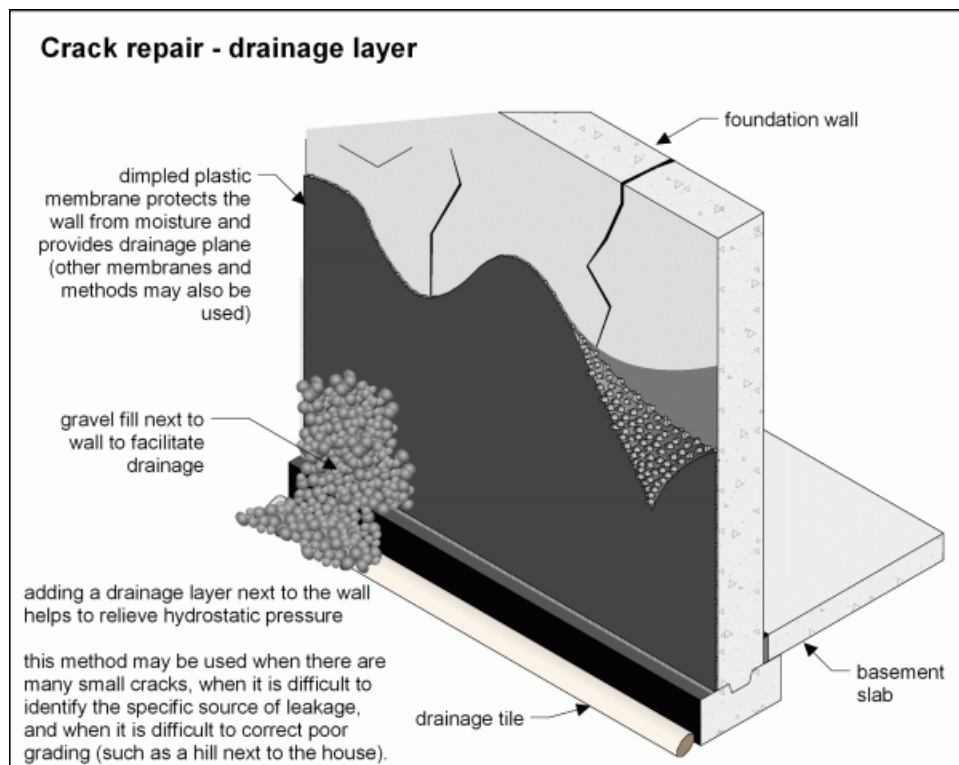
Condition: • ***FOR FUTURE REFERENCE*** Basement Leakage 4-step method.

Task: Monitor / Click link to read more information

Time: Unpredictable
