YOUR INSPECTION REPORT

631 Hudson Ave
Albany, NY

Wednesday, May 2, 2018

RE: Report No. 1001, v.7
631 Hudson Ave
Albany, NY

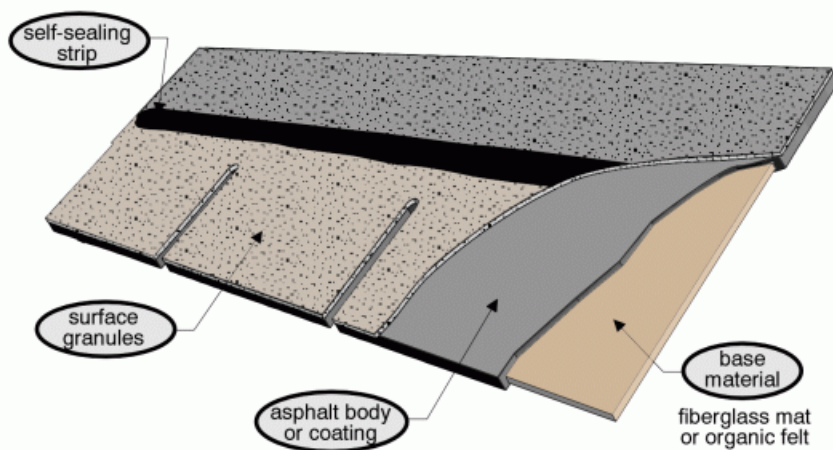
3. Condition: • [Granule loss](#)

Implication(s): Chance of water damage to structure, finishes and contents

Asphalt shingle composition

Task: Replace

Time: Less than 1 year

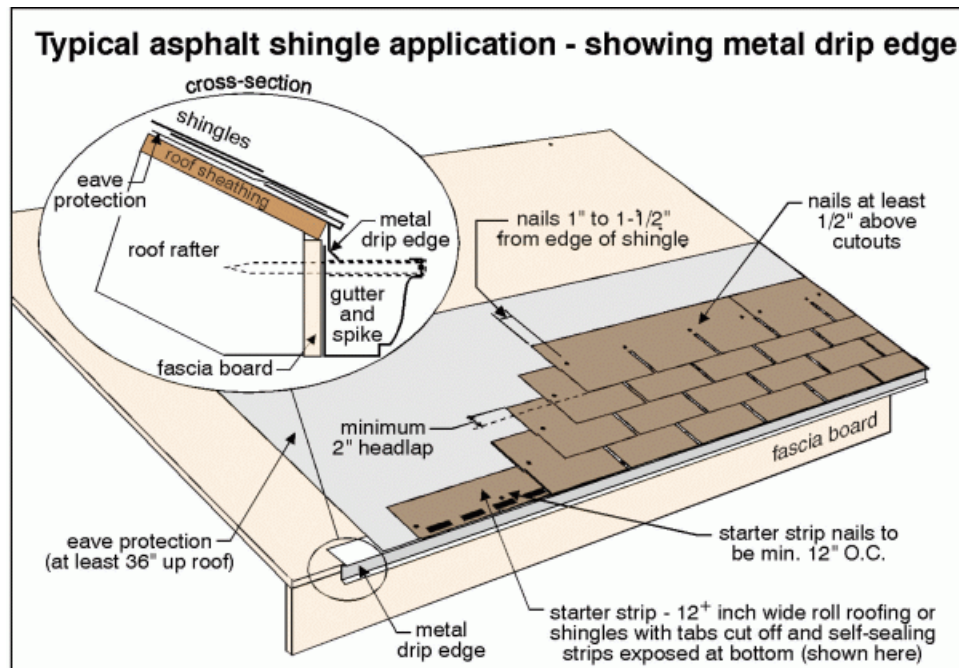
6. Condition: • [Exposed fasteners](#)

Implication(s): Chance of water damage to structure, finishes and contents

Location: Throughout

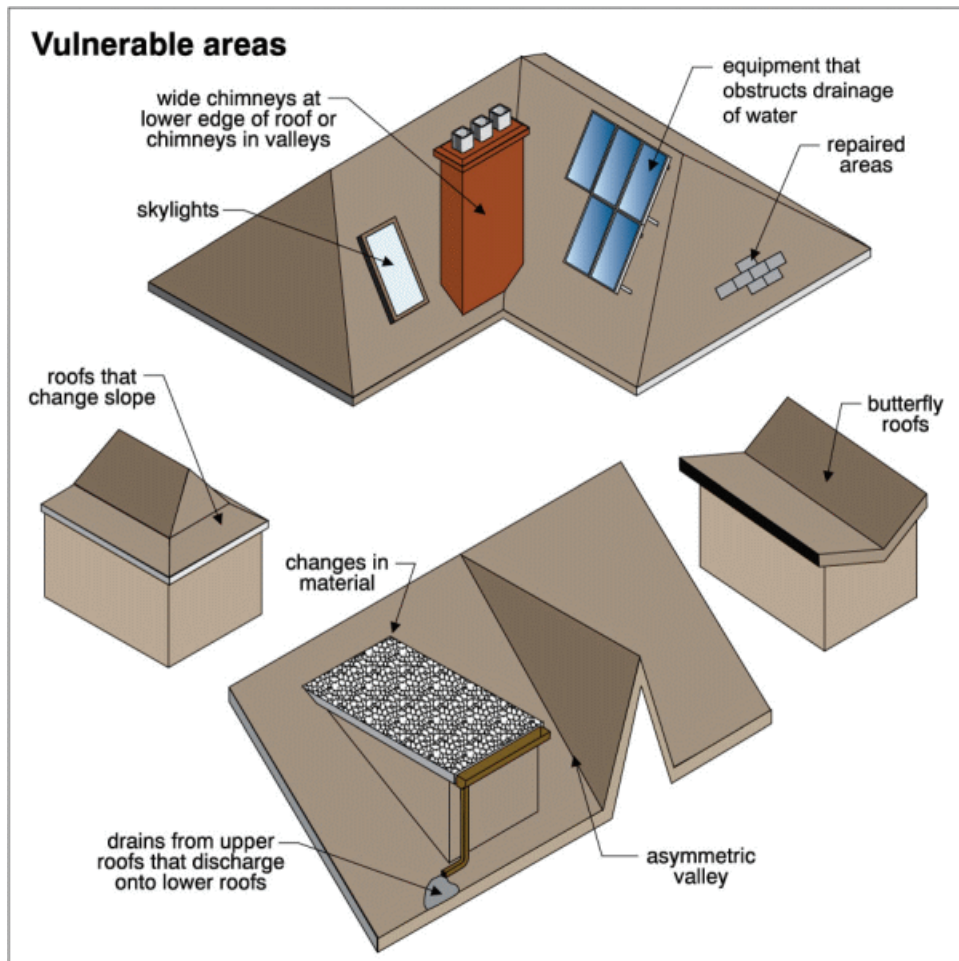
8. Vulnerable areas

7. Condition: • [Vulnerable areas](#)

Implication(s): Chance of water damage to structure, finishes and contents

Task: Repair or replace

Time: Less than 1 year

Cost: \$3,000 - \$7,000

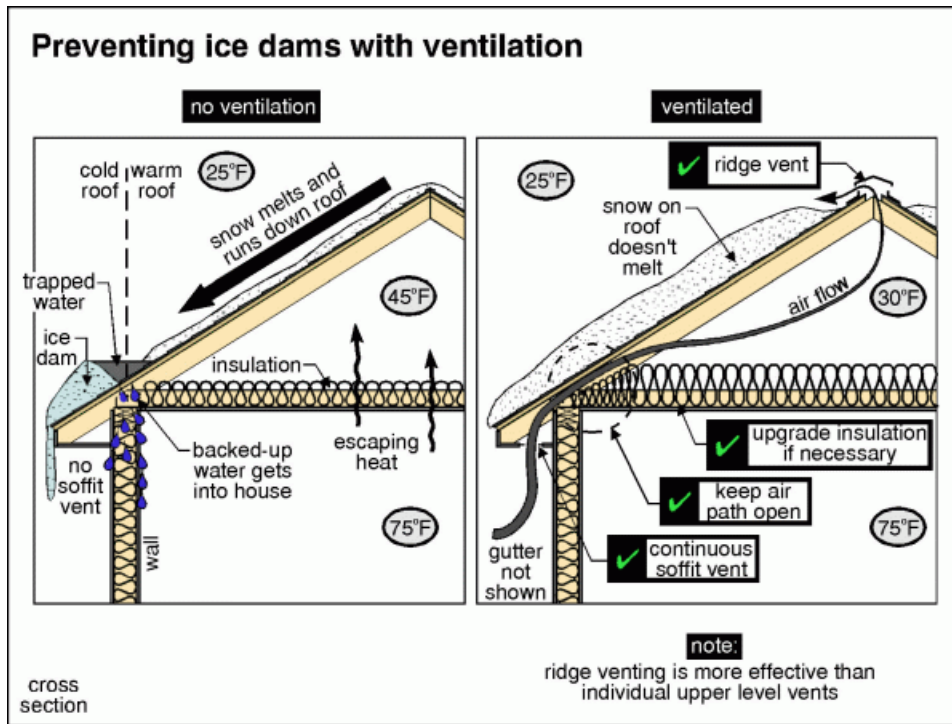
8. Condition: • [Vulnerable to ice damming](#)

Implication(s): Chance of water damage to structure, finishes and contents

Location: Throughout

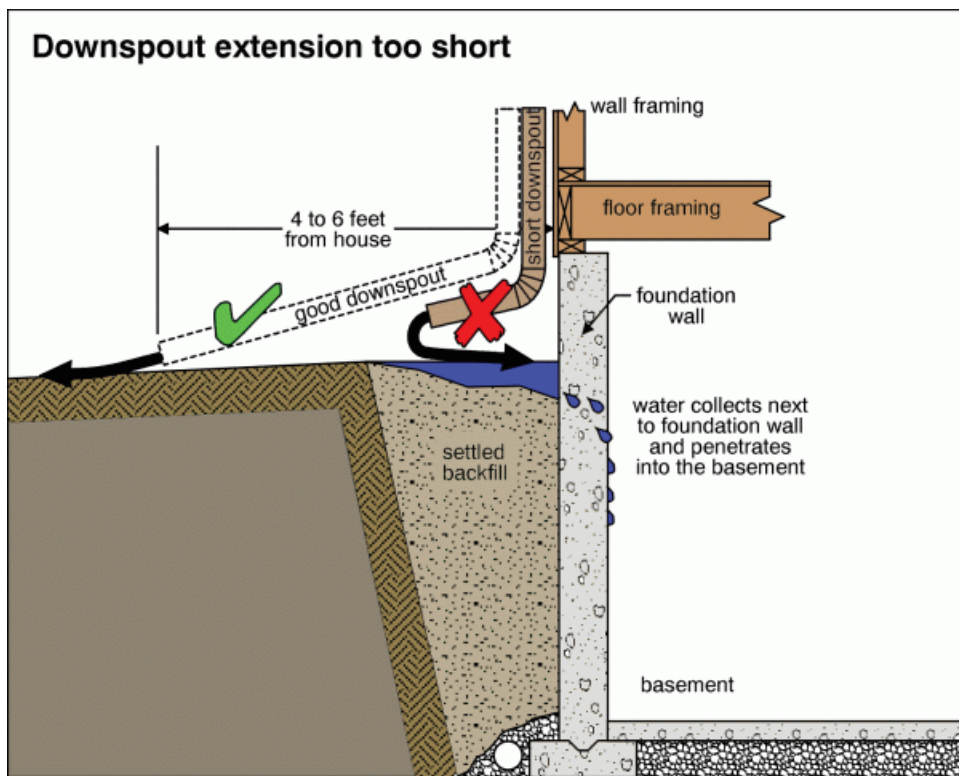
10. Downspouts end too close to building

11. Condition: • [Discharge too close to building](#)

Implication(s): Chance of water damage to structure, finishes and contents

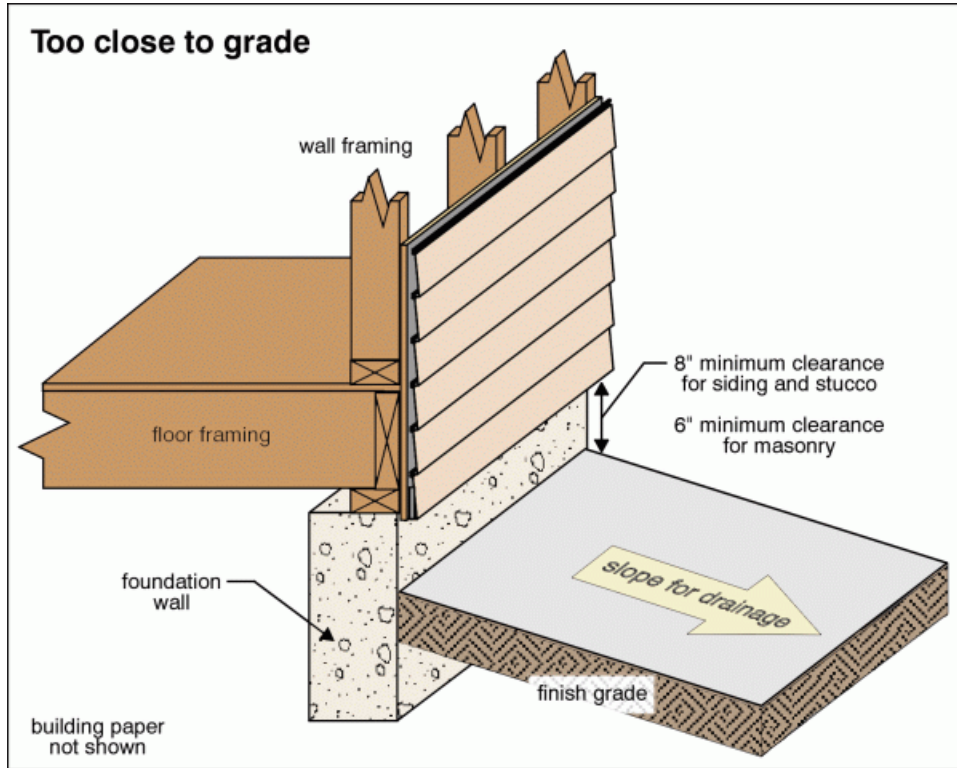
11. Too close to grade

12. Condition: • [Too close to grade](#)

Implication(s): Chance of water damage to structure, finishes and contents | Material deterioration | Rot | Insect

Task: Correct

Time: Less than 1 year

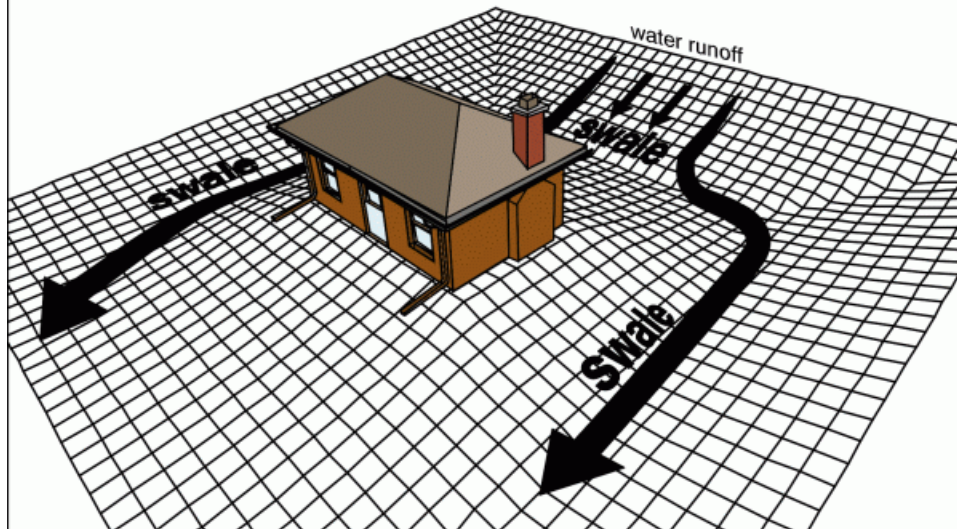
13. No swale

14. Condition: • [No swale](#)

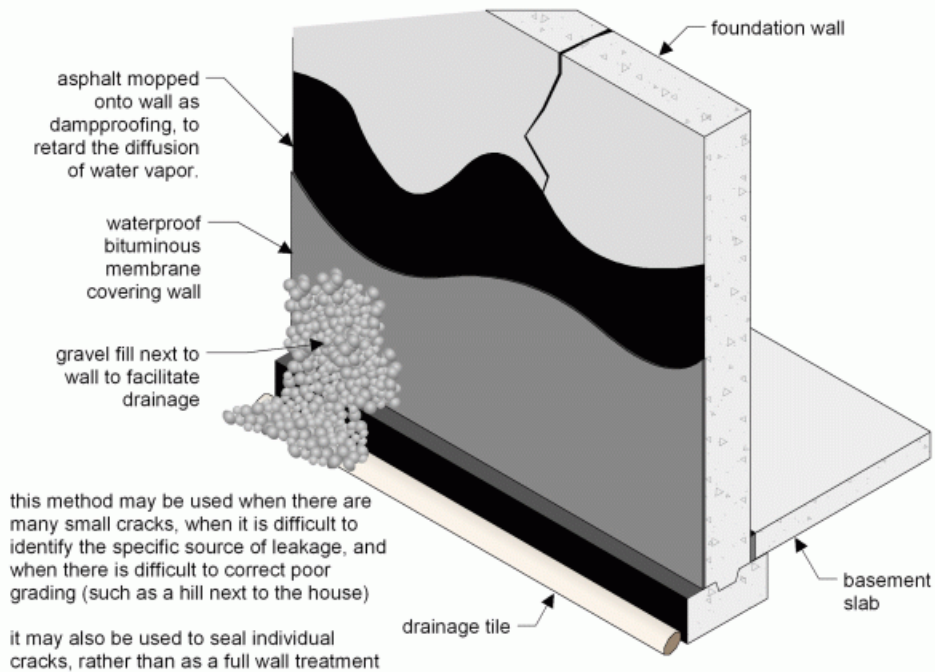
16. Typical minor cracks

15. Condition: • Typical minor cracks

Keep the water away from the foundation by extending the down spouts. Patch and monitor all cracks.

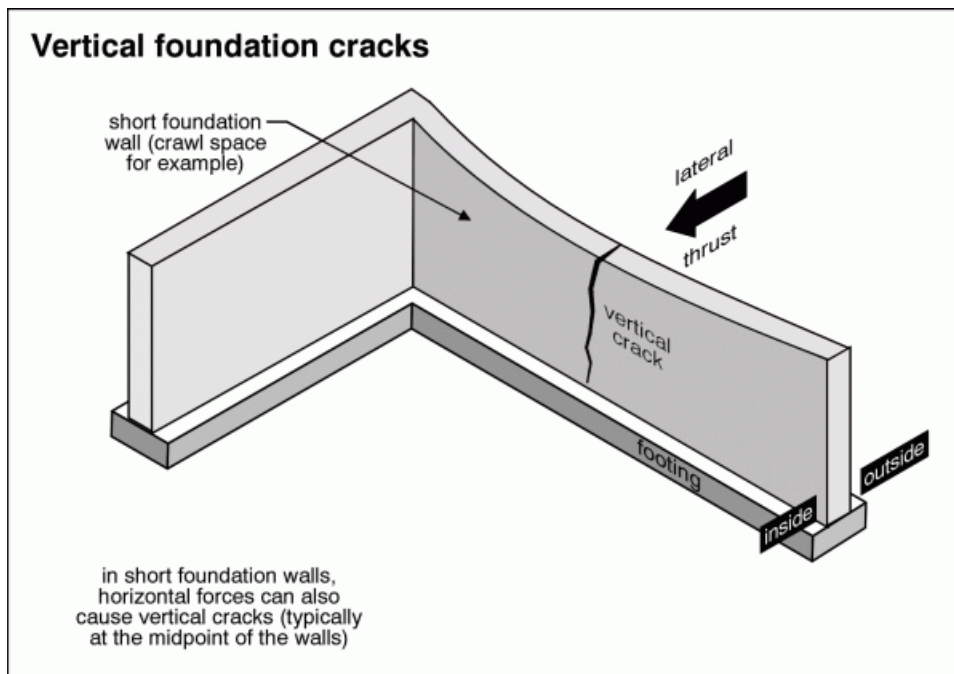
18. Cracked

16. Condition: • [Cracked](#)

Implication(s): Chance of water damage to structure, finishes and contents | Weakened structure

Task: Further evaluation

Time: Immediate

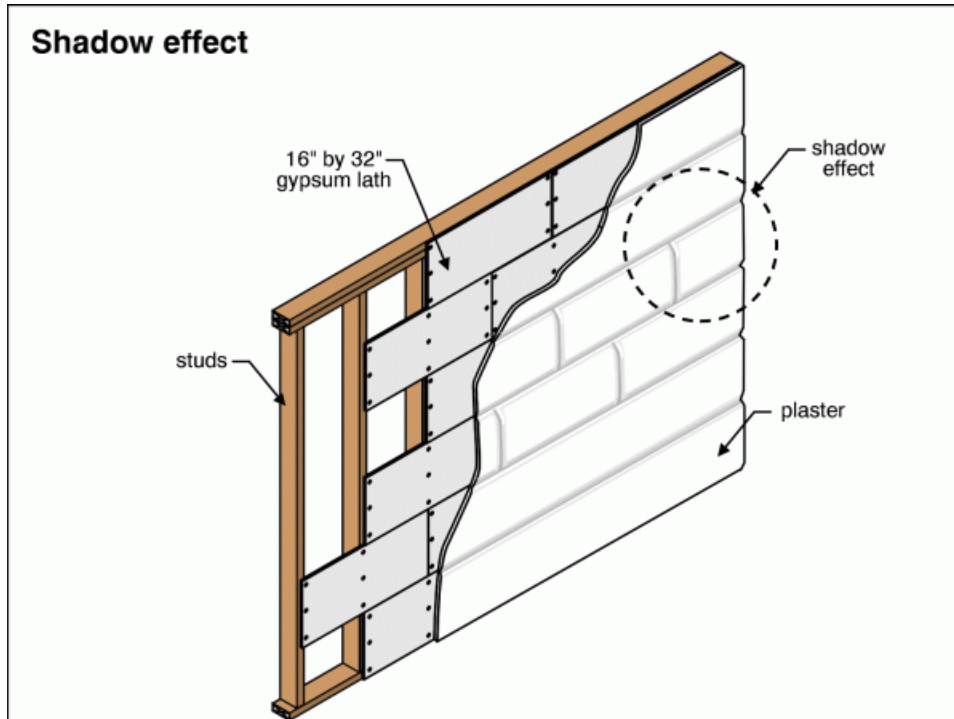
27. Shadow effect

20. Condition: • [Shadow effect](#)

Air quality test recommended
