YOUR INSPECTION REPORT

FOR THE PROPERTY AT: 309 Beresford Toronto, ON

INSPECTION DATE: Thursday, June 8, 2017

RE: Report No. 2125, v.5 309 Beresford Toronto, ON

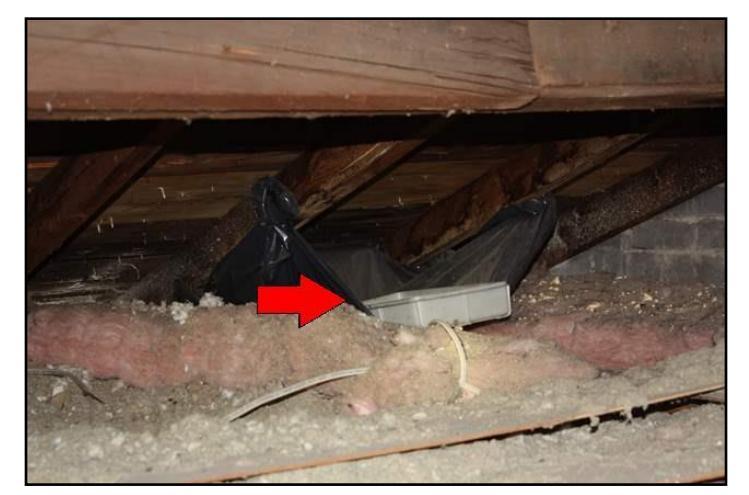
Condition: • Leak

We observed a drip pan and bag at rear attic. Homeowner reported that was likely put there a long time ago to catch a leak from roof which is no longer active. Have roofing contractor inspect the rear roof at some point within the year to confirm the quality of repair.

Implication(s): Chance of water damage to contents, finishes and/or structure

Task: Further evaluation

Time: less than one year

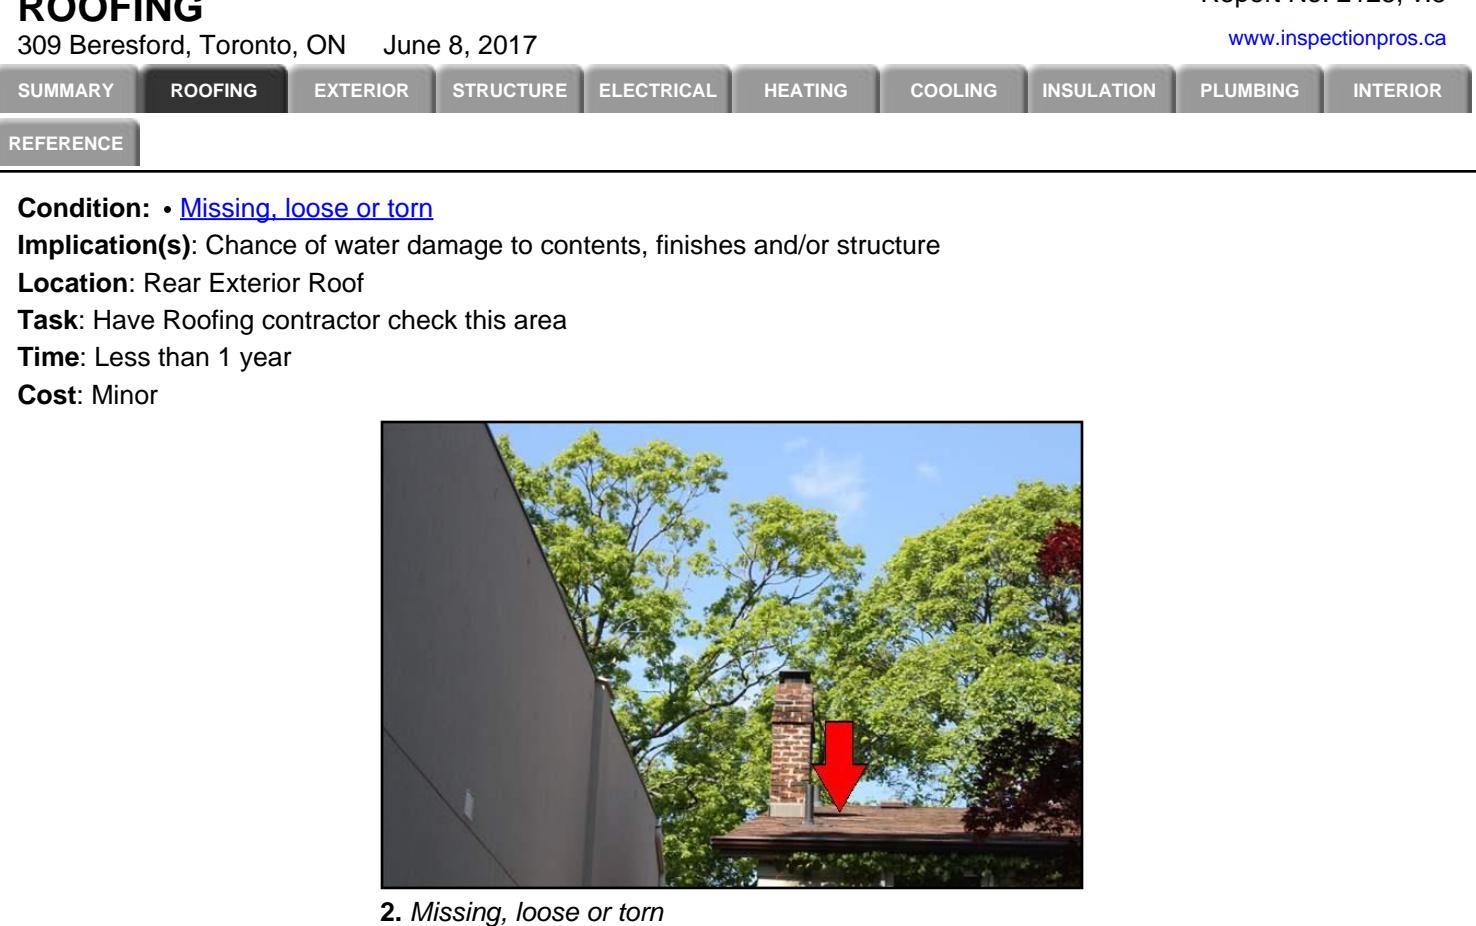
Condition: • Patched Implication(s): Chance of water damage to contents, finishes and/or structure Location: Rear Exterior Roof Task: Monitor Time: Ongoing

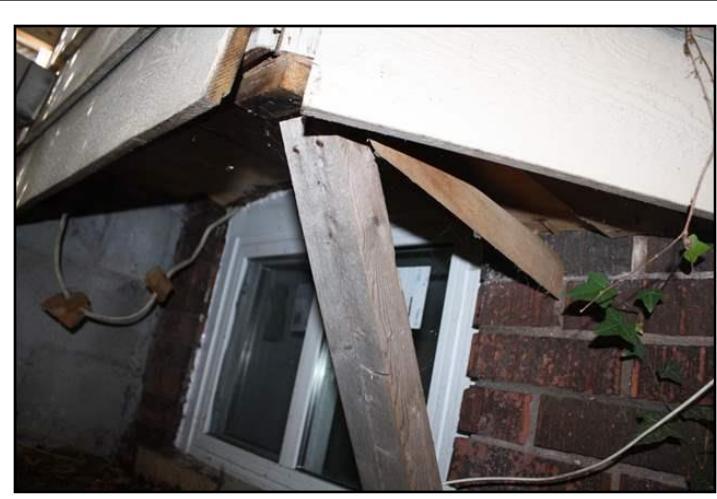
5.

PORCHES, DECKS, STEPS, PATIOS AND BALCONIES \ Handrails and guards

Condition: • Loose Implication(s): Fall hazard Location: Exterior Porch Task: Improve Time: Regular maintenance

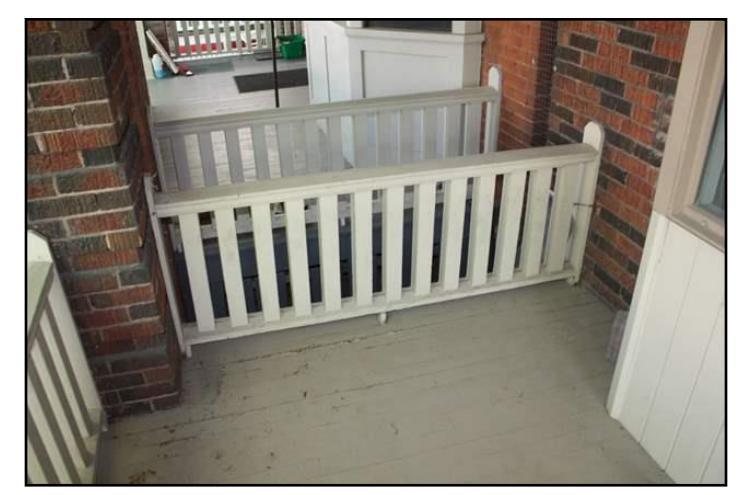
Condition: • Too low Below modern standards Implication(s): Fall hazard Location: Porch Task: Upgrade Time: Discretionary

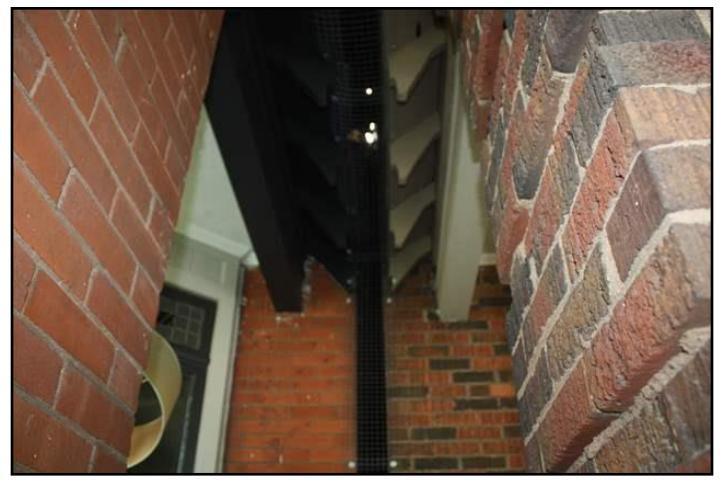
10. Space between buildings

Space between buildings

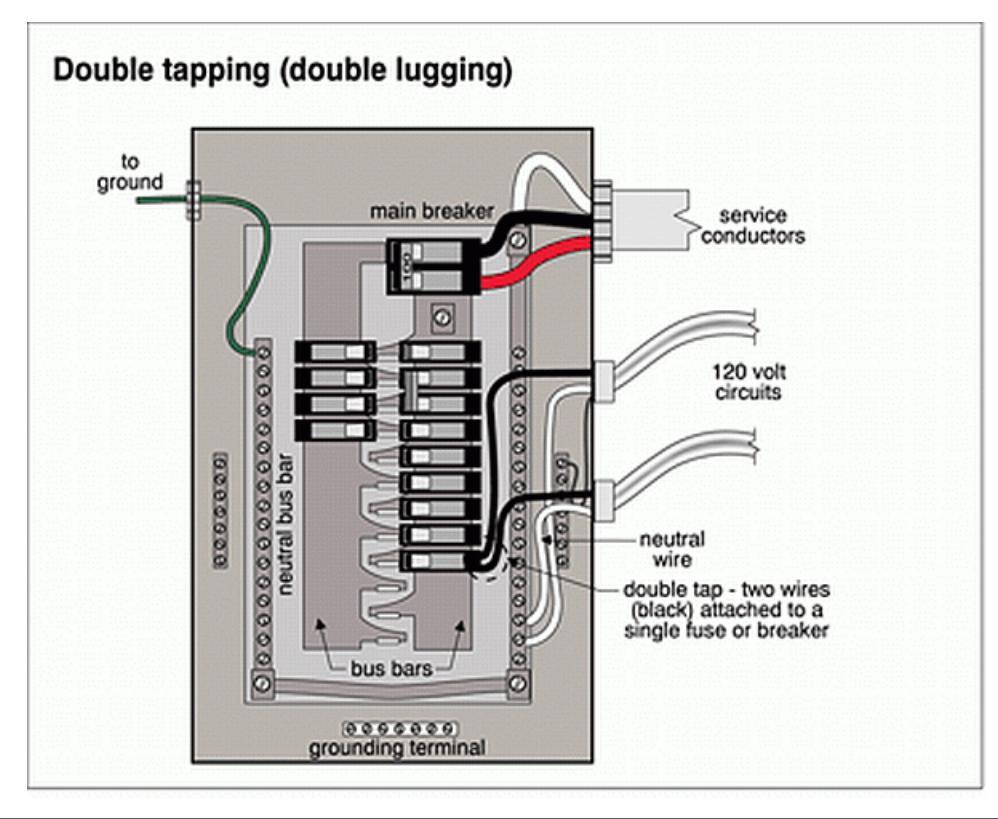
SERVICE BOX, GROUNDING AND PANEL \ Distribution fuses/breakers

Condition: • <u>Double taps</u> Implication(s): Fire hazard Location: Basement Panel Task: Correct Time: Immediate Cost: Minor

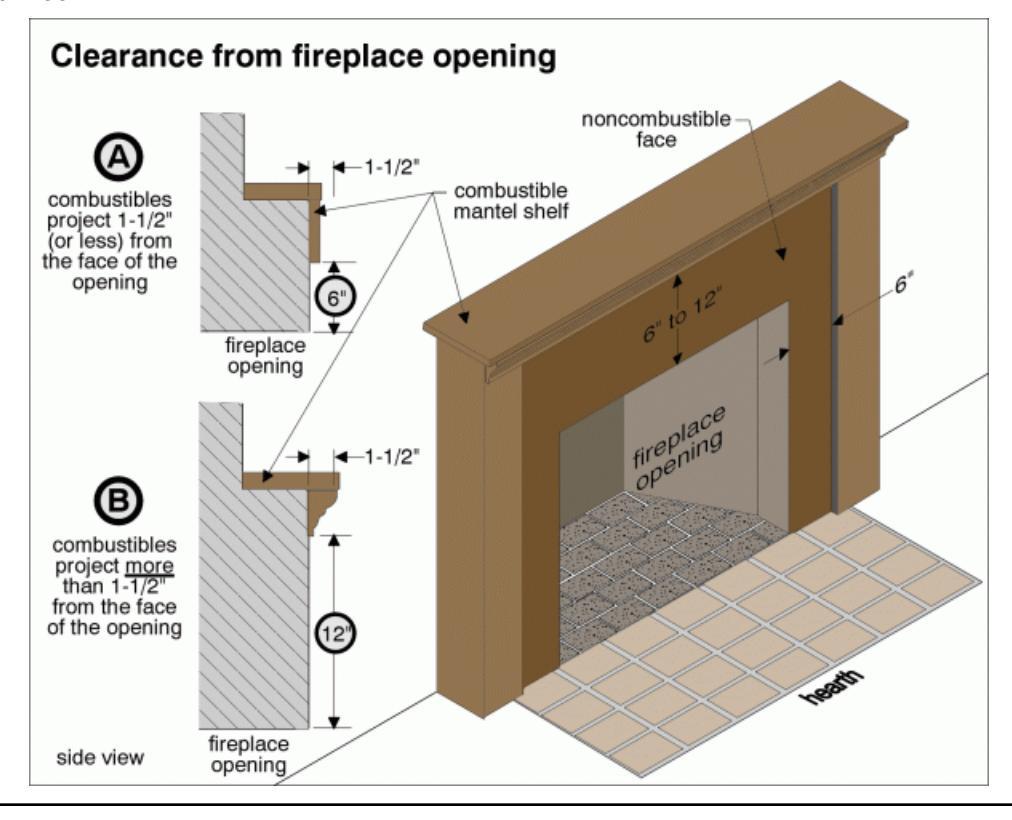
FIREPLACE \ Fireplace face or breast

Condition: • <u>Combustible clearances</u> Do not use. Fireplace not in service Implication(s): Fire hazard Location: Second Floor

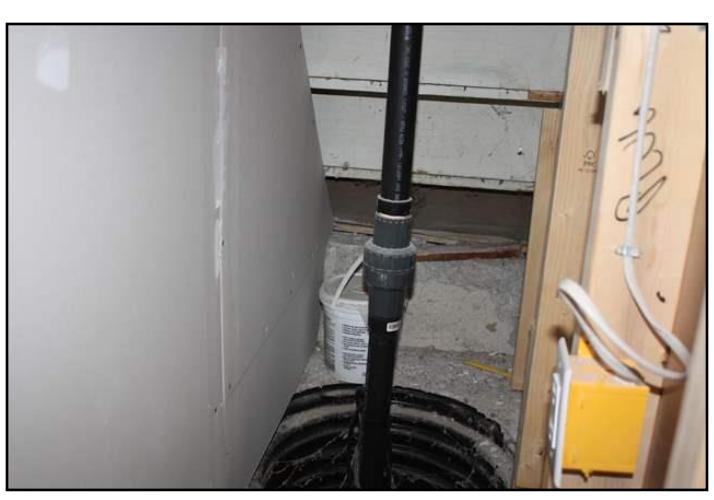
19.

Condition: • Provide backup battery powered power source for sump pumps.

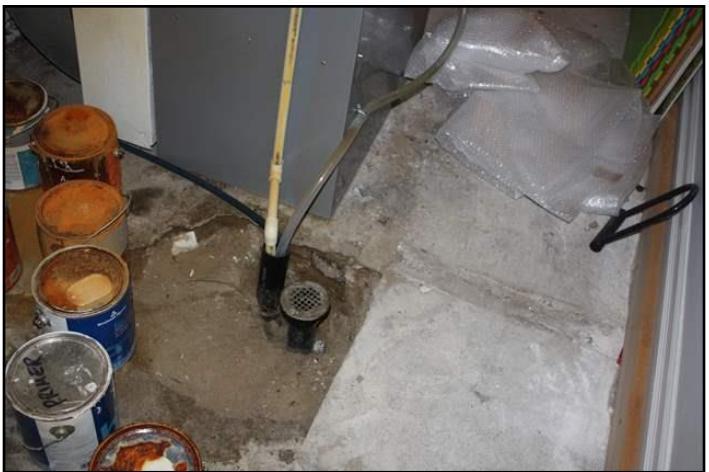
FLOORS \ General

Condition: • Missing Location: Basement Furnace Room Task: Repair area around floor drain Time: Less than 1 year

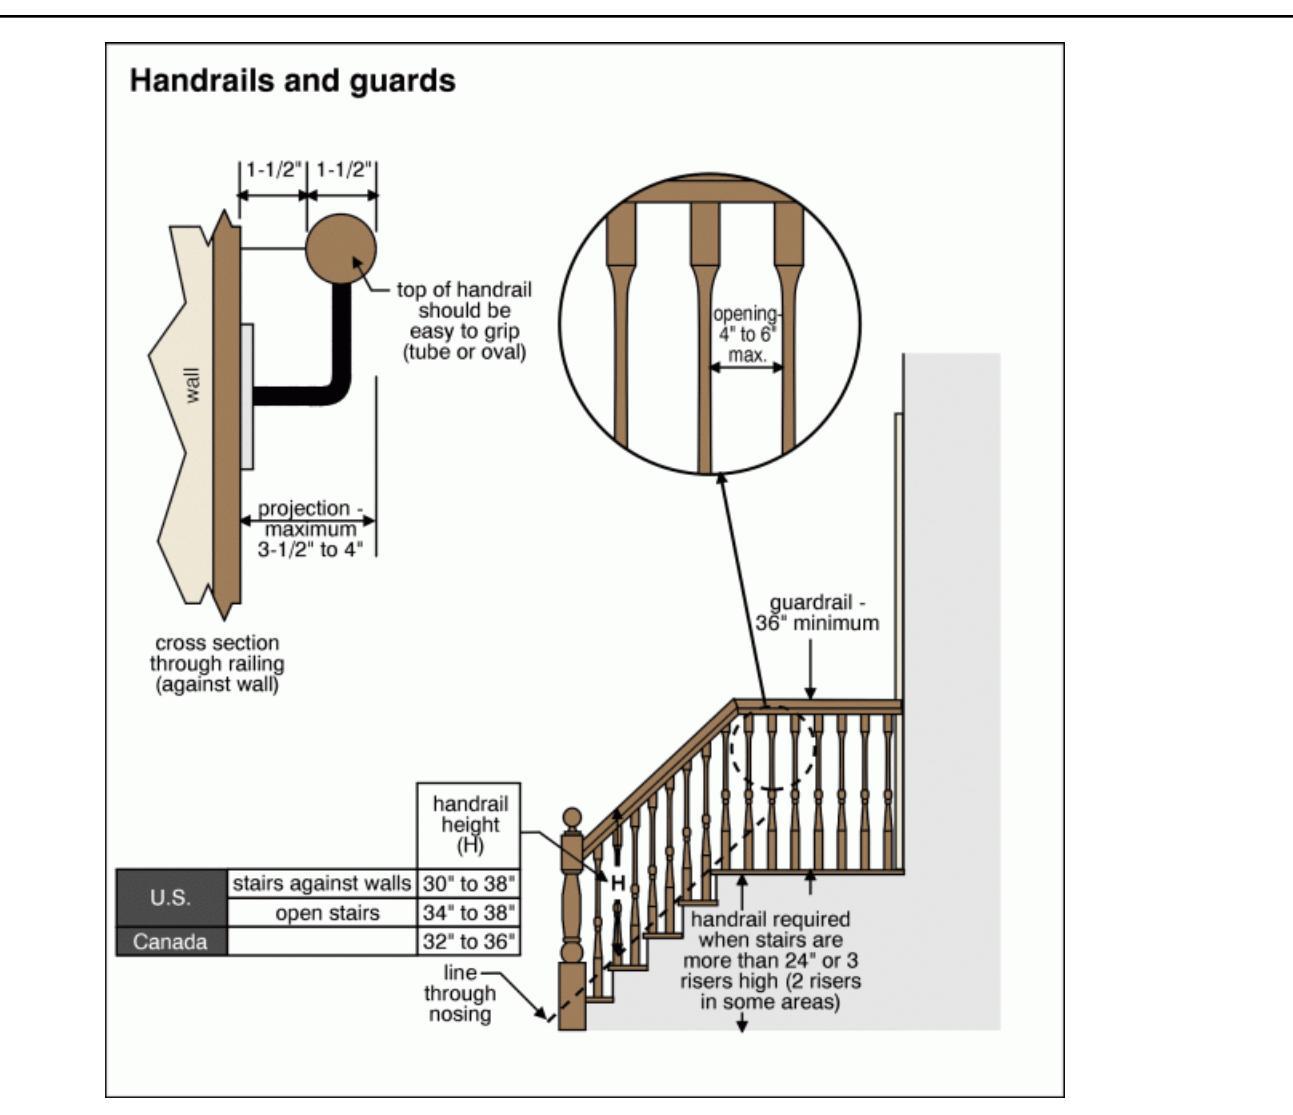
Condition: • Missing Implication(s): Fall hazard Location: Basement Staircase Task: Provide handrail Time: Less than 1 year Cost: Minor

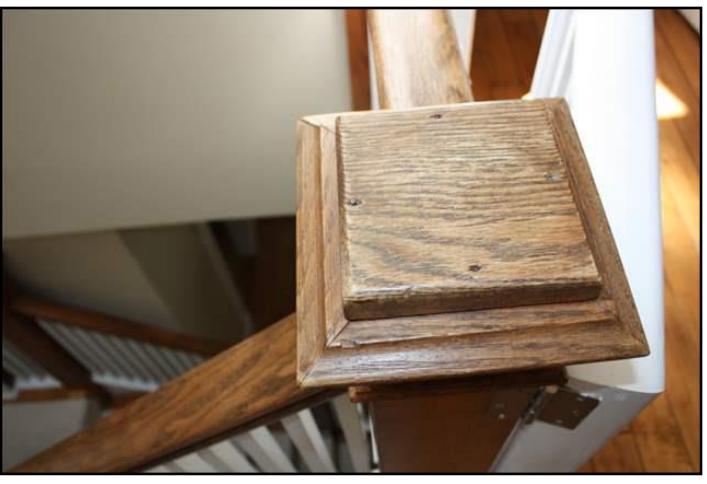
23.

STAIRS \ Spindles or balusters

Condition: • nail visible Location: Second Floor Staircase Task: Improve Time: Regular maintenance Report No. 2125, v.5
