YOUR INSPECTION REPORT

FOR THE PROPERTY AT:
490 Windermere Avenue
Toronto, ON M6S 3L6

INSPECTION DATE:
Monday, September 22, 2025

RE: Report No. 8592, v.2
490 Windermere Avenue
Toronto, ON
M6S 3L6

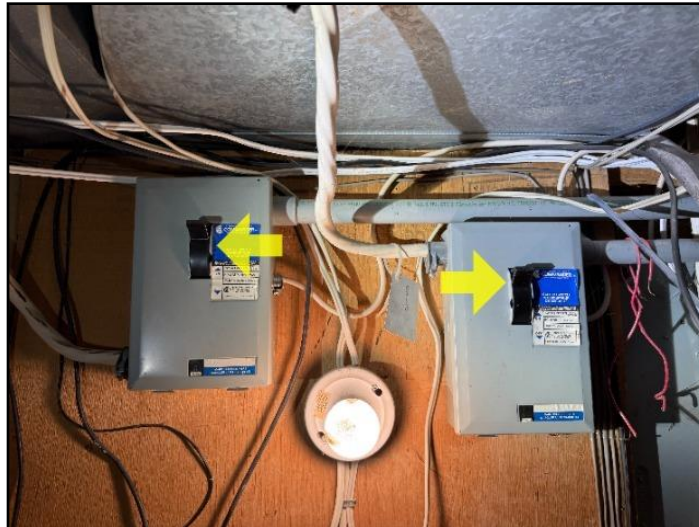
25. Main disconnects for 1st and 3rd floor

The main disconnects for the first and third floor panels are located in the furnace room

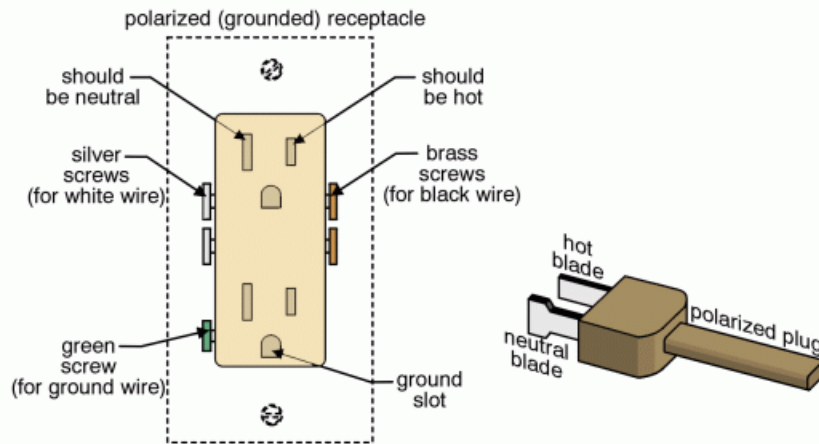
Reversed polarity

when the polarity is reversed, the wide receptacle slot is (incorrectly) hot and the narrow slot is neutral - this is not uncommon when people forget that the black wire should be attached to the receptacle's brass screws

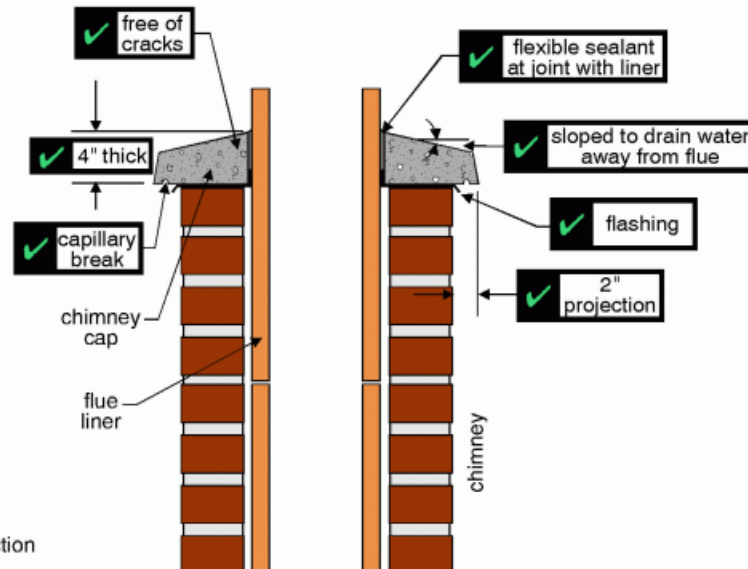
Drip edge on cap

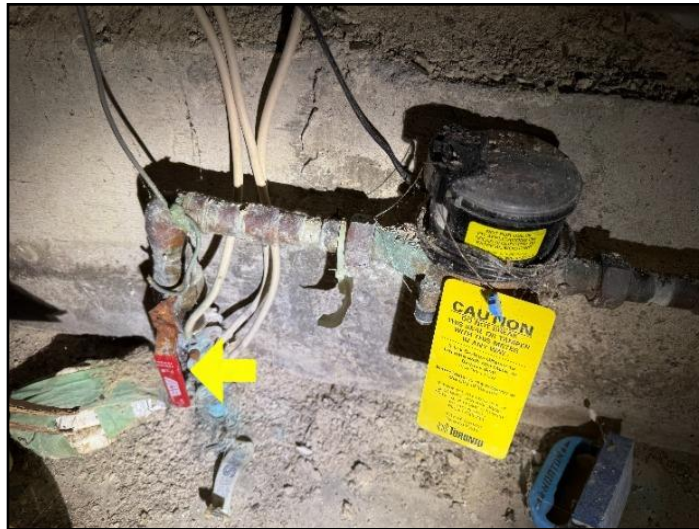
34. Main water shut off valve - Front of the...

- Main water shut off valve - Front of the basement
