# INSPECTION REPORT

For the Property at:  
**1234 MAIN ST.**  
KELOWNA, BC

Inspection Date: Friday, June 12, 2015

RE: Report No. 1574, v.2  
1234 Main St.  
Kelowna, BC

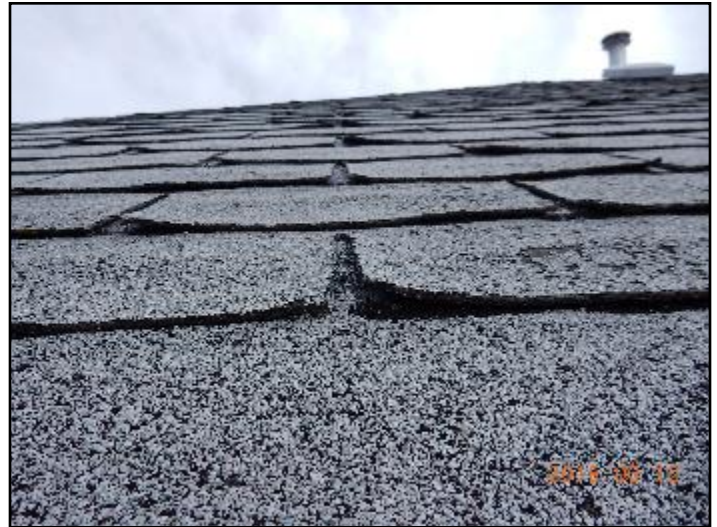
2. Close up of roof shingle

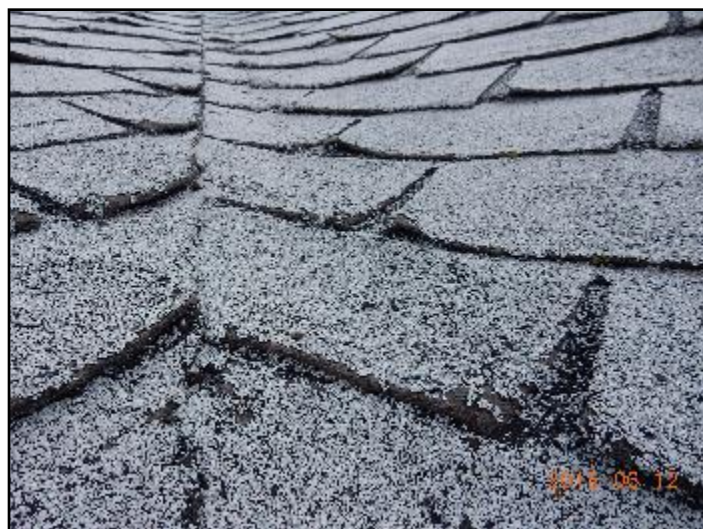
6. Close up of roof valley

The asphalt roof shingles are old and showing signs of deterioration including granule loss, widened slots as well as cupping and curling. Recommend replacement within 2 years

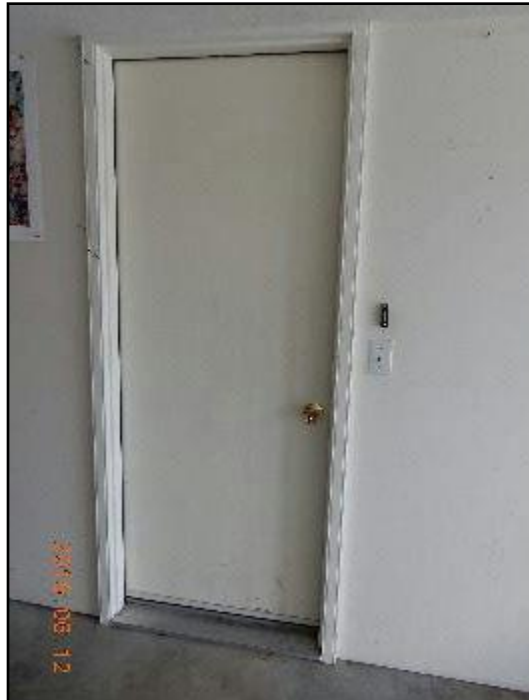
26. Self closing, metal, garage man-door

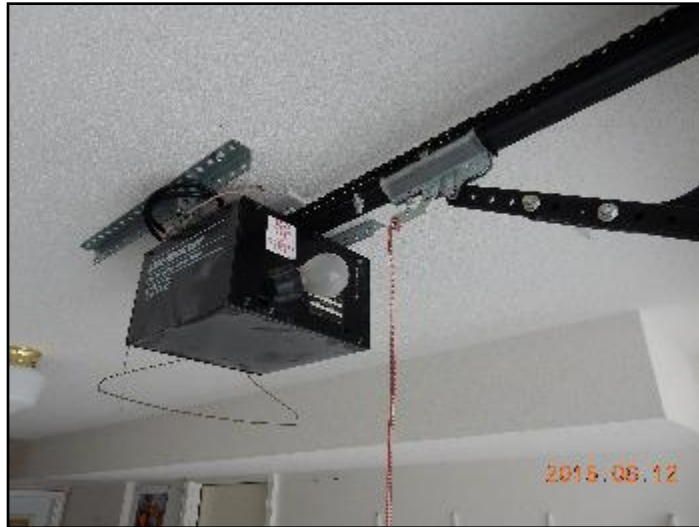
28. Tested for auto reverse function

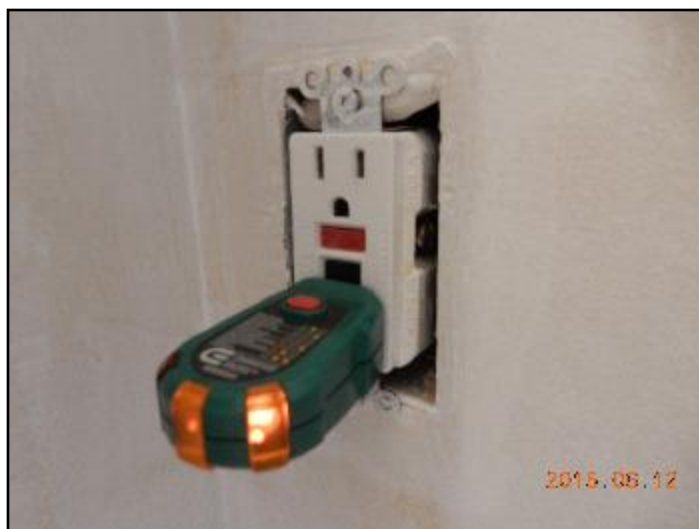
52.

All bathroom outlets protected by GFCI and tested

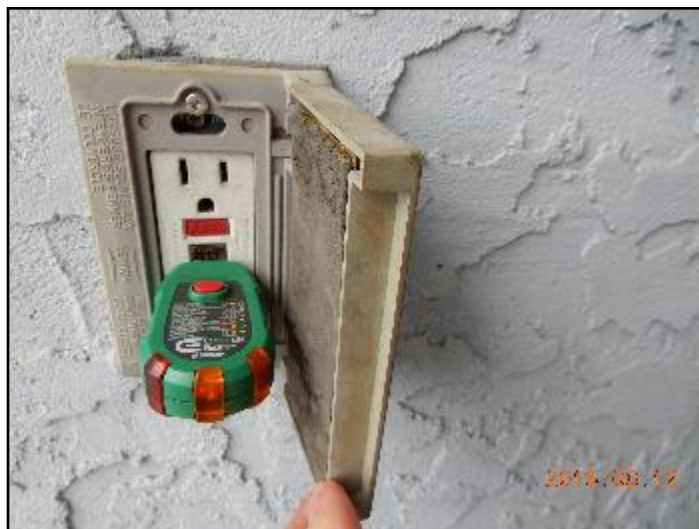
53.

Exterior GFCI tested

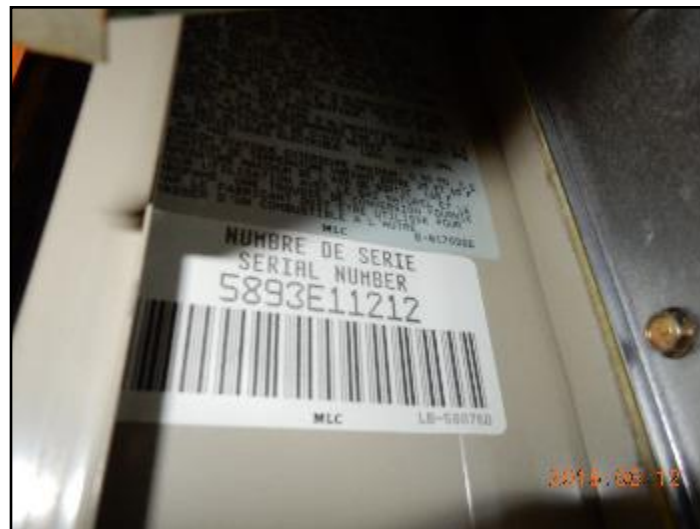
62. Data plate - Date 1993

**17. Condition:** • [Near end of life expectancy](#)

The furnace is 22 yrs old. It is near the end of its typical 25 year life expectancy. Recommend service by a qualified technician to determine service schedule and remaining life expectancy. It is wise to budget for replacement

**Implication(s):** Equipment failure | No heat for building

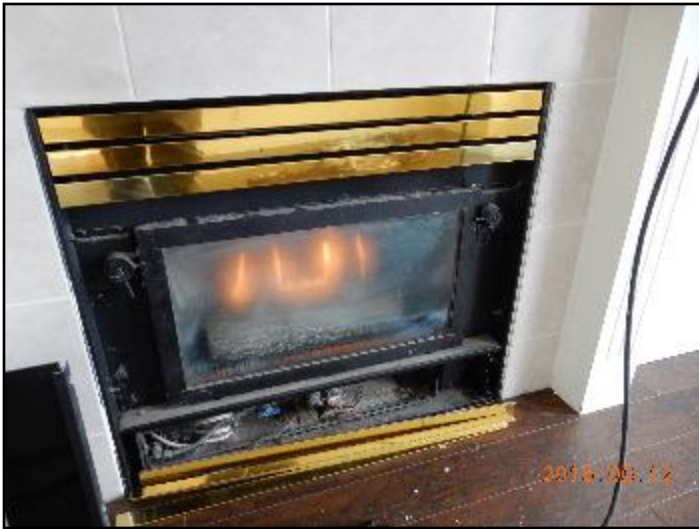
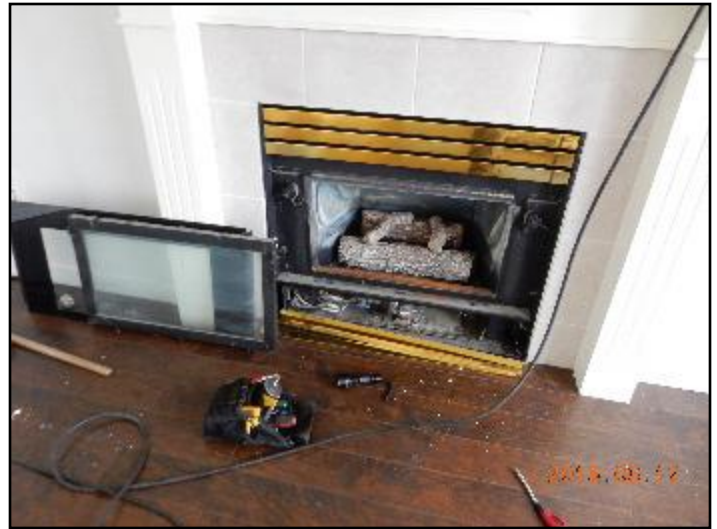
Tested - Responds to normal operating controls.

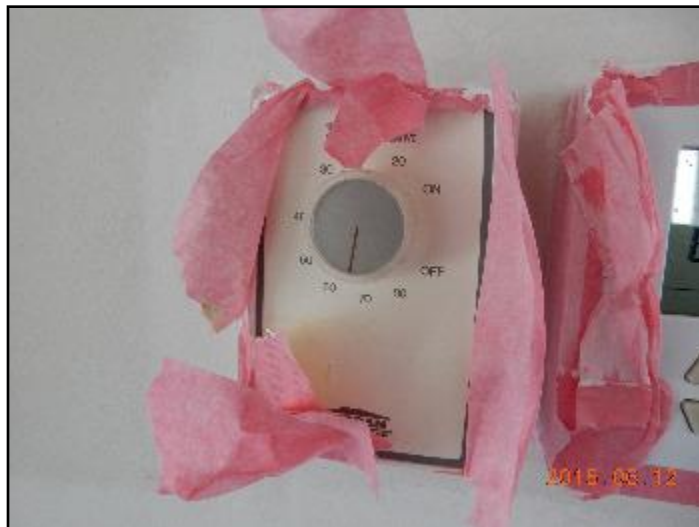
67.

De-humidistats activate bathroom fan to exhaust moist house air to reduce humidity. Tested

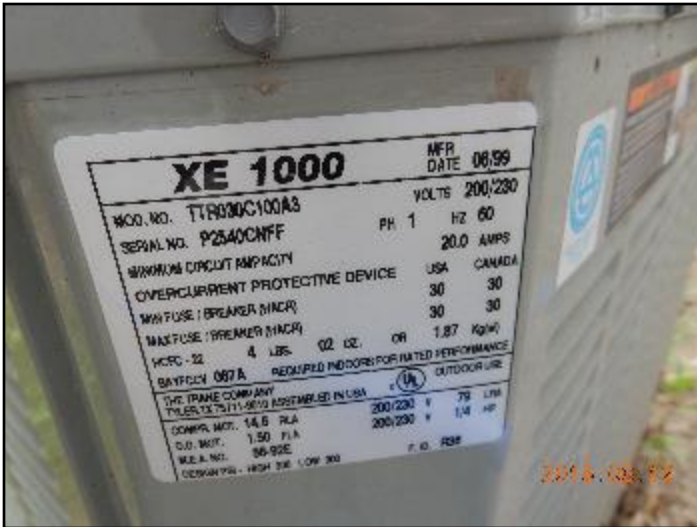
69. Data plate - Date 1999

**19. Condition:** • Exceeded typical life expectancy.

The air conditioner is past its typical life expectancy of 10-15 yrs. Although in good working order, with cold air noted at all registers, its remaining life expectancy is unpredictable. Replace when necessary,.

**Implication(s):** Equipment failure

**Task:** Replace

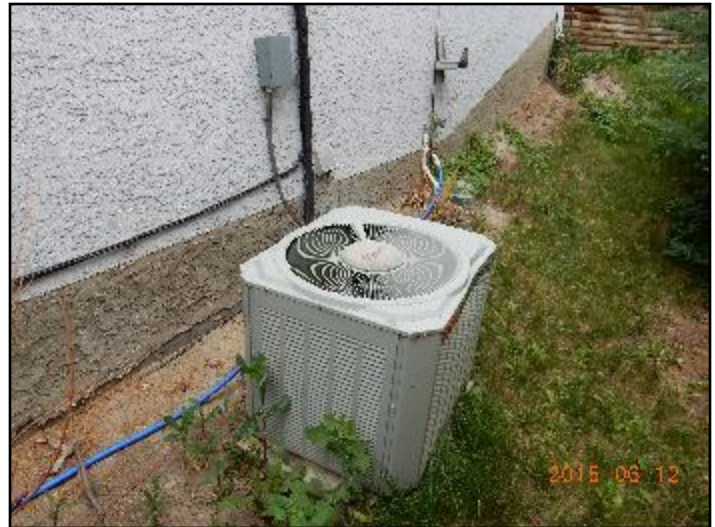
70. Air conditioner

### 20. Condition: • Out of level

The air conditioner has settled and is no longer level. This can stress refrigerant lines and shorten life expectancy of the equipment. The refrigerant lines appear to have no added stress or damage at the time of the inspection. The settlement is minor. Monitor for further movement and improve as needed.

**Implication(s):** Reduced system life expectancy | Damage to equipment

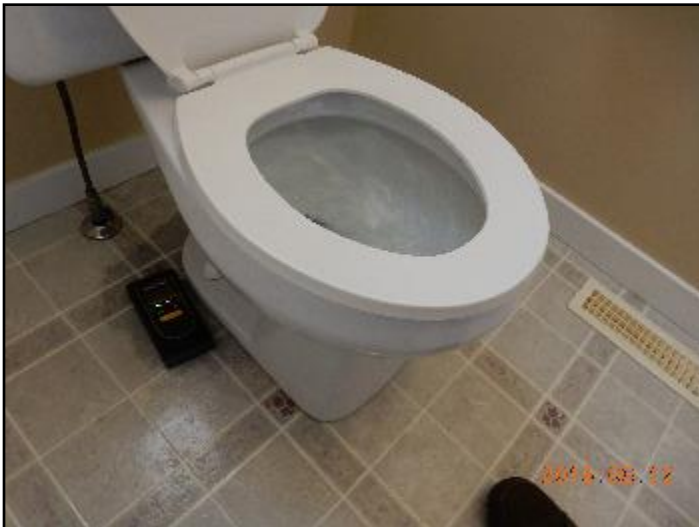
74. master bathroom toilet

**25. Condition:** • Suspect wax seal leak. Moisture present around base of toilet.

The master bathroom toilet as well as the hallway bathroom toilet have moisture present in the floor when tested with a moisture meter. It is likely that the wax seal is leaking. Repair is recommended immediately. Concealed damage of the floor may exist.

**Implication(s):** Water damage to structure and finishes.

**Task:** Repair

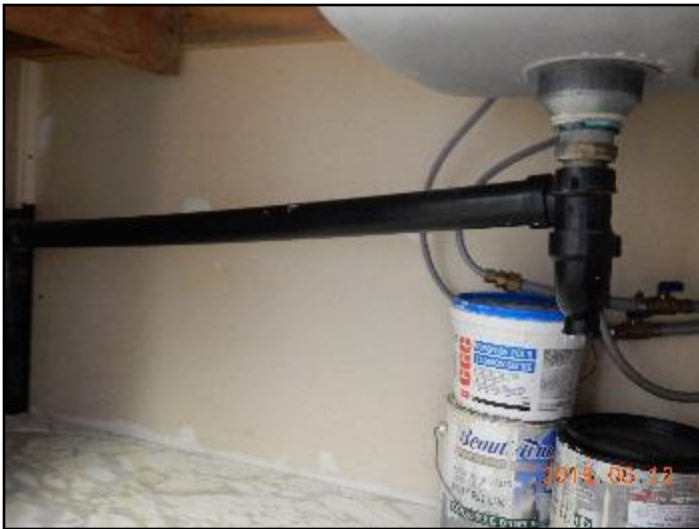
78. laundry sink

#### 24. Condition: • [Hot and cold reversed](#)

The laundry sink faucet has the hot and cold reversed. This is a safety concern. Recommend repair immediately. It may be as simple as switching supply plumbing lines under the sink.

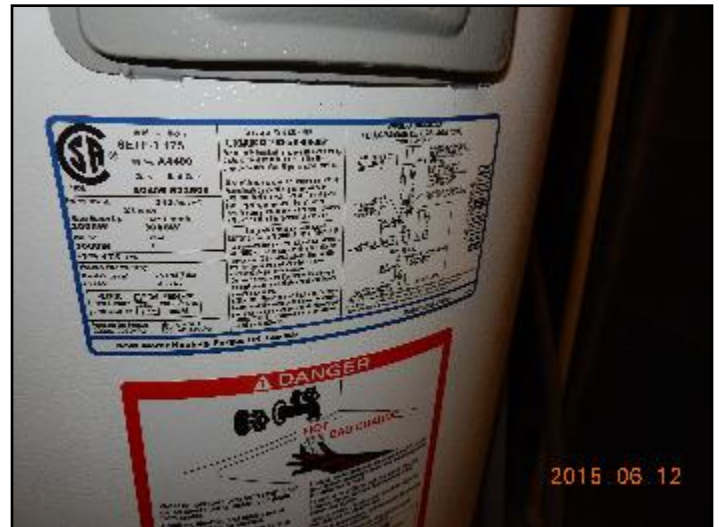
87. Data plate - Date 2004

#### 23. Condition: • [Near end of life expectancy](#)

Hot water heater is 11 years old. It is near the end of its life expectancy. Budget for replacement.

**Task:** Replace

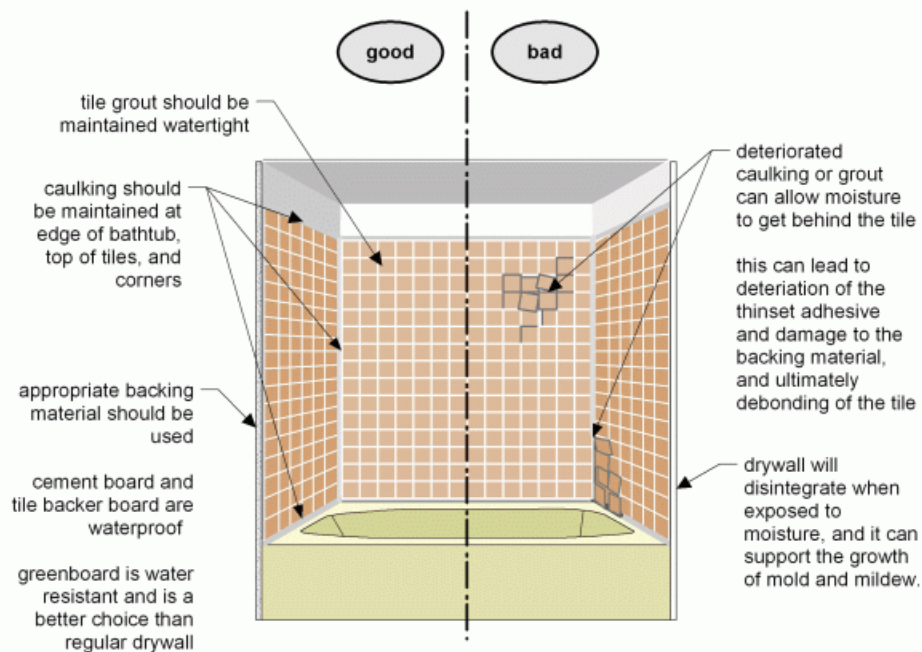
95.

The master bathroom has areas around the tub/floor intersection with deteriorated or missing caulking. This is typical for a home this age. These areas need to be protected as part of regular maintenance with new caulking to ensure no moisture penetration.

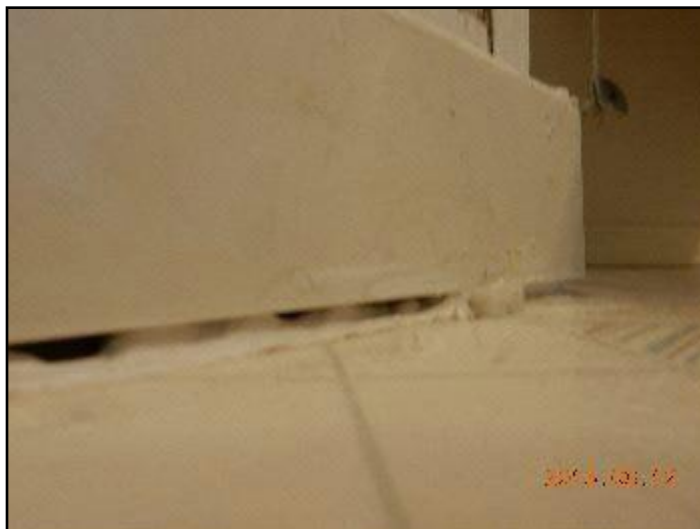
96.

The basement bathroom shower pan is poorly sealed at the floor. There is also some shims noted that were left behind after the install. Repair is recommended immediately to prevent the possibility of moisture penetration between the floor and shower pan.

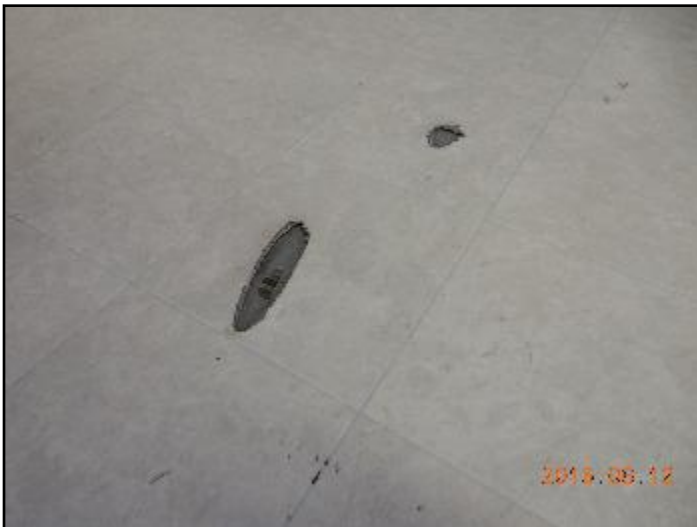
123.

There are areas of the laminate floor that are damaged and worn. There are also areas that have paint drips. This is a cosmetic issue.

There are areas of the resilient floor that are torn or damaged. Repair or replace as needed.

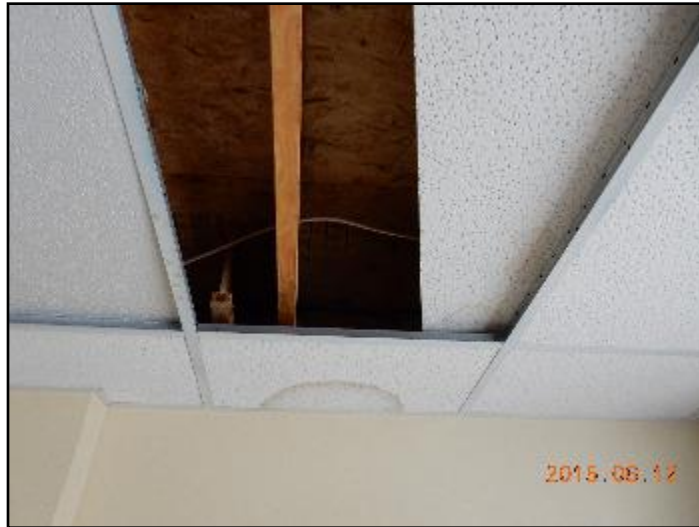
127.

There are areas of the drop down ceiling in the basement with water stains. Paneling was removed in each area to determine the cause. There are no visible signs of moisture damage, nor are there sources of water noted with leaks. Repair or replace panels at your discretion.

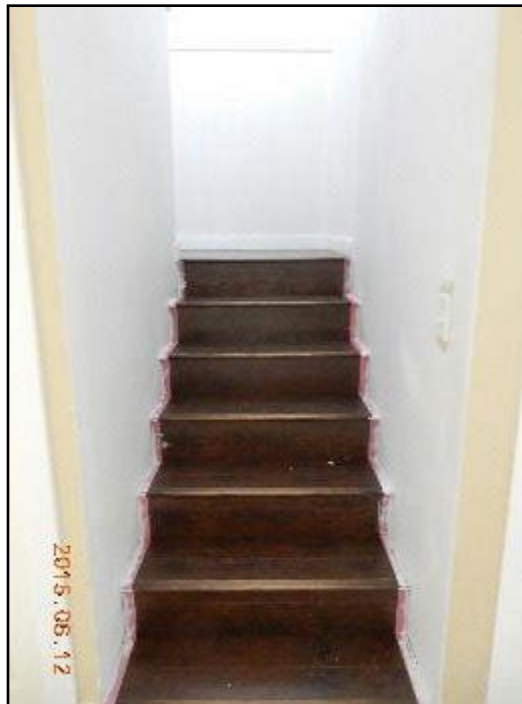
129.

### 33. Condition: • [Missing](#)

**Implication(s):** Fall hazard

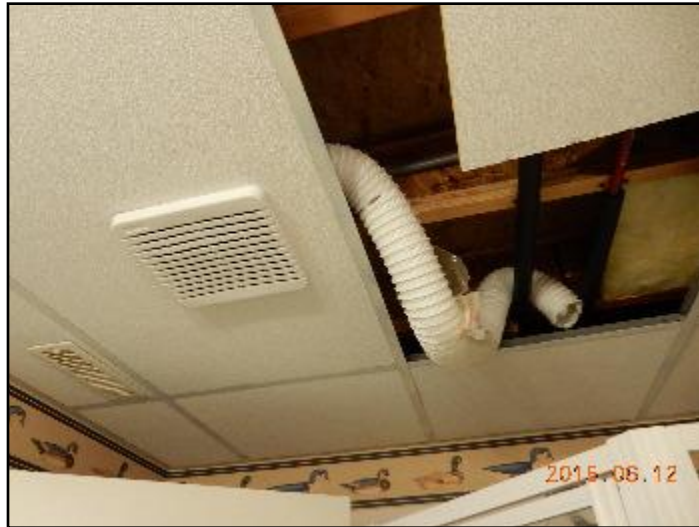
130.

The basement bathroom exhaust fan duct terminates in the ceiling. It is recommended to extend the exhaust duct to the exterior to prevent the possibility of condensation damage. There is no damage noted as a result of the arrangement.

**Implication(s):** Chance of condensation damage to finishes and/or structure
