YOUR INSPECTION REPORT

45 Kennedy Park Road
Toronto, ON M6P 3H2

INSPECTION DATE:
Tuesday, April 22, 2025

RE: Report No. 8257
45 Kennedy Park Road
Toronto, ON
M6P 3H2

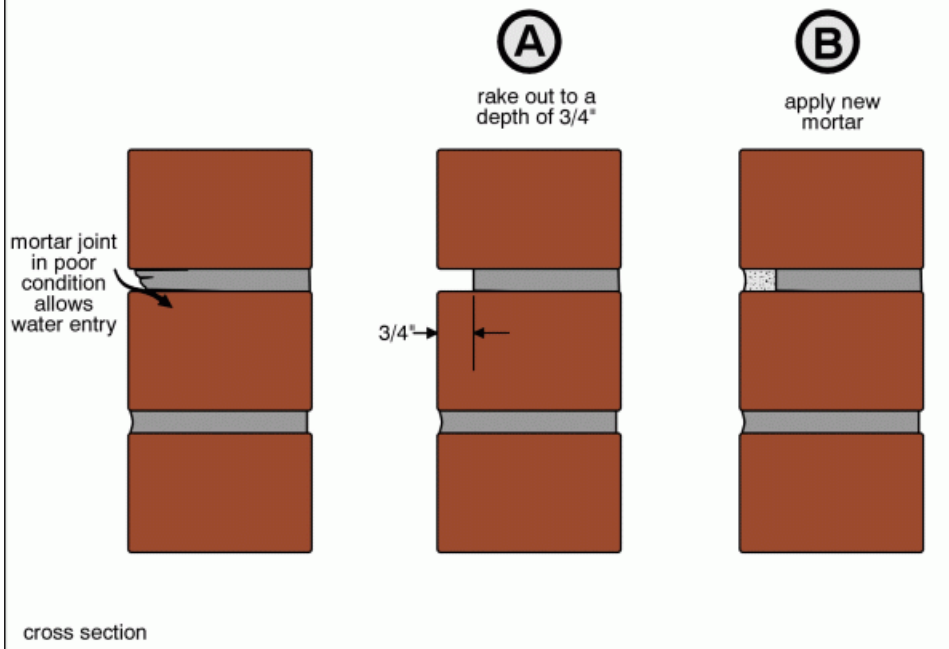
Repointing

Condition: • [Mortar deterioration](#)

Task: Repair

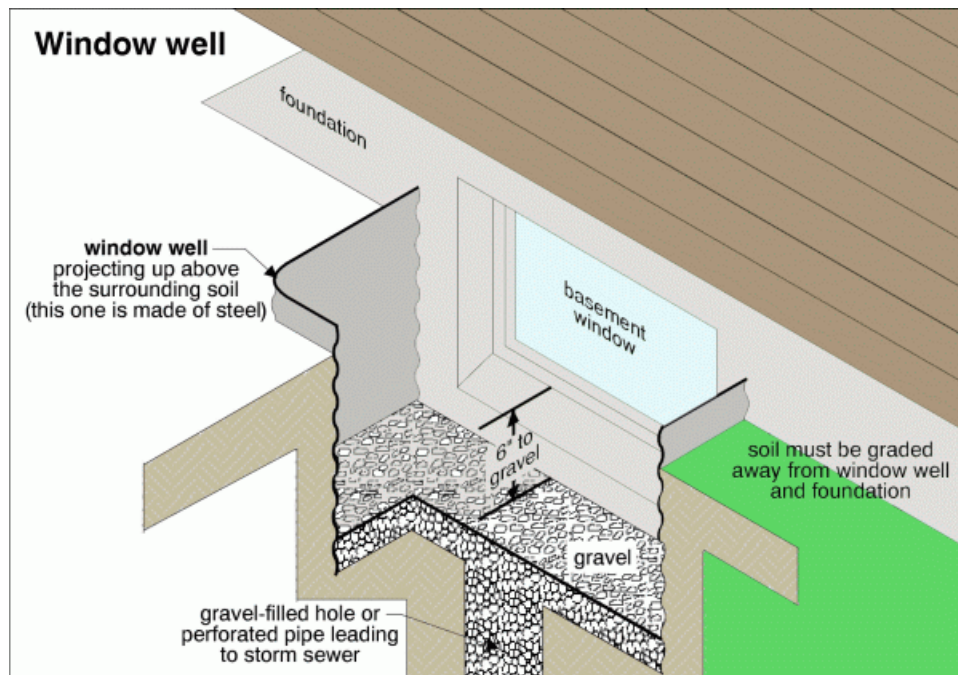
Condition: • [Less than 6 inches below window](#)

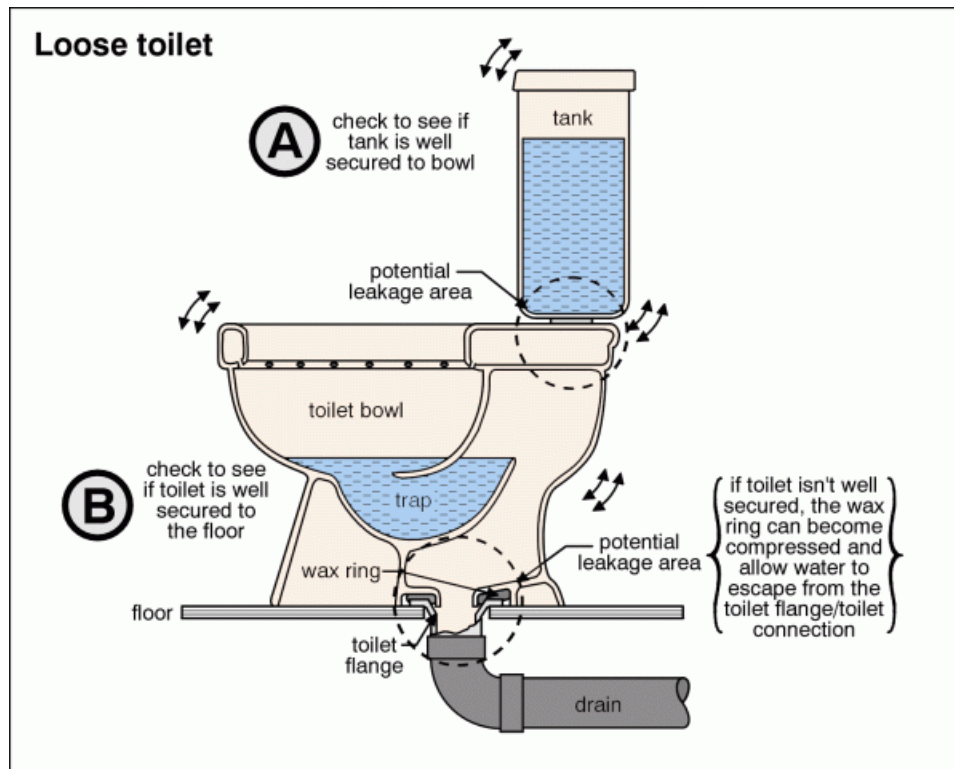
Condition: • The following are minor plumbing deficiencies and upkeep items noted during the inspection. These are common for the age of the home and should be addressed through routine maintenance to reduce risk of deterioration and/or leaks.
