# YOUR INSPECTION REPORT

446 Armadale Avenue  
Toronto, ON M6S 3X9

INSPECTION DATE:  
Friday, March 23, 2018

RE: Report No. 2245  
446 Armadale Avenue  
Toronto, ON  
M6S 3X9

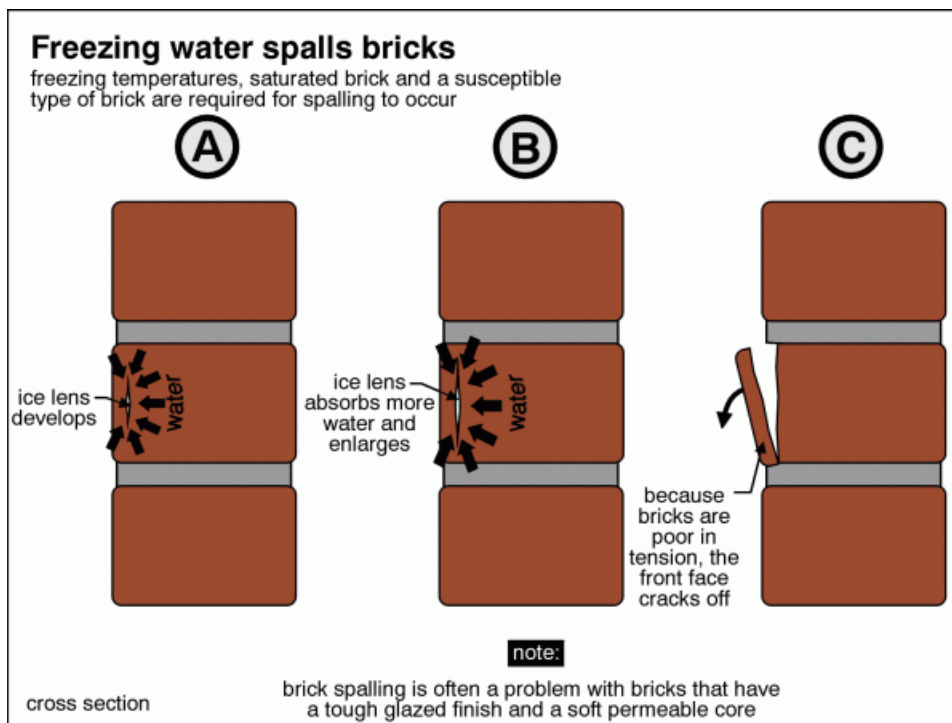
**Condition:** • [Spalling](#)

Spalling/ masonry deterioration noted at various areas. Repair / Replace / Tuck point masonry. This is regular maintenance for a home of this age.

**Task:** Repair

**Time:** Regular maintenance

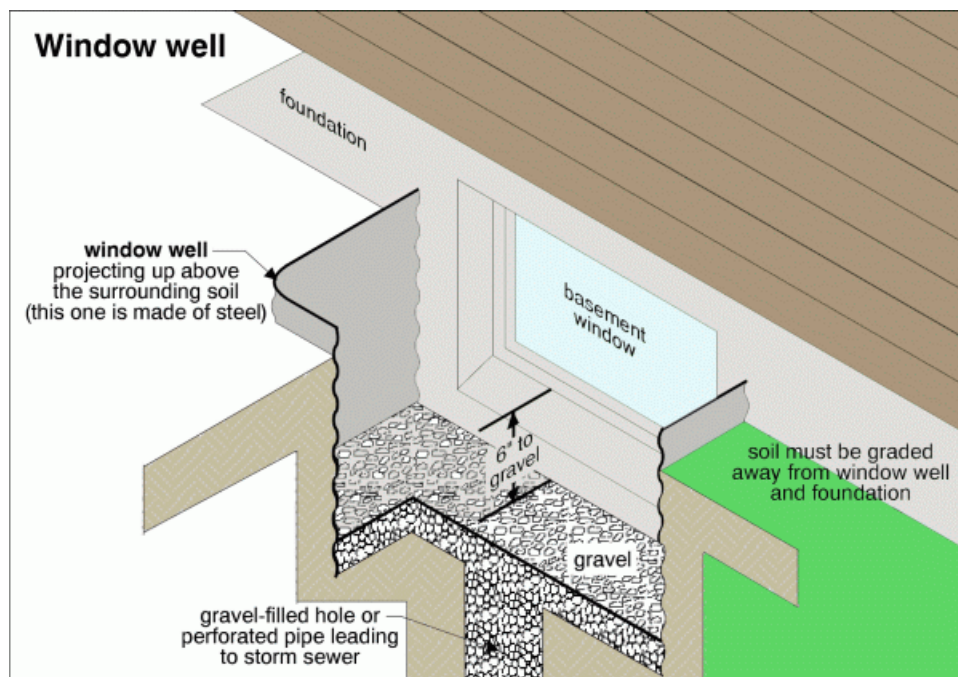
3. Rear window

**Condition:** • [Missing](#)

Window wells help manage the water in areas where windows are at or below grade. A properly installed window well will help prevent water entry / damage to windows and structure. THIS IS SOMETHING TO MONITOR FOR NOW, especially through the Spring rainy season. In the meantime, you may consider adding clear window covers to manage the water in this area.

**Task:** Provide window well

**Time:** If necessary / if landscaping

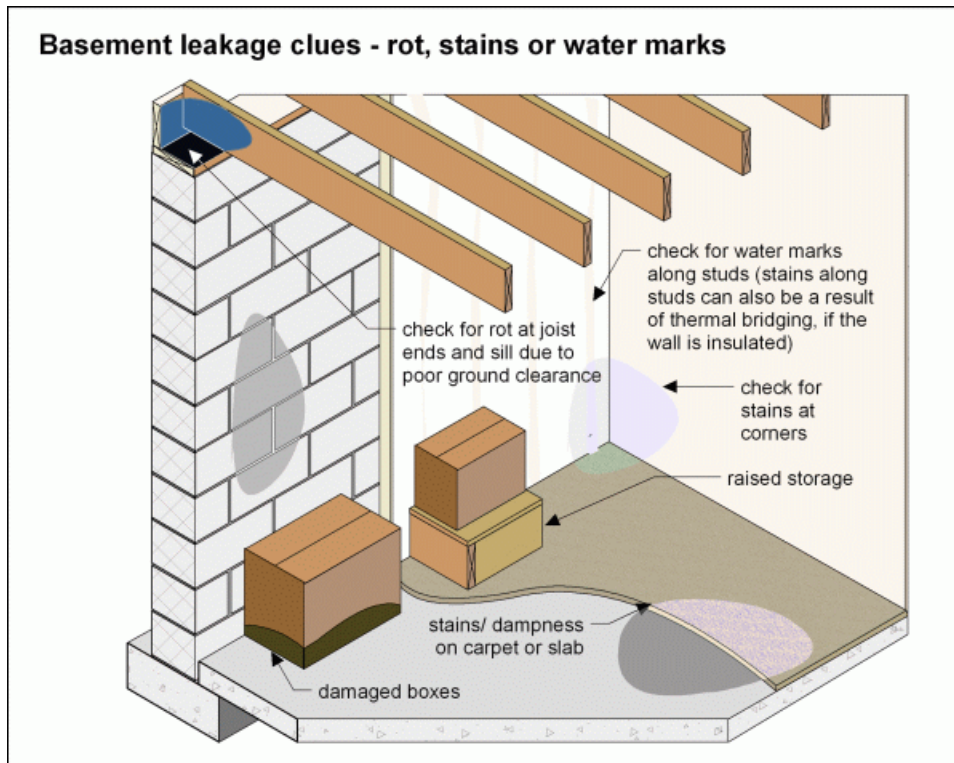
**Condition:** • [Stains](#)

It is common to find stains in a home of this age. No active water leakage was observed during the inspection. Stone foundations are more porous than other types of foundations. Prudent to monitor, especially through the Spring or after heavy rainfalls.

**Task:** Monitor

**Time:** Unpredictable
