YOUR INSPECTION REPORT

27 Nelles Avenue

Toronto, ON M6S 1T6

Sunday, September 22, 2019

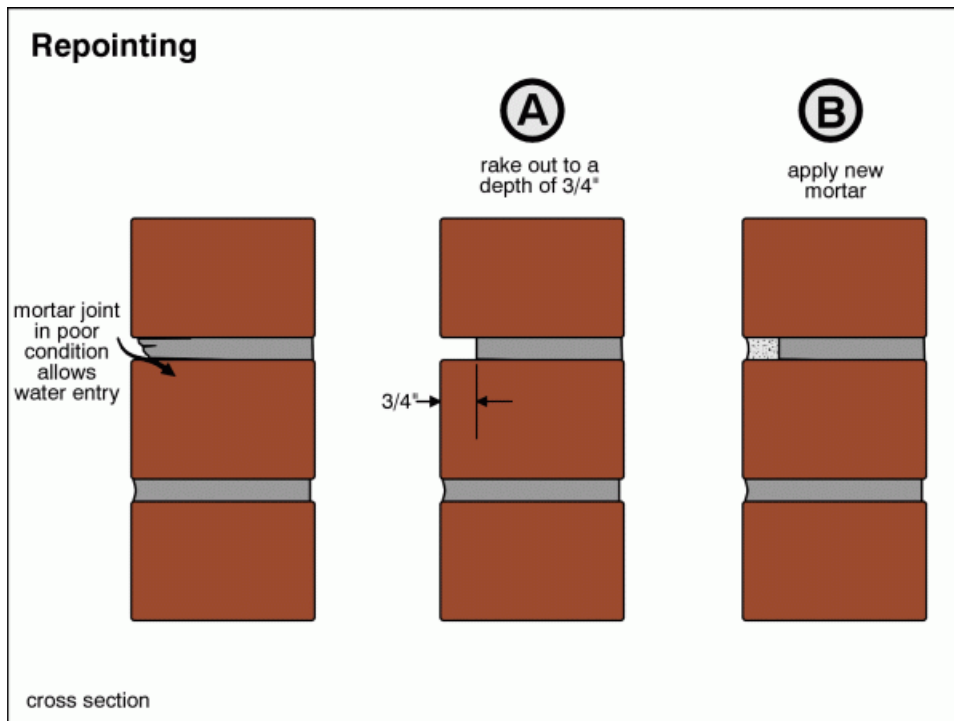
Condition: • [Mortar deterioration](#)

Task: Tuck-point

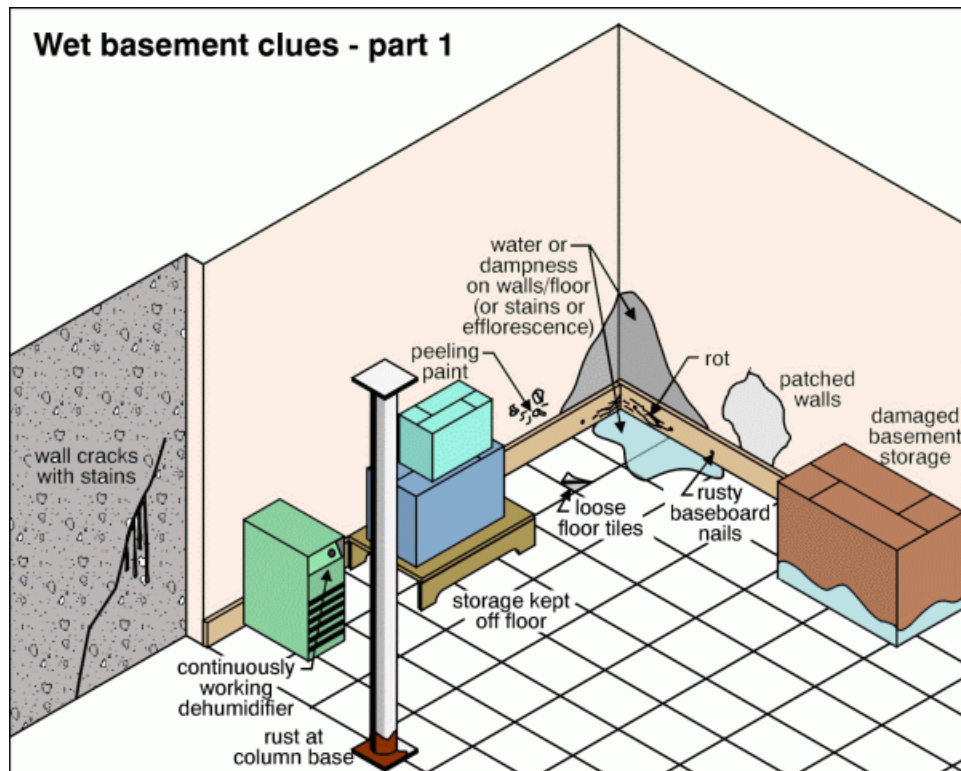
Wet basement clues - part 2

High moisture levels were found along the East and West exterior walls as well as residual moisture found wicking at centrally located walls. The source of the moisture is impossible to determine during a non-invasive. home inspection. Further evaluation is required.

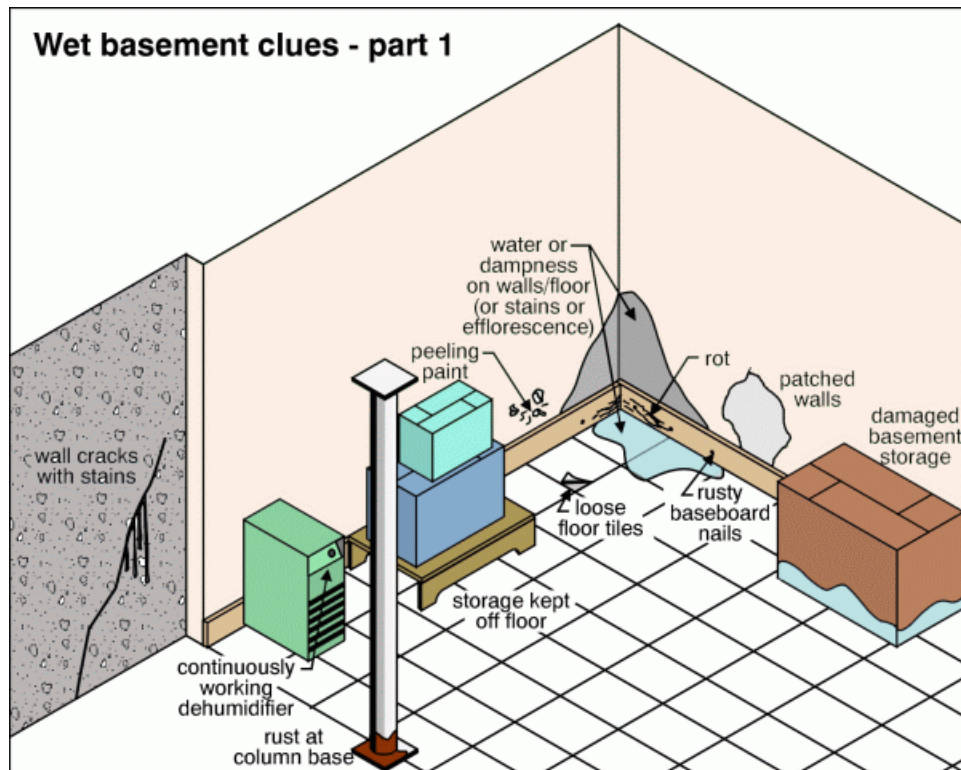
Condition: • [Mold](#)

The evaluation and analysis of mold is outside the scope of a home inspection. Mold was noted in various areas of the basement. Further Evaluation is recommended. EDIT SEPT 27 - Seller advises that they have addressed some of the mold issues. We did not verify as mold/air quality issues are outside our scope of work.
