Your Inspection Report

Any street
Calgary, AB

INSPECTION DATE:
Wednesday, September 25, 2019

Report No. 1112, v.3

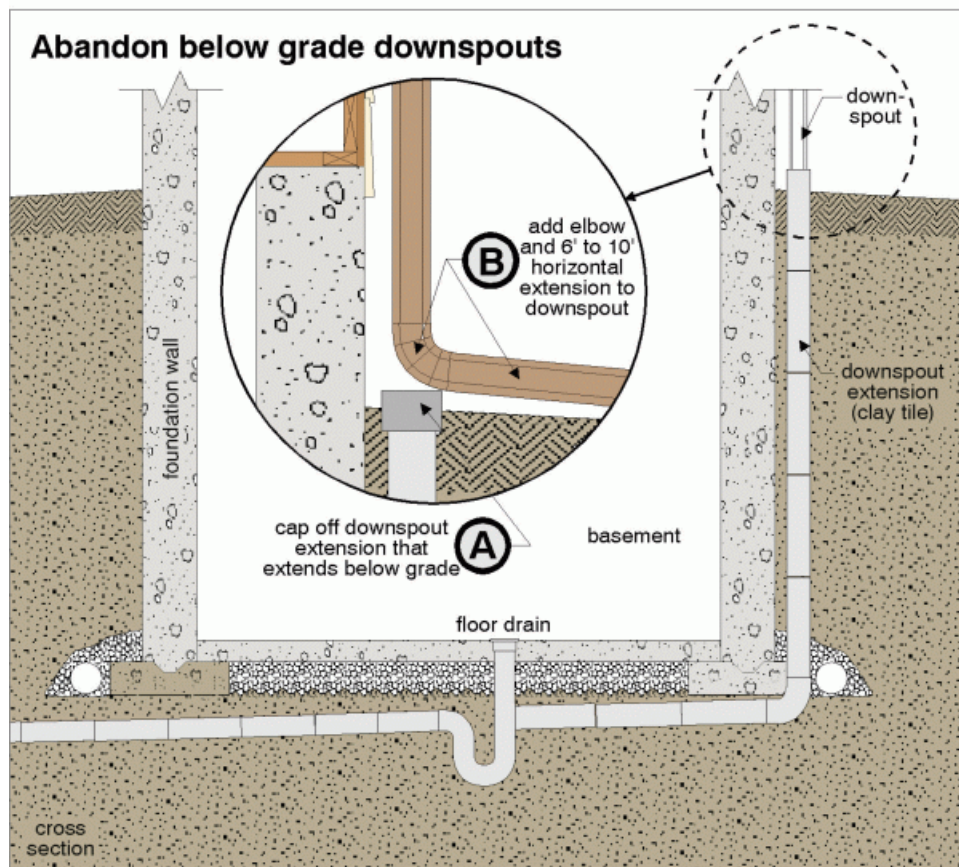
6. Condition: • Discharge below grade

Implication(s): Chance of water damage to contents, finishes and/or structure

Task: Have a licensed gutter installer correct

Time: Less than 1 year

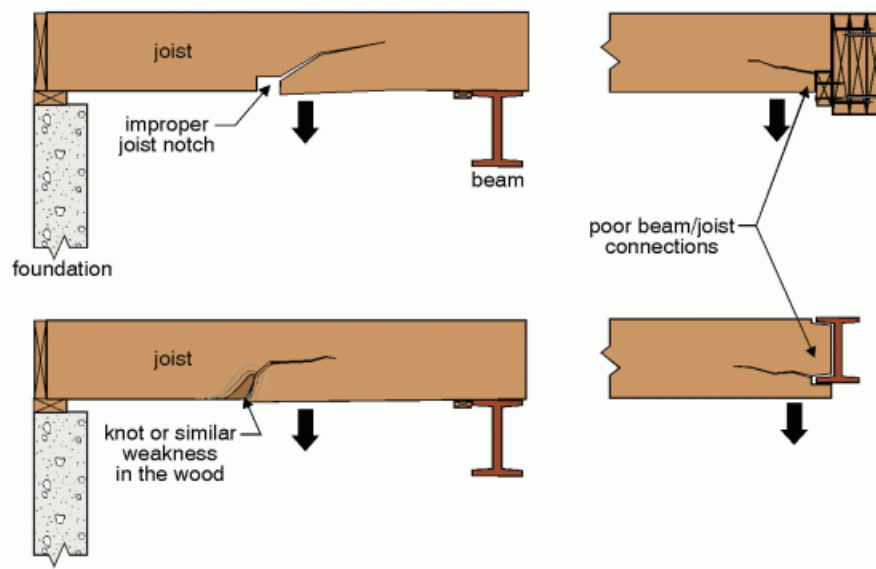
Common causes of cracked joists

Time: Immediate
