Your Inspection Report

505 Queen Street East
Toronto, ON

Friday, February 8, 2019

RE: Report No. 2685
505 Queen Street East
Toronto, ON

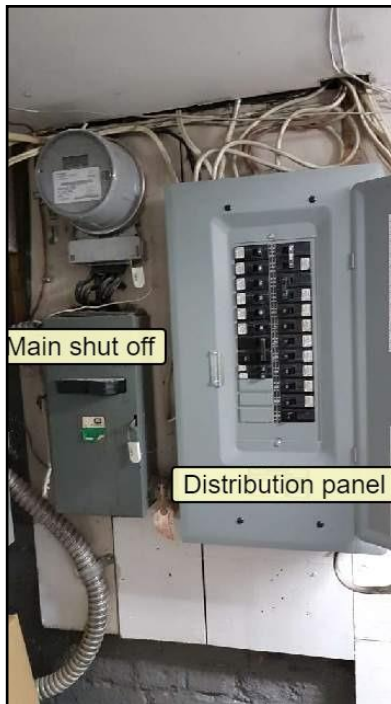
6.

Distribution panel type and location:

• [Breakers - basement](#)

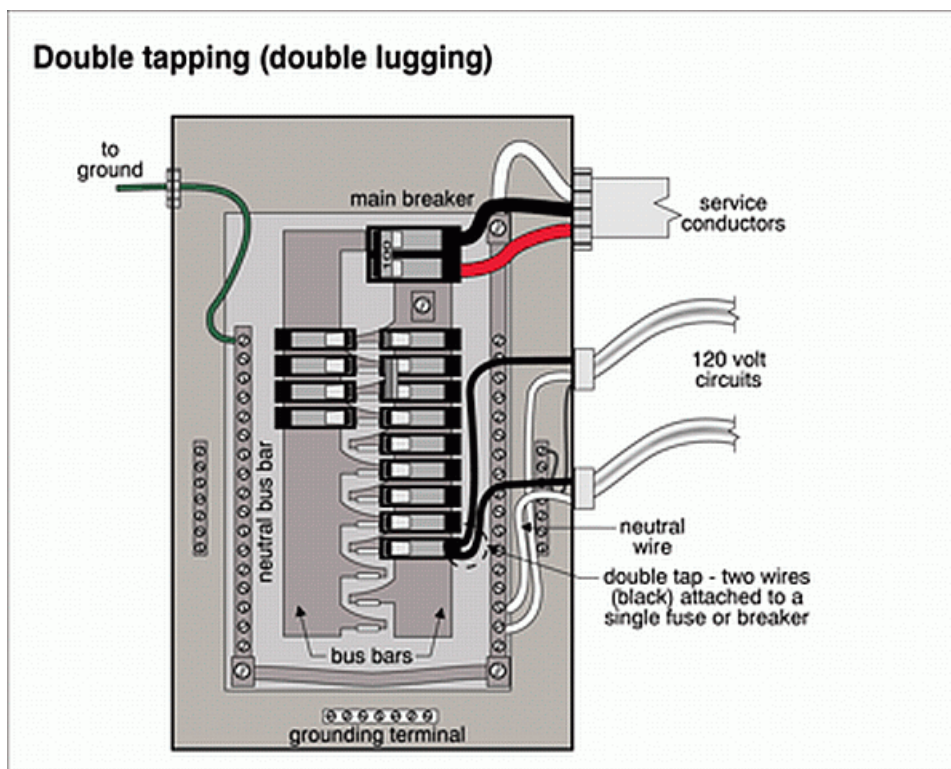
7. Double taps

4. Condition: • [Double taps](#)

Implication(s): Fire hazard

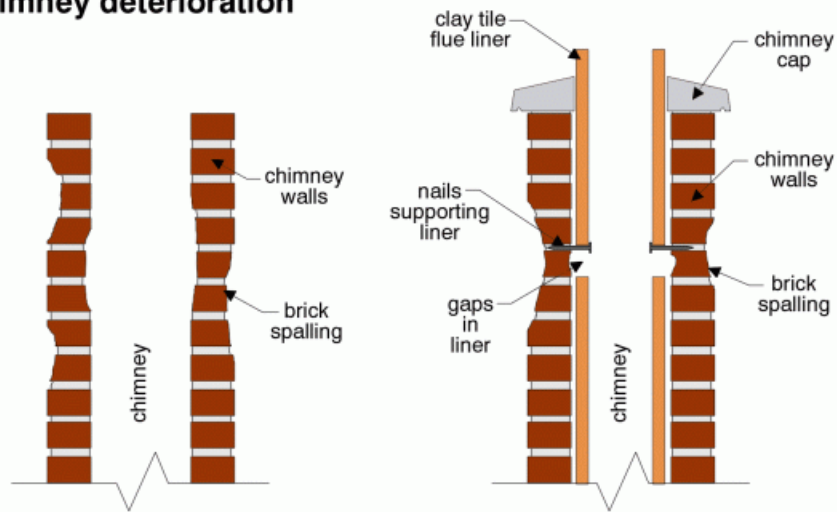
10. Condition: • [Spalling](#)

Minor parging needed at chimney. Not urgent, complete in conjunction with roof repairs.

Chimney deterioration

unlined chimneys are particularly prone to damage caused by condensation of flue gases - the damage tends to be worse near the top of the chimney

Task: Repair
