YOUR INSPECTION REPORT

3 Sunnybrook Road
Toronto, ON M6S 1G3

INSPECTION DATE:
Friday, October 8, 2021

RE: Report No. 2952
3 Sunnybrook Road
Toronto, ON
M6S 1G3

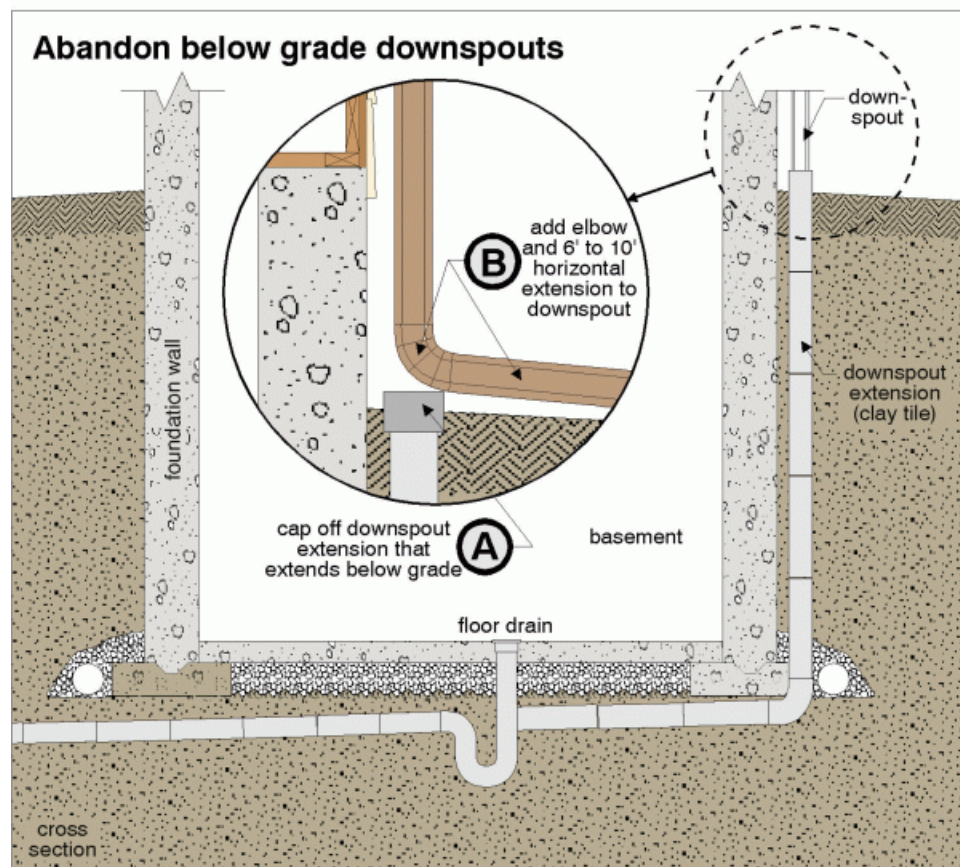
Condition: • Discharge below grade

Task: Monitor / Improve

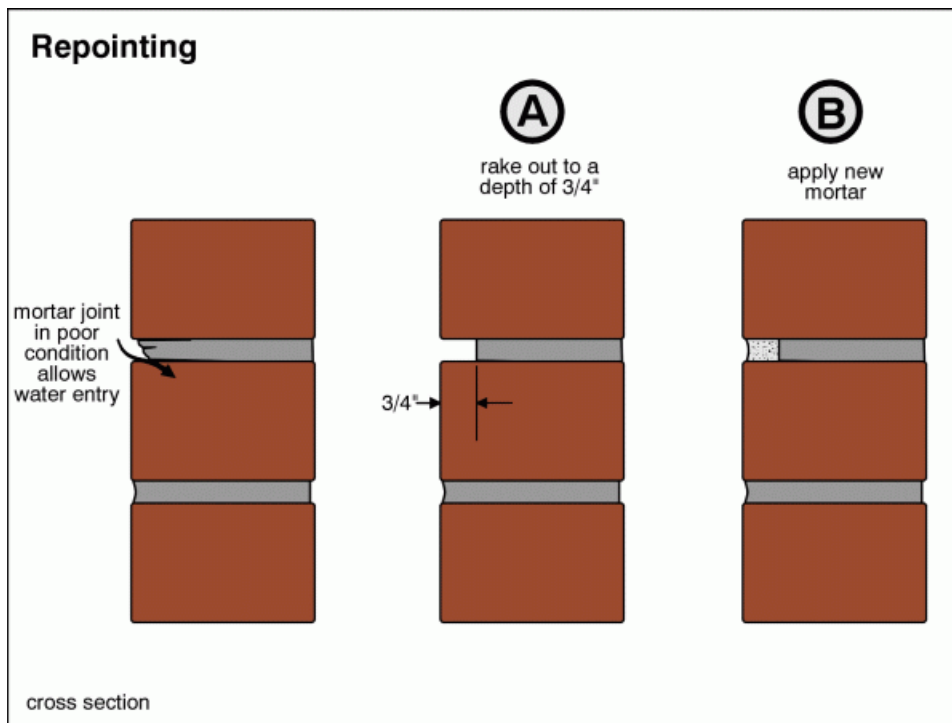
Condition: • [Mortar deterioration](#)

Provide mortar (Repointing, Tuck pointing) at various areas of the exterior brick or foundation. This is routine maintenance for homes of this age. Overall the brick and mortar is in good condition. photos show sampling.

Task: Repair
