YOUR INSPECTION REPORT

6 Mountview Avenue
Toronto, ON M6P 2L3

INSPECTION DATE:
Tuesday, September 5, 2017

RE: Report No. 2159, v.2
6 Mountview Avenue
Toronto, ON
M6P 2L3

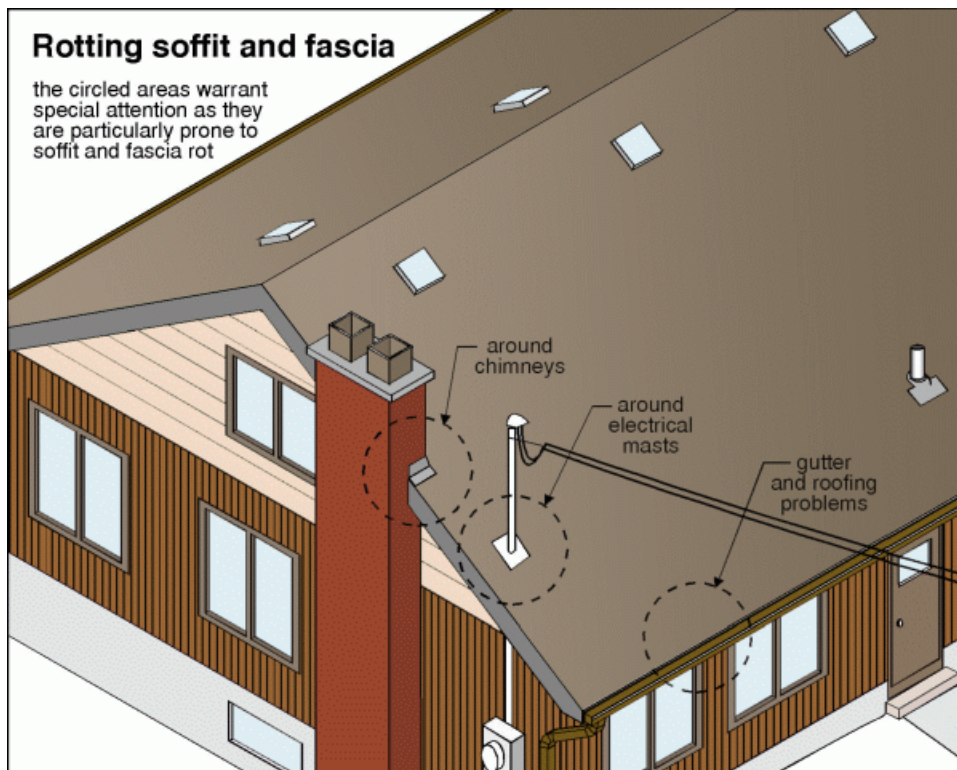
2. Damage

Condition: • [Damage](#)

Implication(s): Chance of water damage to contents, finishes and/or structure

Task: Repair

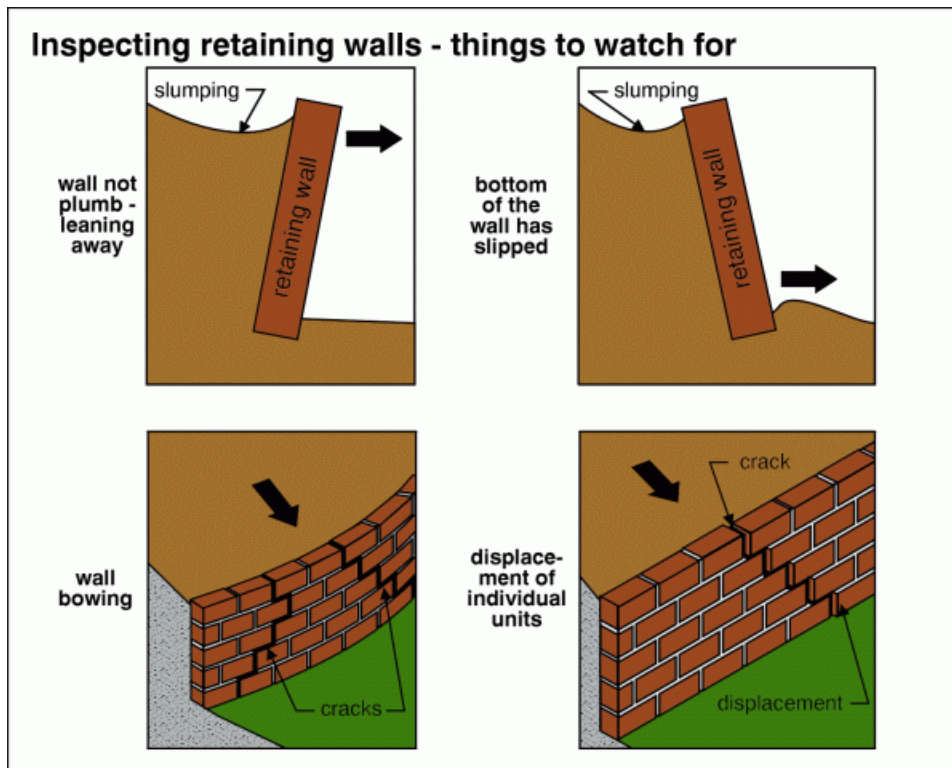
4. Bowing or bulging

Condition: • [Bowing or bulging](#)

At rear yard we noted a stone retaining wall that is bulging. We cannot determine from a one-time visit if the wall is moving and at what rate. Also, we cannot determine what side of the property the wall was built. Sometimes these walls are shared. Maintenance with yard retainers are very common in this neighbourhood.

Time: As Needed / Unpredictable

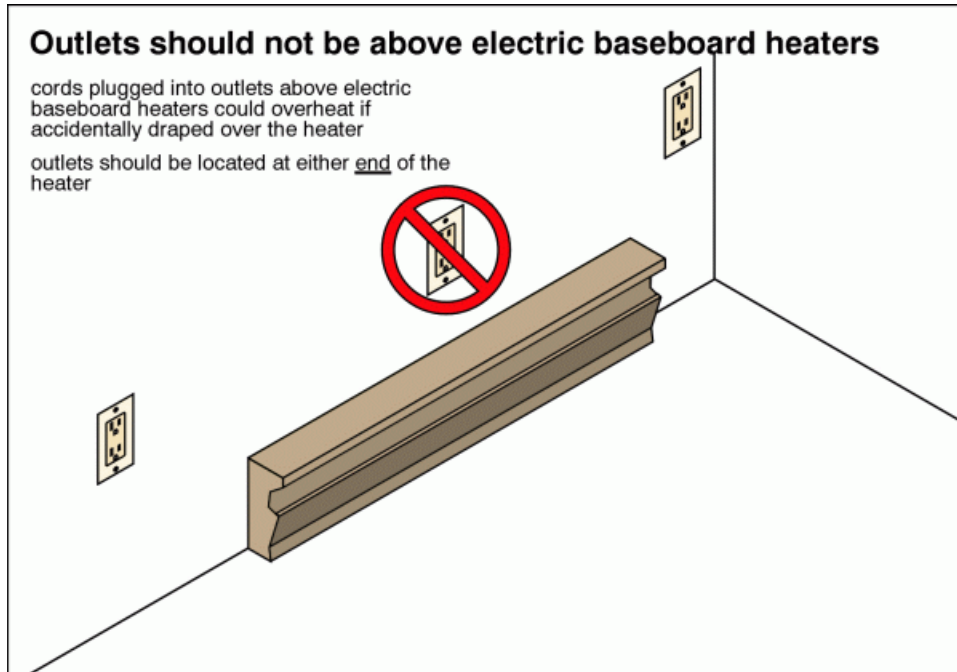
12. Above electric baseboard heaters

cords plugged into outlets above electric baseboard heaters could overheat if accidentally draped over the heater

outlets should be located at either end of the heater

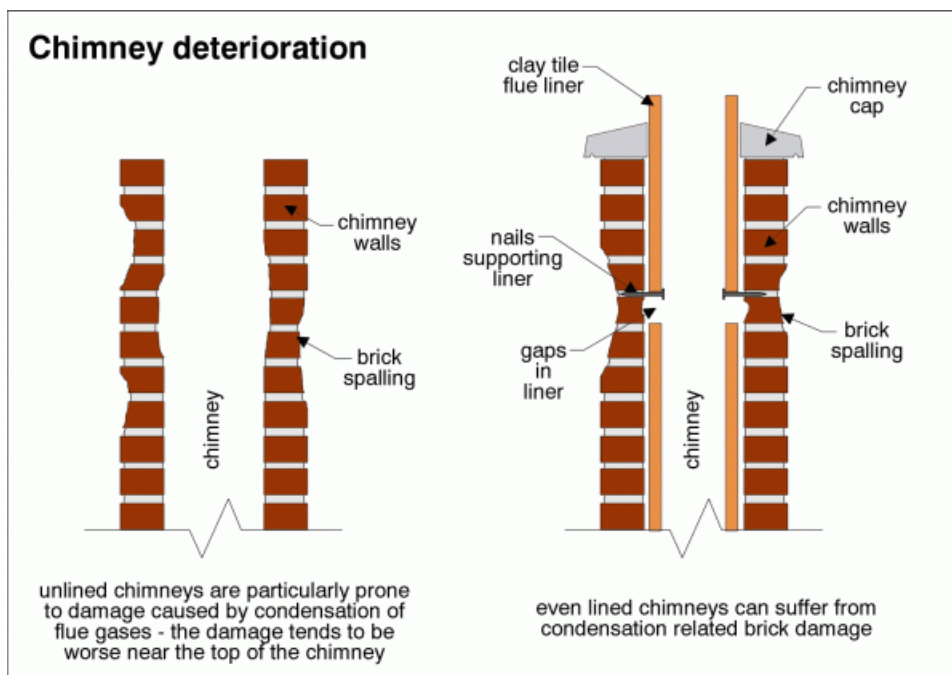
Deteriorated clay chimney liner
