Your Inspection Report

231 Ashdale Avenue
Toronto, ON M4L 2Y8

Tuesday, May 26, 2020

RE: Report No. 3046, v.3
231 Ashdale Avenue
Toronto, ON
M4L 2Y8

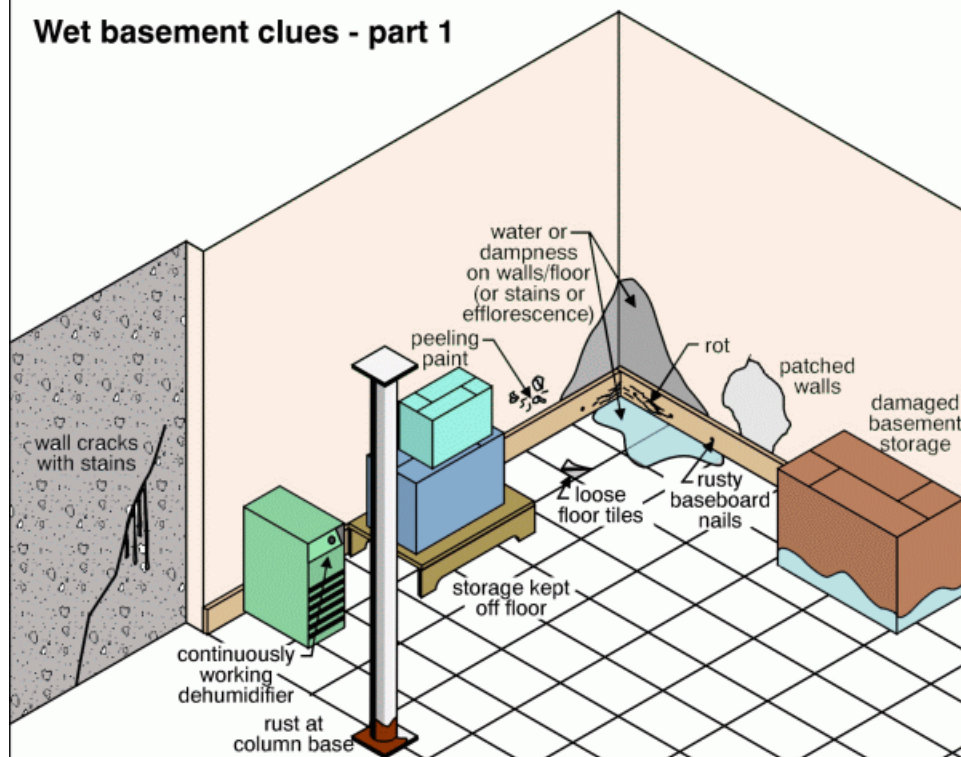
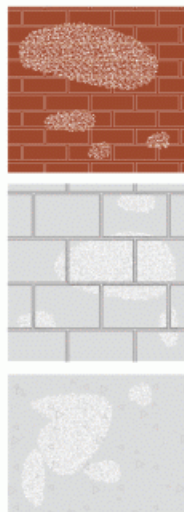
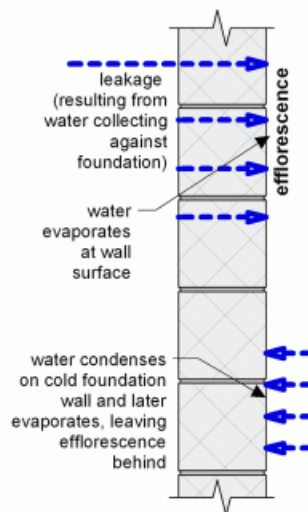
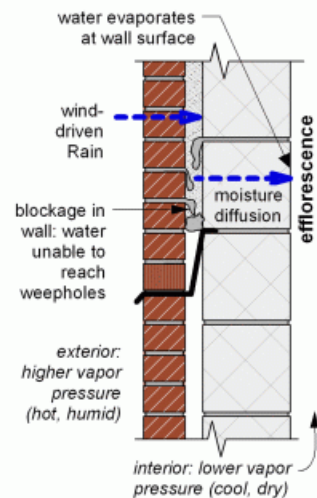
Wet basement clues - part 1

Basement leakage clues - efflorescence

efflorescence is a powdery, white substance that appears when water with dissolved minerals evaporates

efflorescence may form because of water on the surface of the wall, either from leaks or from condensation, for example:

efflorescence may also form because of moisture diffusion through a wall

concrete and clay are not water-tight
