Report No. 1021, v.5

777 Runningbrook Drive, Mississauga, ON December 4, 2019

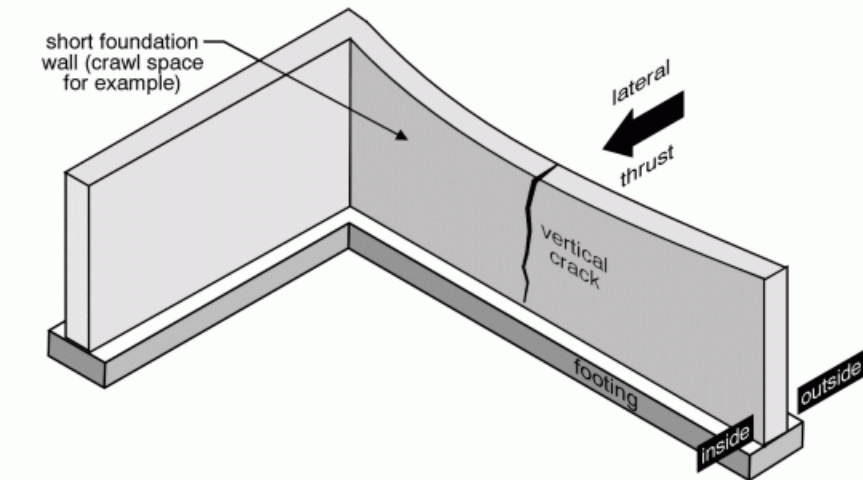
Vertical foundation cracks

7. Condition: • [Cracked](#)

Foundation cracks noted throughout, this appears not to pose a structural concern. In order to protect the interior finishes from water infiltration recommend patching from the exterior, consult with a foundation expert on the approach and material required. Homes of this age do not have a water tight membrane protecting the foundation walls, ensure the lot grading is kept away from the foundation walls, all downspouts at least 4to6 feet away from the house.

in short foundation walls, horizontal forces can also cause vertical cracks (typically at the midpoint of the walls)

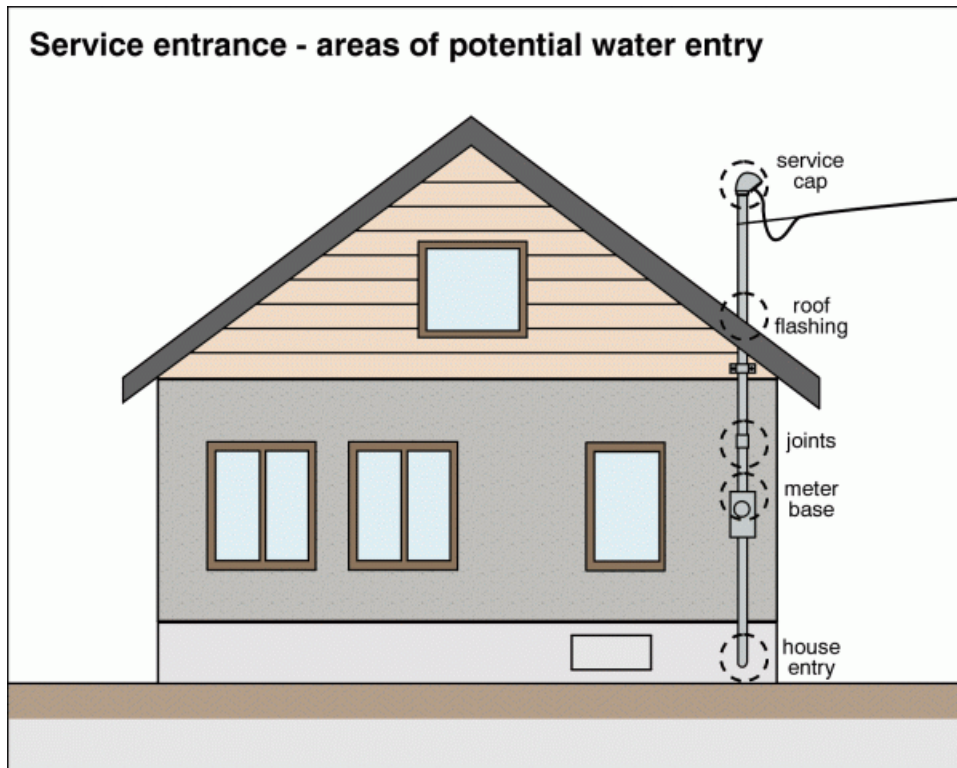
20. Conduit or cable not weather-tight

8. Condition: • [Conduit or cable not weather-tight](#)

Conduit not weather tight, recommend to seal the opening to prevent water infiltration

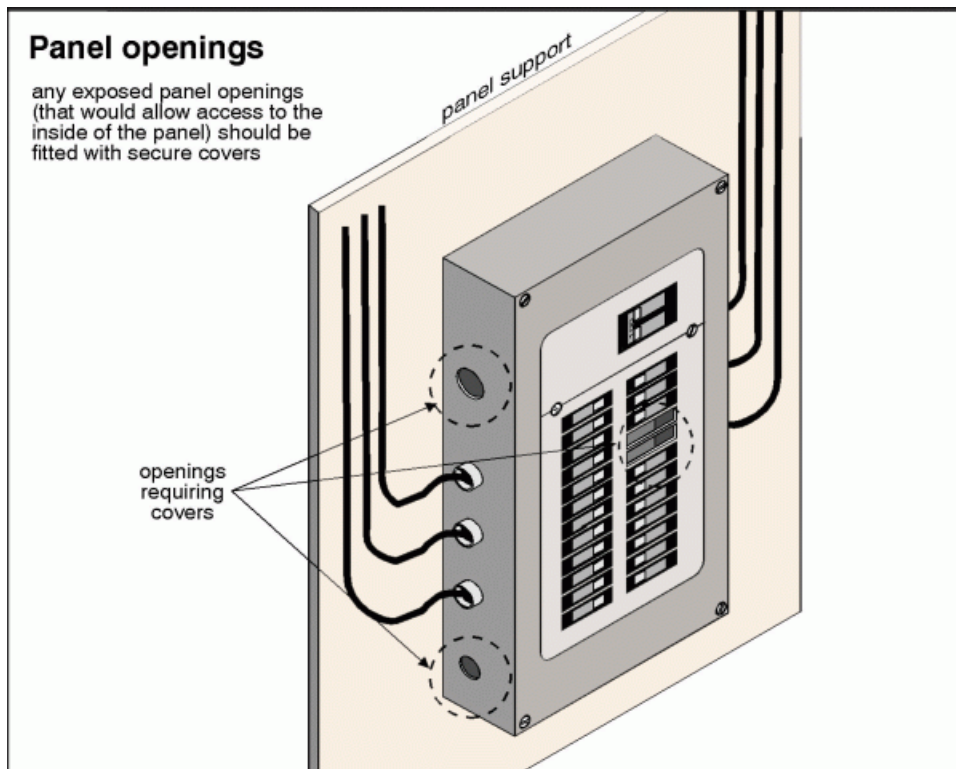
21. Unprotected openings

9. Condition: • [Unprotected openings](#)

open receptacle, repairs required immediatly
