# YOUR Inspection Report

3905 Catamaran Crt  
Quincy, IL 62305

Thursday, September 6, 2018

Report No. 1511, v.3

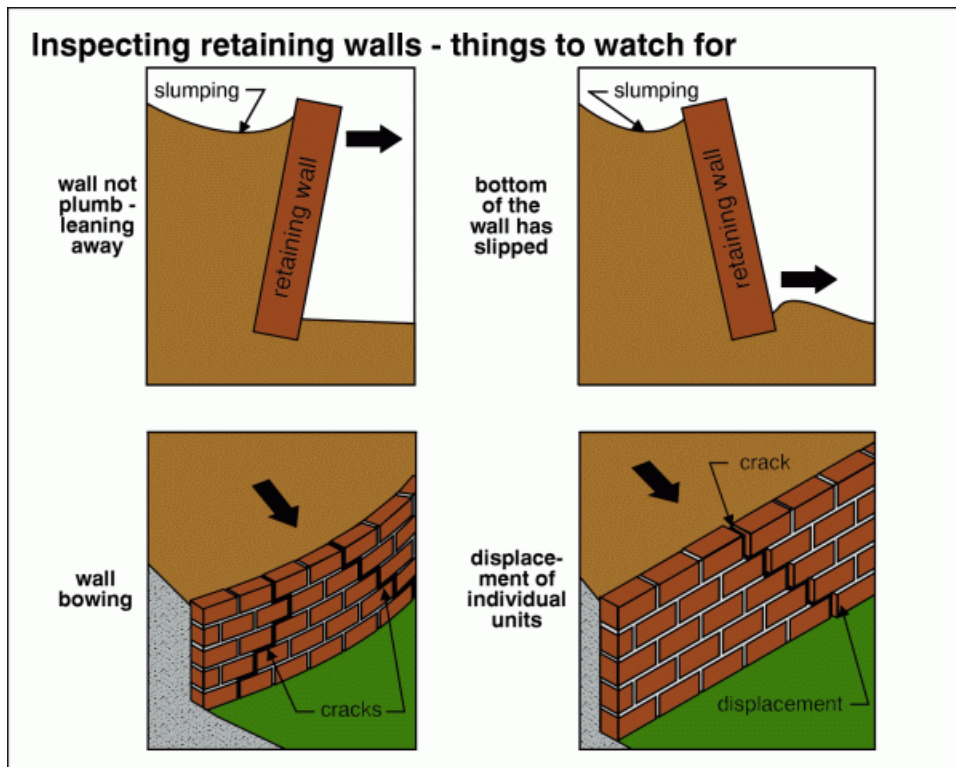
**Condition:** • [Leaning](#)

Recommend correcting leaning retaining walls, both upper and lower.

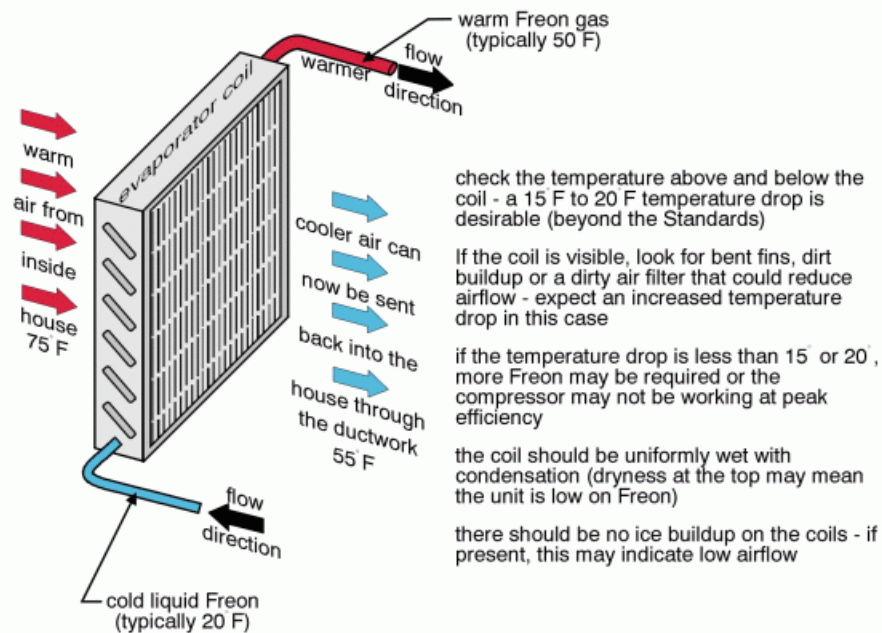
### Evaporator coil - inspection procedures

**Condition:** • [Frost](#)

Recommend further evaluation for coil frosted over and unit is not cooling the home.
