# Your Inspection Report

129 South Dr  
Toronto, ON M4W 1R9

RE: Report No. 83424  
129 South Dr  
Toronto, ON  
M4W 1R9

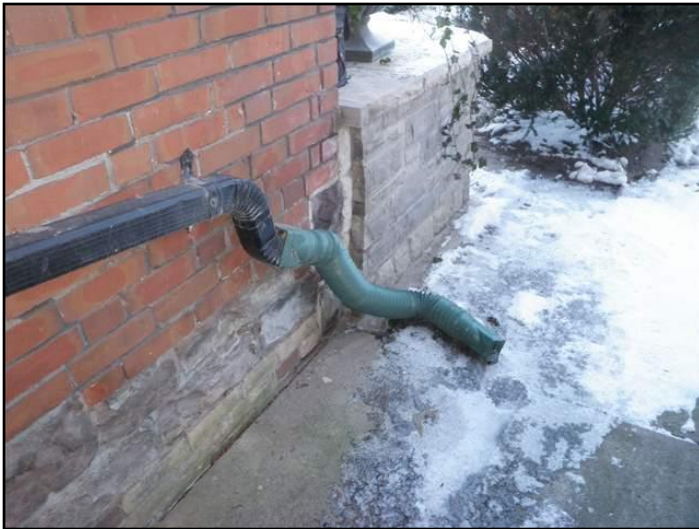
**Condition:** • [Discharge too close to building](#)

Always transfer water as far away from the house as practical. However attention to erosion, tripping hazard, or creating a slippery ice surface should also be considered.

*Discharge too close to building*

**Time:** Less than 1 year

**Cost:** Less than \$500

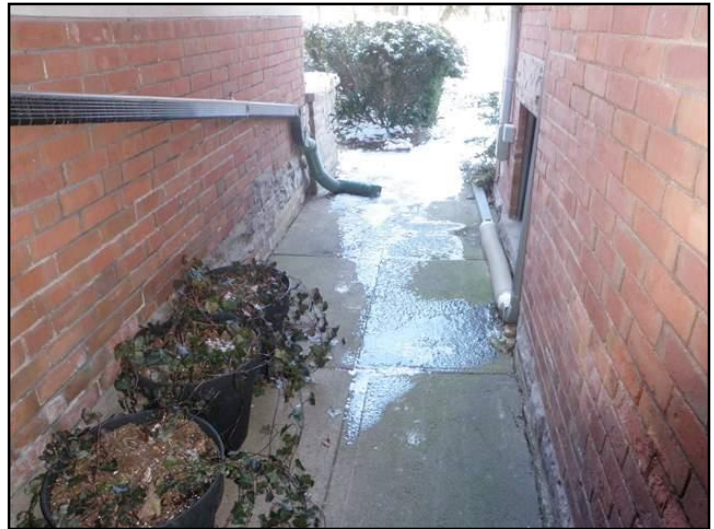
*Ice formation in walkway*

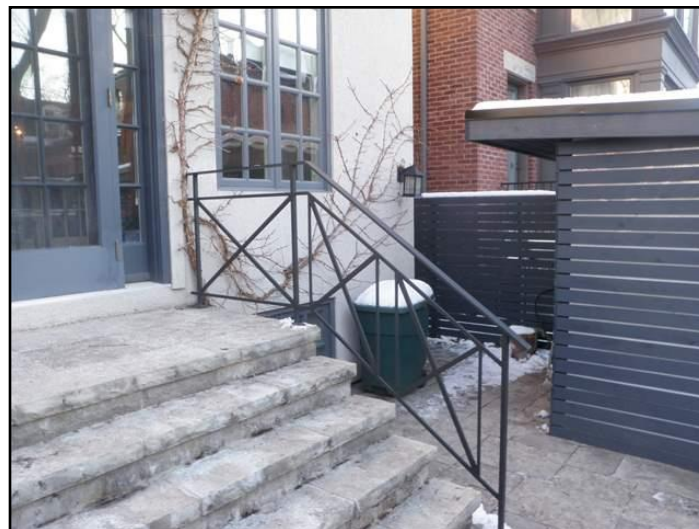
**Condition:** • [Openings between spindles \(balusters\) too large](#)

Large openings at rear railing may create a fall hazard, particularly for small children that will want to play here.

**Location:** Rear Porch

*Large openings at railings*

**Task:** Monitor / Improve

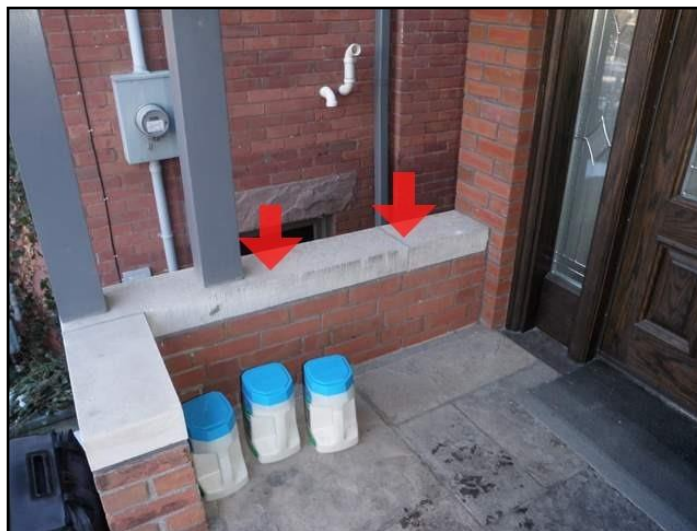
**Condition:** • [Too low](#)

Low wall at front porch is easily climbed, particularly by children. This may become a hazard.

**Location:** Front Porch

*Low wall is easily climbed*

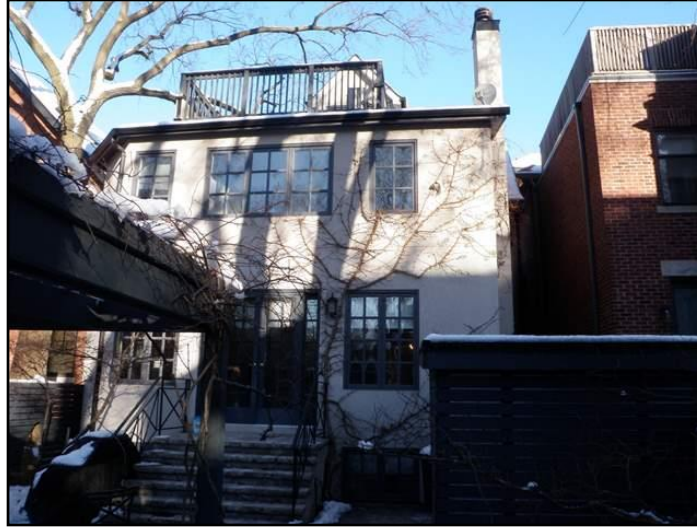
**Condition:** • Vines may damage the home over time. If vines are to remain, and we understand the aesthetic reasons for leaving them, we recommend controlling the growth so vines do not attach to wood surfaces or roofs, and do not clog gutters and downspouts.

*Vines may damage the home -*

**Task:** Monitor / Improve

**Time:** As necessary

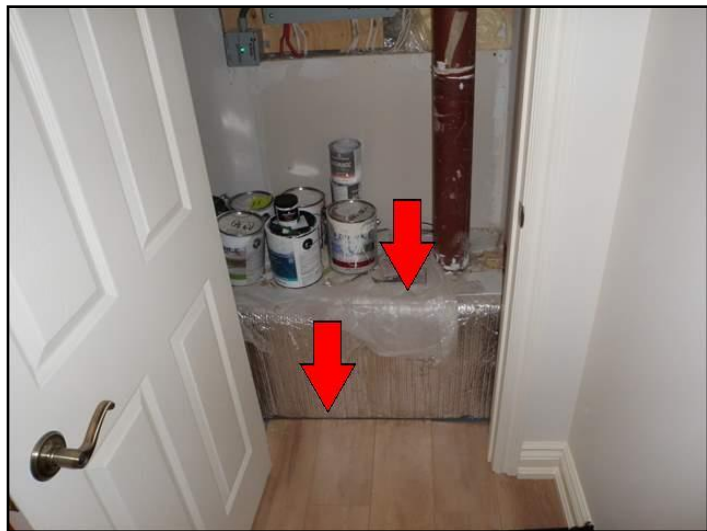
## Lowering basement floors - bench footing

**Condition:** • [Basement lowered](#)

*Basement lowered*

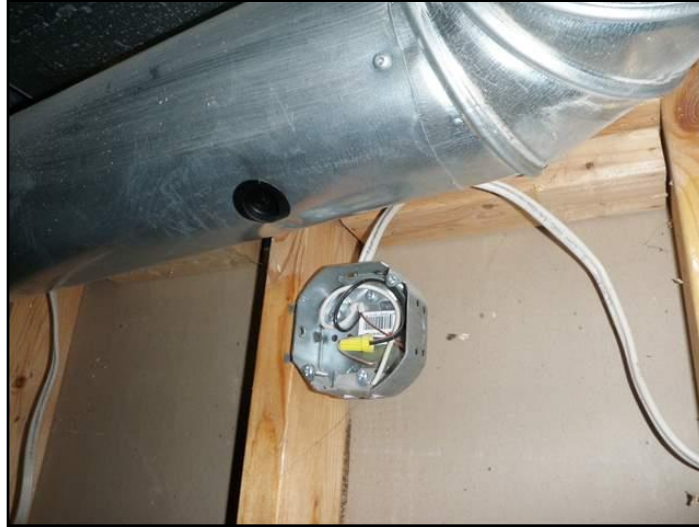
**Condition:** • [Cover loose or missing](#)

*Cover missing at junction box*

**Task:** Correct

**Cost:** Minor

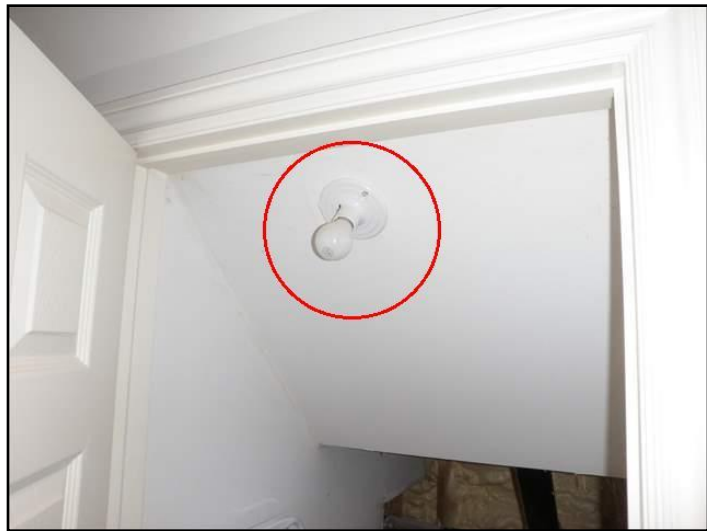
**Condition:** • Exposed to mechanical damage (No cage or protective lens).

*Exposed bulb*

Provide covers as necessary at any exposed bulbs to prevent damage.

**Time:** As soon as practical

**Cost:** Minor

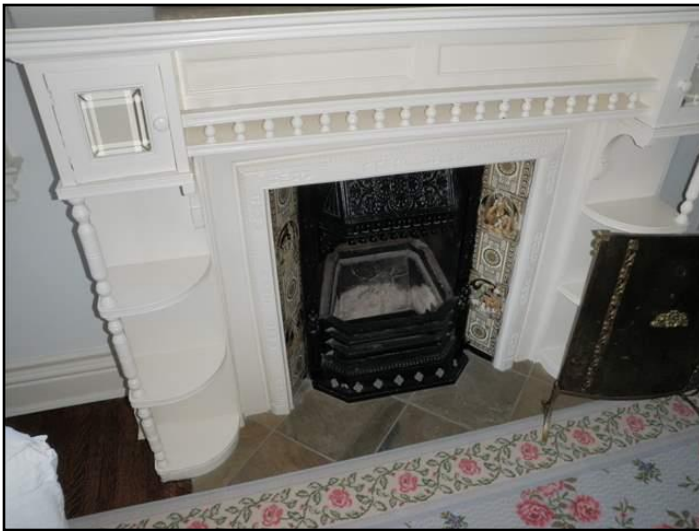
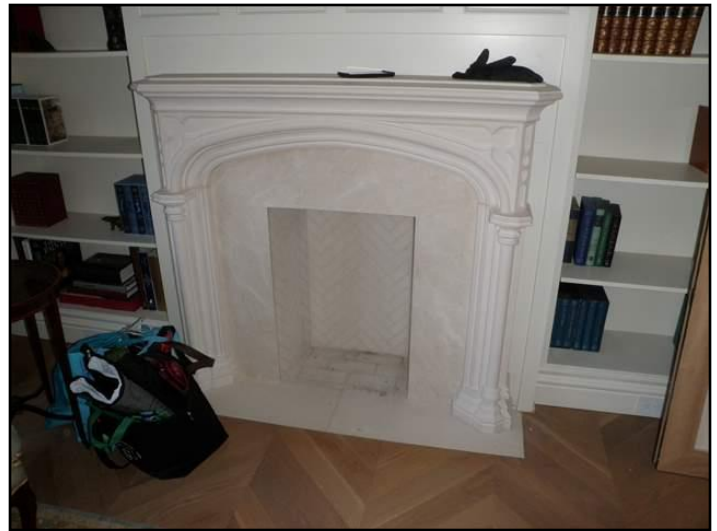
- Non-functional

Non-functional

**Condition:** • A specialist should be engaged to inspect the gas fireplace prior to using the appliance. There are many manufacturers and many models of these units, with many different installation rules. We also recommend the gas fireplace be covered under a maintenance contract that includes regular service.

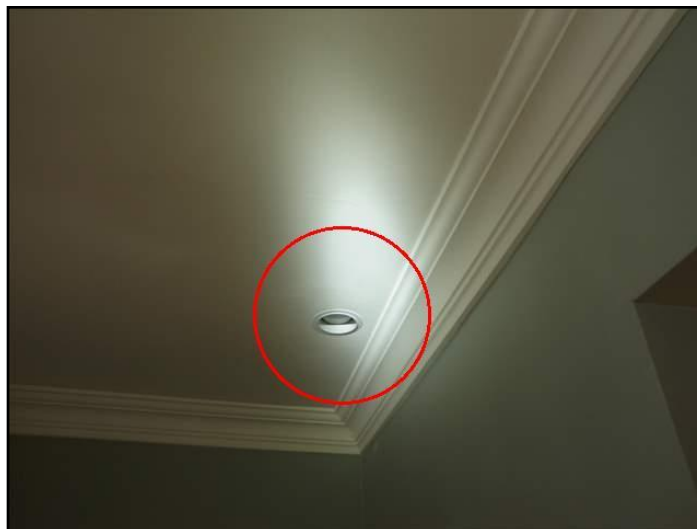
**Condition:** • Patched

Seller reports prior repair at the bathroom above before renovations were done. Drywall repairs are professionally done and effective- this area was dry at the inspection. Ask seller for details regarding the work done here.

**Location:** Rear First Floor

*Patched ceiling under rear ensuite*

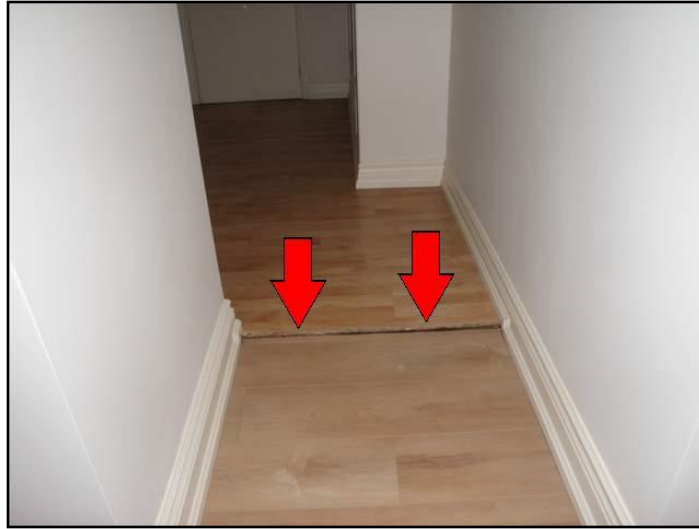
**Condition:** • [Trip hazard](#)

Raised floor at rear room entrance will become a trip hazard. A more gradual (sloped) transition is needed.

*Trip hazard*

**Task:** Repair

**Cost:** Minor

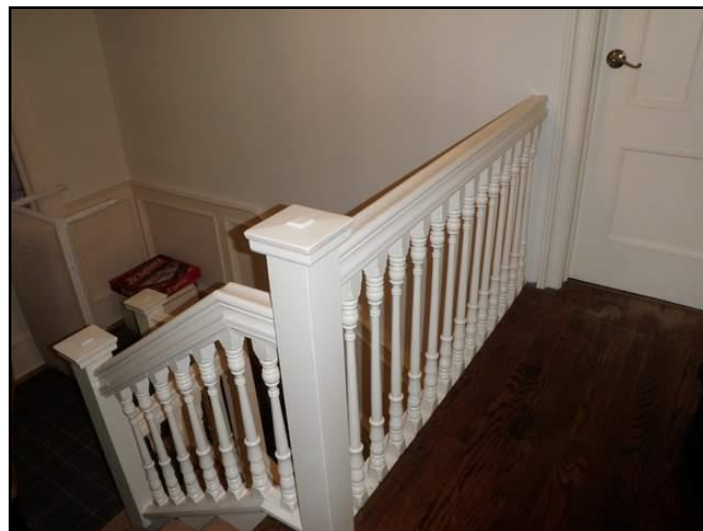
**Condition:** • [Too low](#)

**Location:** Second Floor Hall

Low railing

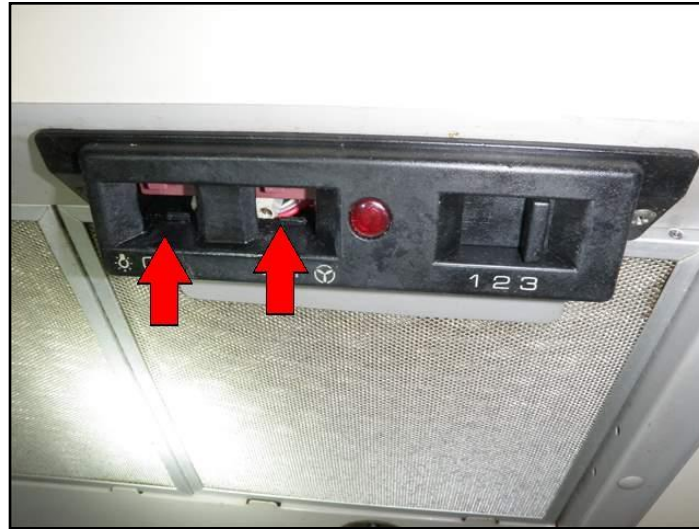
**Condition:** • [Damage](#)

Slider switch controls are missing for the fan/light controls above the range. both components are fully functional but the switches are difficult to operate.

*Missing sliders at fan and light switches*

**Task:** Repair

**Time:** Less than 1 year

**Cost:** Minor

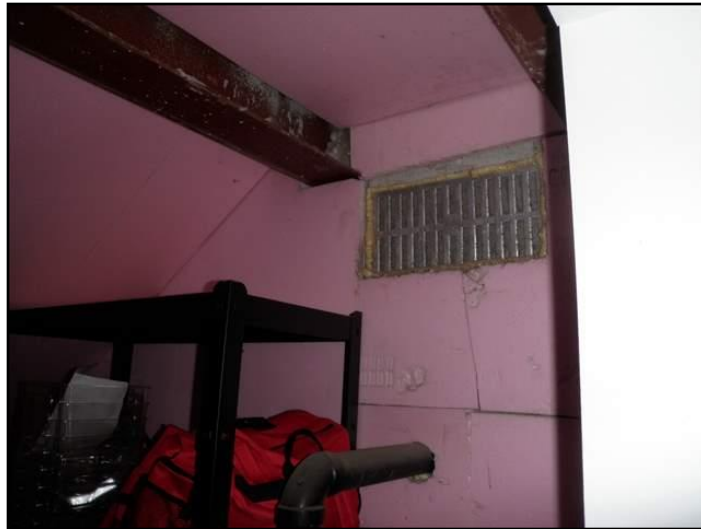
**Condition:** • Combustible insulation exposed

*Combustible insulation exposed*

**Task:** Improve

**Time:** As necessary

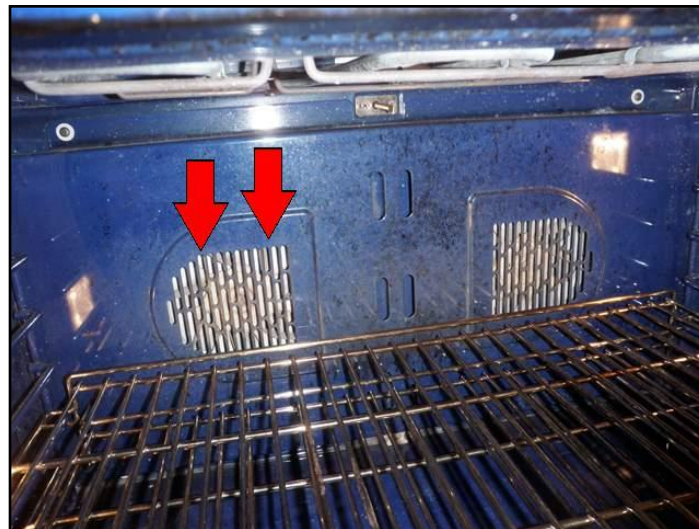
**Condition:** • Noisy convection oven fan

*Noisy fan- blade hits housing*

**Task:** Correct

**Time:** If/as necessary
