# **Your Inspection Report**

# 60 Pine Crest Rd Toronto, ON

**INSPECTION DATE:** Friday, February 12, 2016

RE: Report No. 51871 60 Pine Crest Rd Toronto, ON

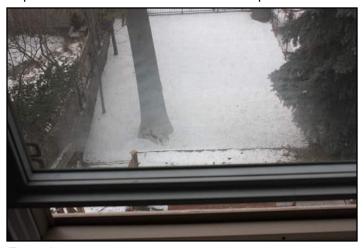
Example

• Snow/ice on the roof restricted access during the inspection. A full inspection by a specialist is recommended when the snow is gone. Repairs may be required based on the results of the full inspection.

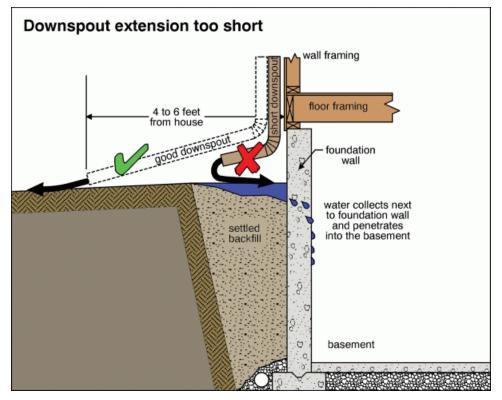
Discharge too close to Foundation (should...

Condition: • Discharge too close to Foundation (should discharge at least 2 m / 6 ft away); provide Downspout Extension

Time: Less than 1 year

Cost: Regular maintenance item

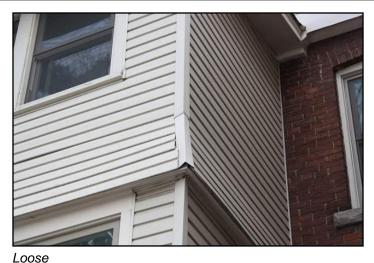
Condition: • Loose

Task: Repair

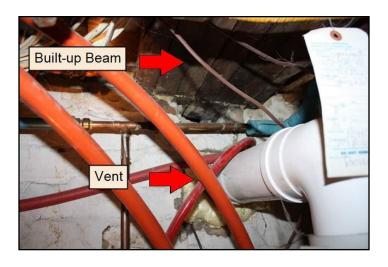
Condition: • The vent for the tankless boiler was installed through the foundation wall a few inches below the main built-up wood beam. This may have been done when the tankless was installed in 2008. This is not an ideal location for the vent as it could affect the support bearing of the beam. There is still some support on either side of the beam and there does not appear to be signs of distress over the 8 years. PRUDENT TO MONITOR THIS AREA. If any movement/cracking is noted, have contractor relocate vent and provide support post in this area. See photo for reference

Location: Rear Basement

Task: Monitor Time: Ongoing

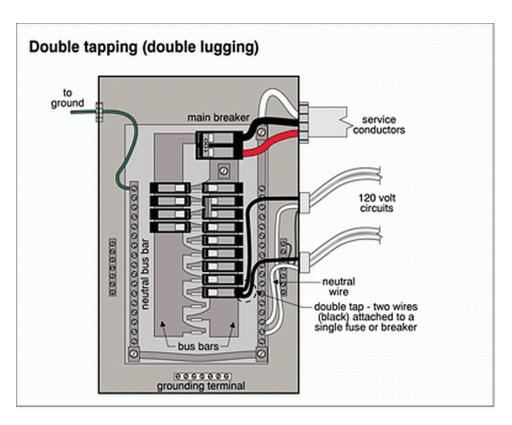
Condition: • Double tap (two wires on one breaker or fuse)

**Location**: Basement Panel

Task: Correct
Time: Immediate
Cost: Minor
