Your Inspection Report

1234 Anywhere
Shreveport, LA 71078

INSPECTION DATE:
Thursday, January 28, 2021

RE: Report No. 2202, v.2
1234 Anywhere
Shreveport, LA
71078

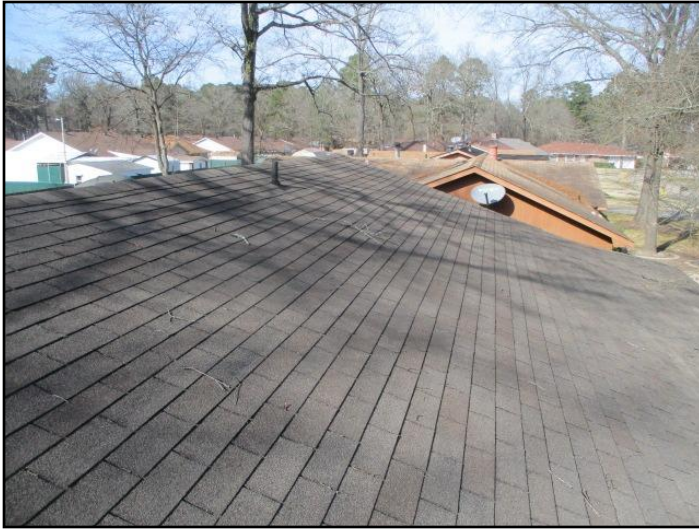
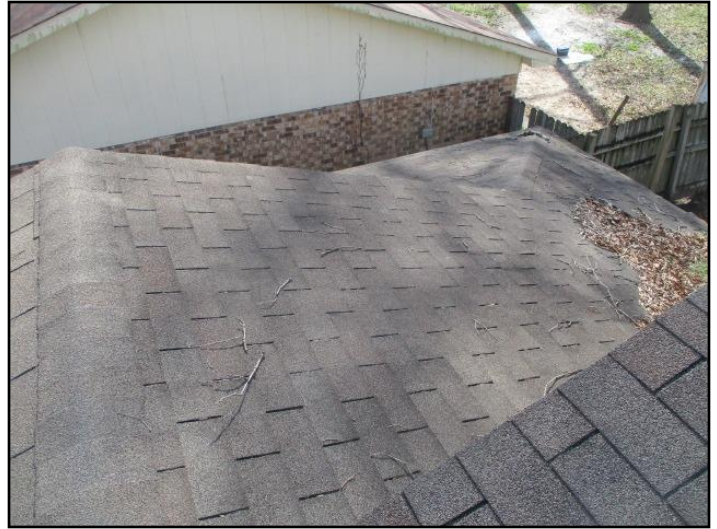
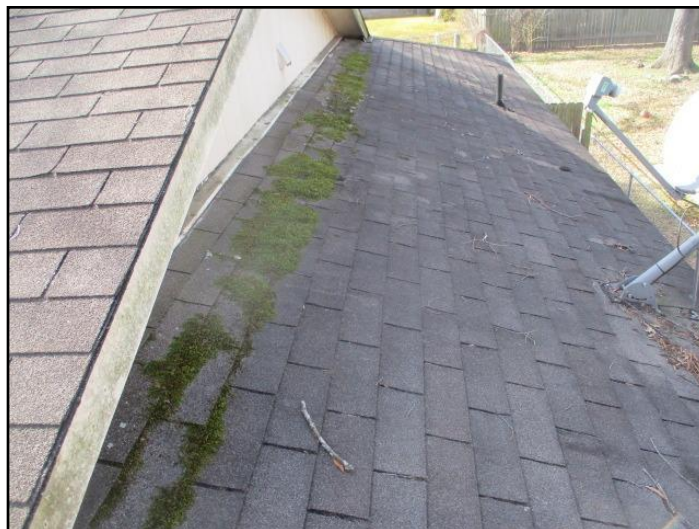
The roof materials show signs of ageing, however we observed no evidence of failure. Recommend further evaluation and repairs as needed by roof contractor

1. Aging

2. Aging

3. Aging/ moss growth

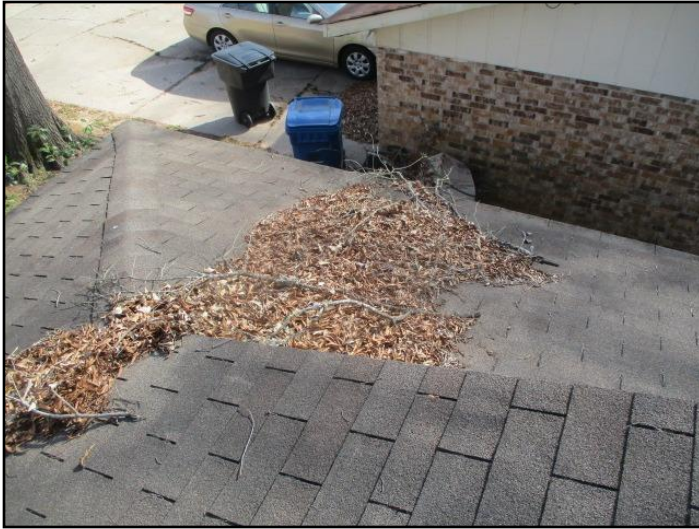
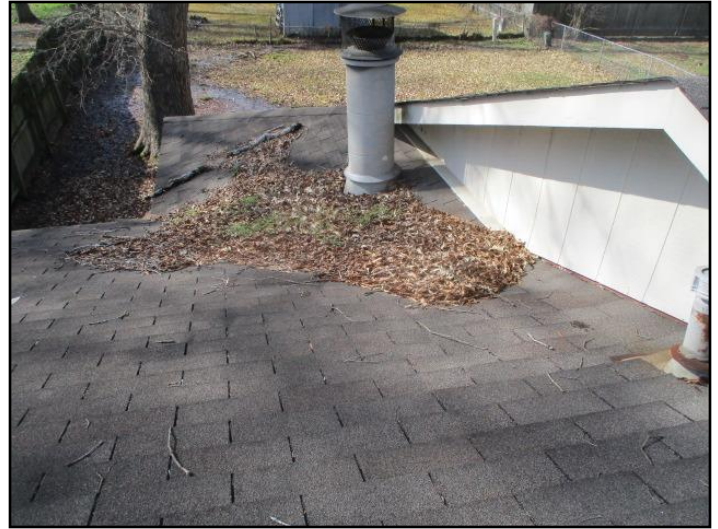
2. Condition: • Debris

4. Debris

5. Debris

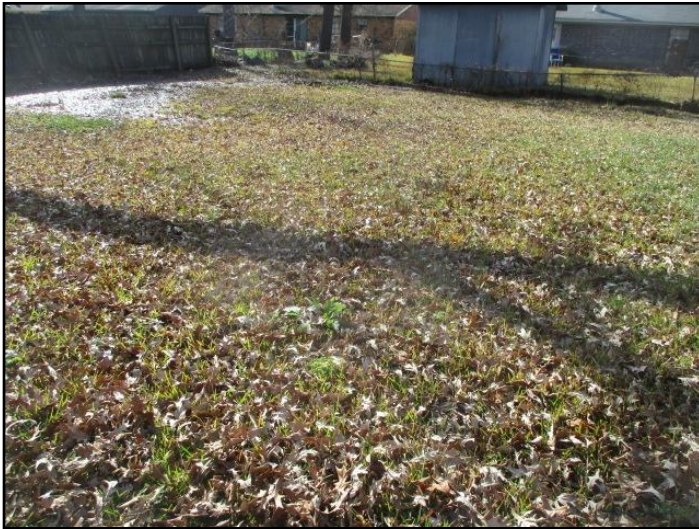
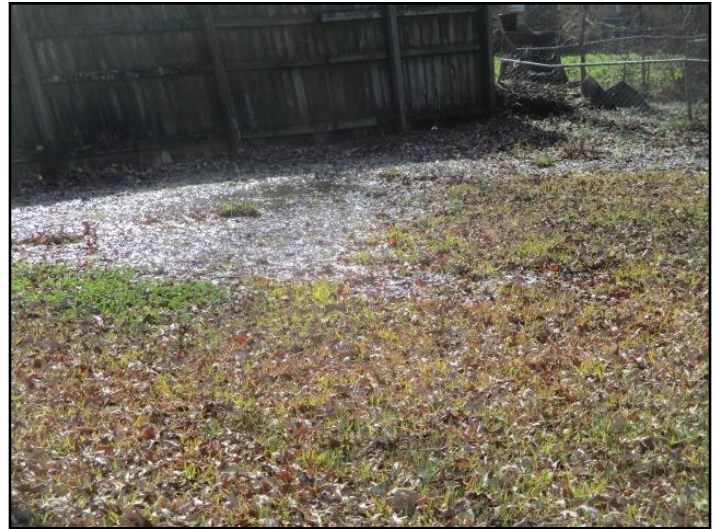
Rear is mostly flat with limited drainage, areas of ponding noted near the fence

9. Rear grading (ponding)

10. Rear grading (ponding)

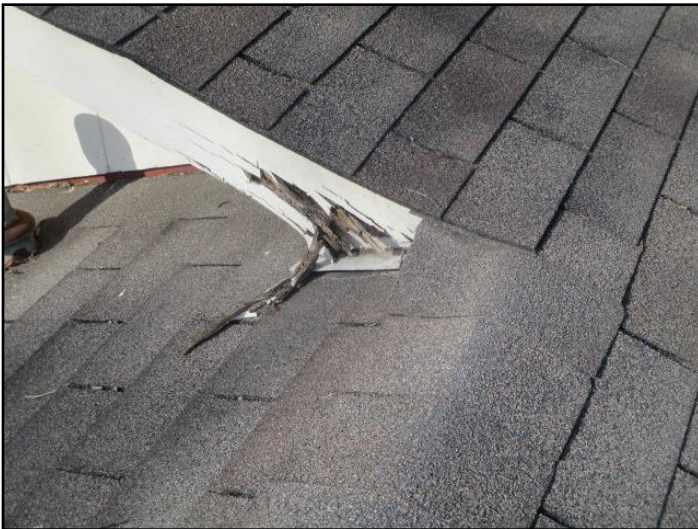
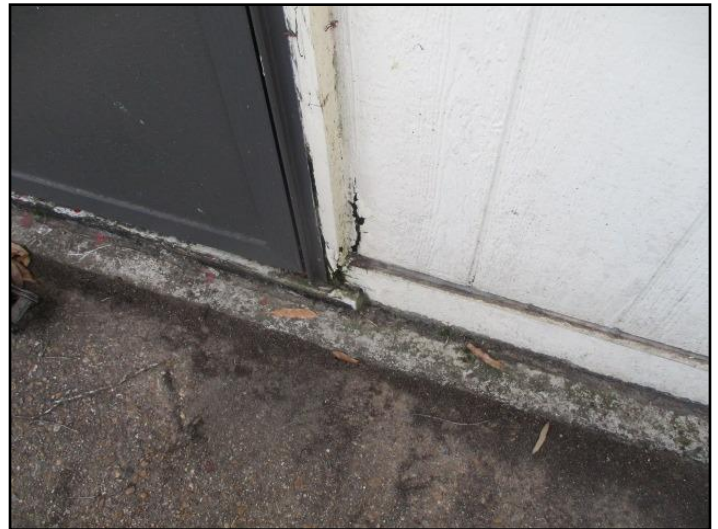
4. Condition: • Moisture damage

11. Moisture damage

12. Moisture damage

Moisture damaged trim should be replaced and painted

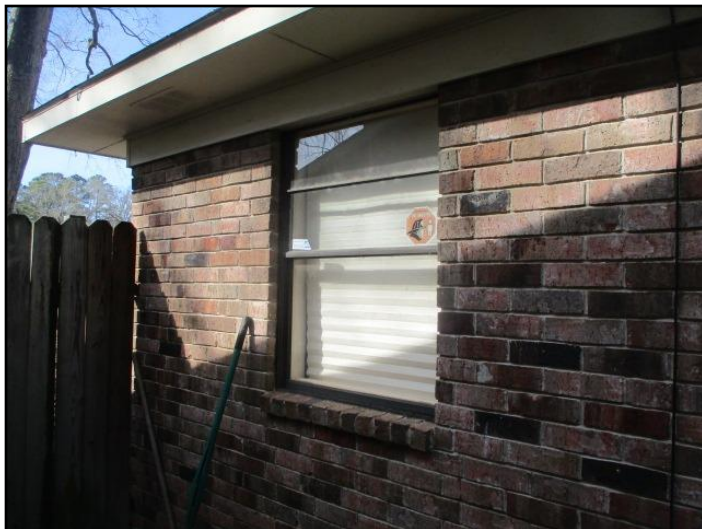
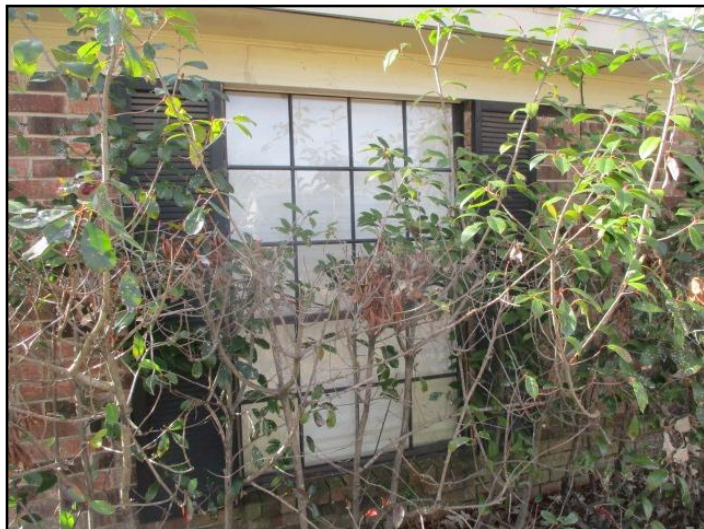
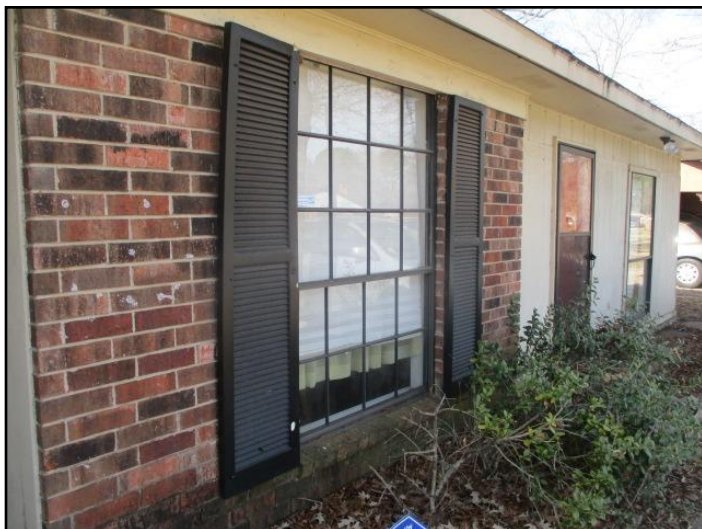
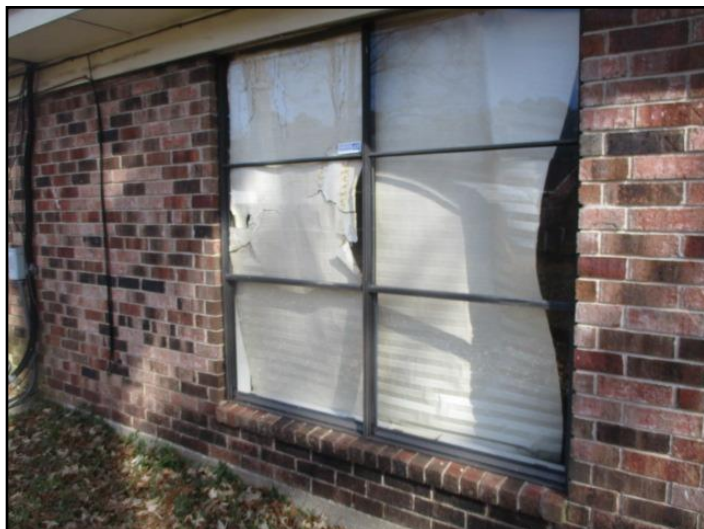
5. Condition: • Missing screens

13. Missing screens

14. Missing screens

15. Missing screens

16. Missing screens

All functioning windows should have secured screens. Recommend all missing screens be replaced.

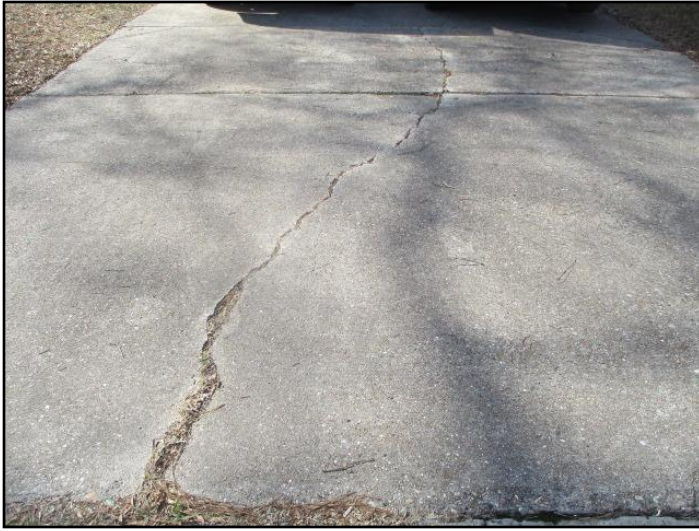
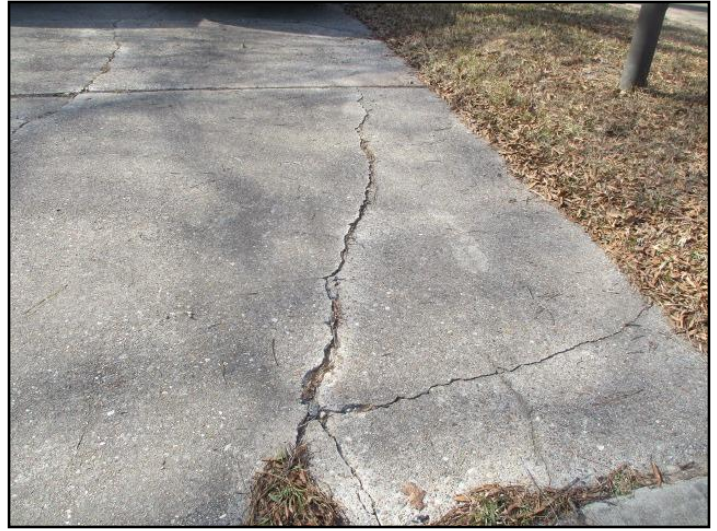
6. Condition: • Cracked or damaged surfaces

Common cracks in driveway should be monitored for movement

17. Cracked or damaged surfaces

18. Cracked or damaged surfaces

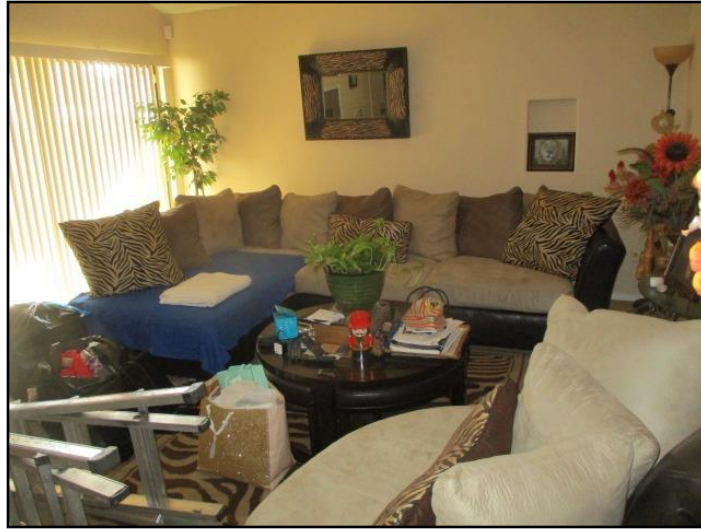
19. Owners belongings

- Owners belongings

Our evaluation of available outlets was limited due to the presence of the tenants belongings

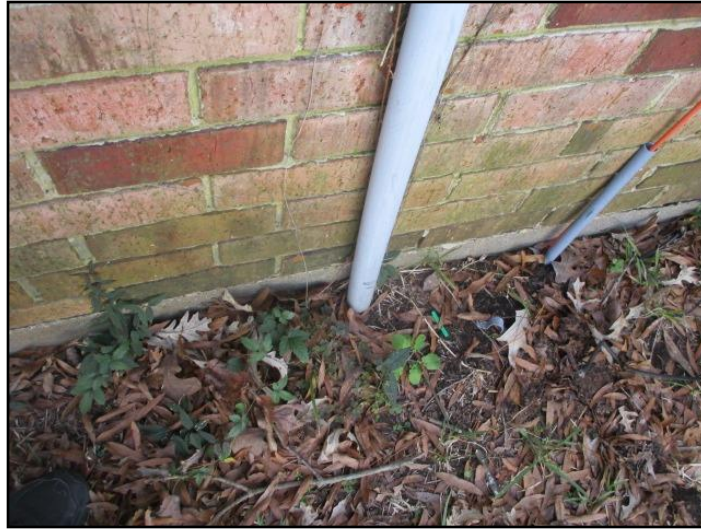
No visible ground rod noted for the electrical system. Recommend further evaluation and repairs as needed by a licensed electrician. A ground rod is designed to have a electrical path to earth to dissipate a static discharge voltage (such as Lightning).

20. Missing ground rod

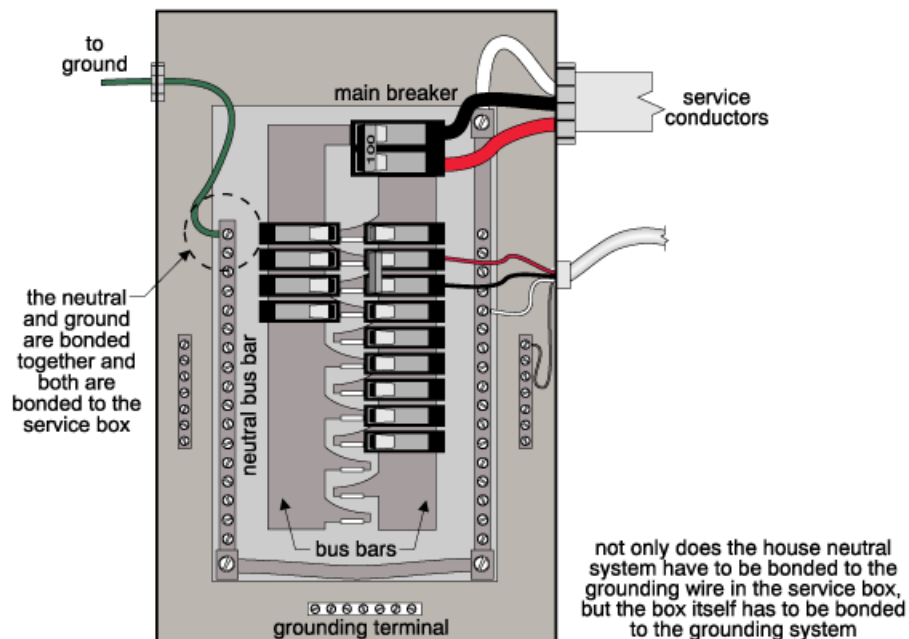
No visible panel bonding noted. A panel bond will insure the panel is safe to touch in the event a failure of the electrical insulation occurs. Recommend further evaluation and repairs as needed by licensed electrician.

Bond service box to ground

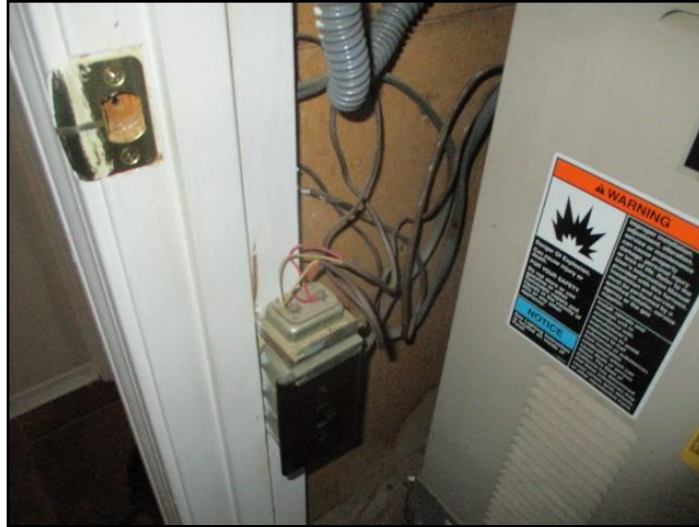
All permanent wiring on the interior of the home should be secured within flexible conduit. Recommend improvement

21. *Flexible conduit needed*

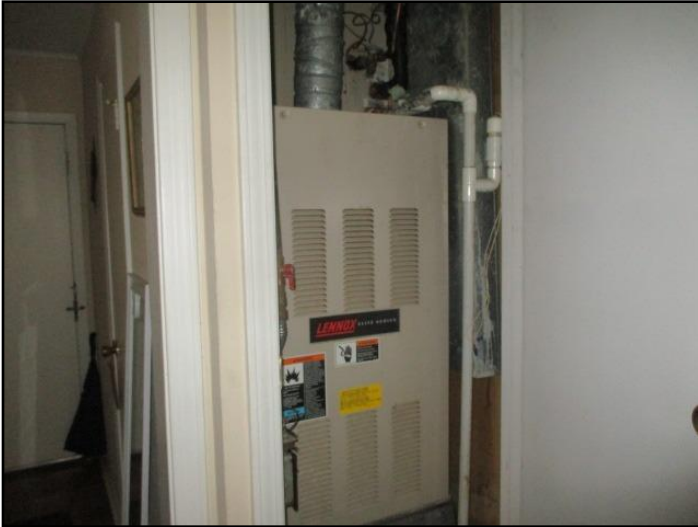
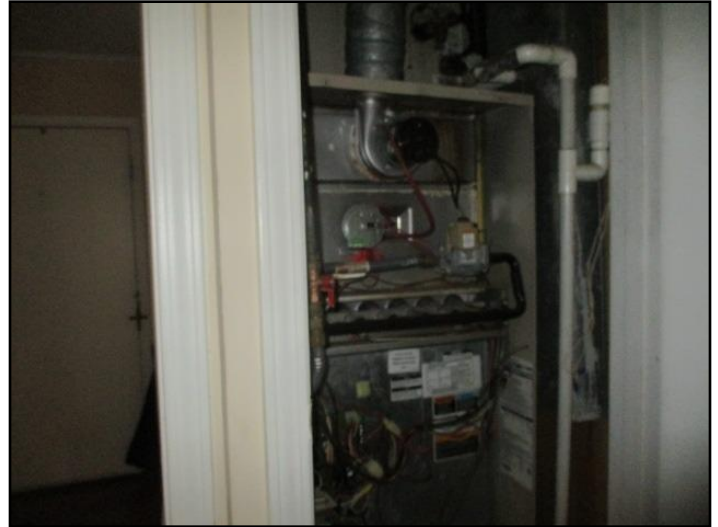
12. Condition: • The unit responded to normal controls, however due to the age of the unit we recommend the unit be serviced by a licensed professional to establish a time line for regular maintenance and to identify the true condition of the unit

22. Heating unit

23. Heating unit

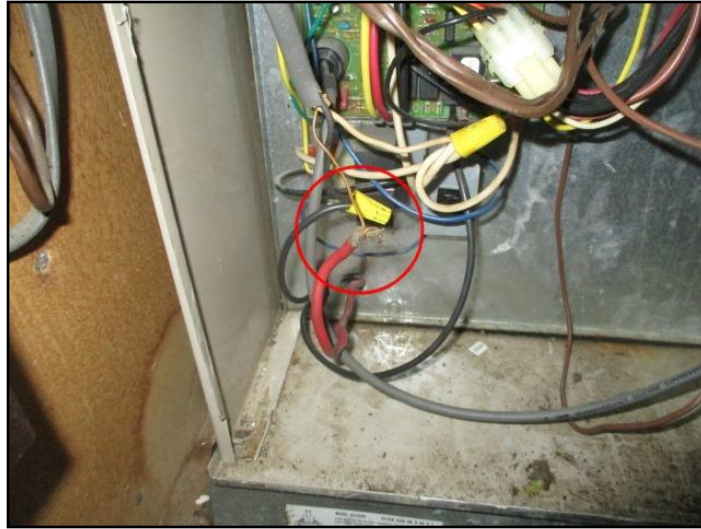
13. Condition: • Open splices should be properly secured with wire nuts

24. Open splices

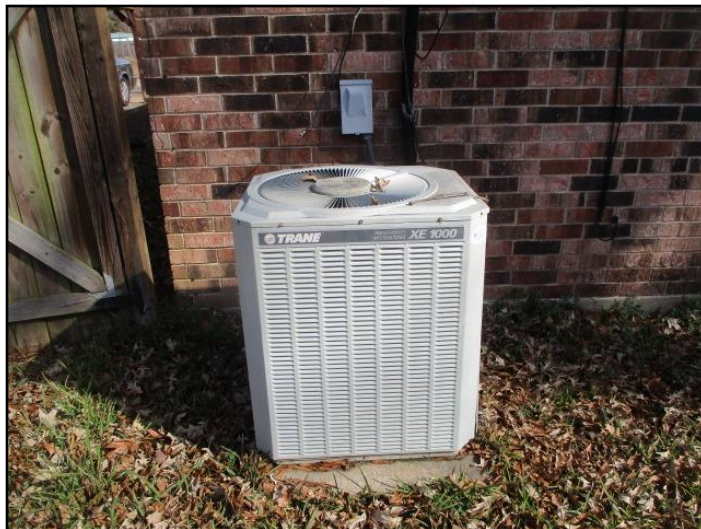
14. Condition: • The unit responded to normal controls, however due to the age of the unit we recommend the unit be serviced by a licensed professional to establish a time line for regular maintenance and to identify the true condition of the unit

25. A/C unit

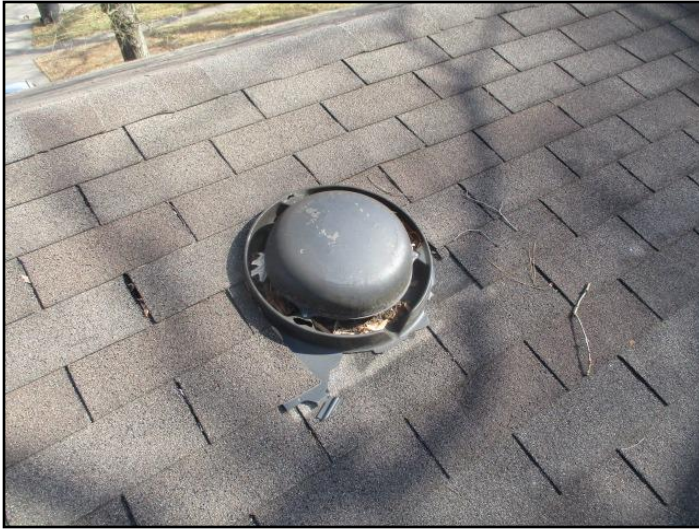
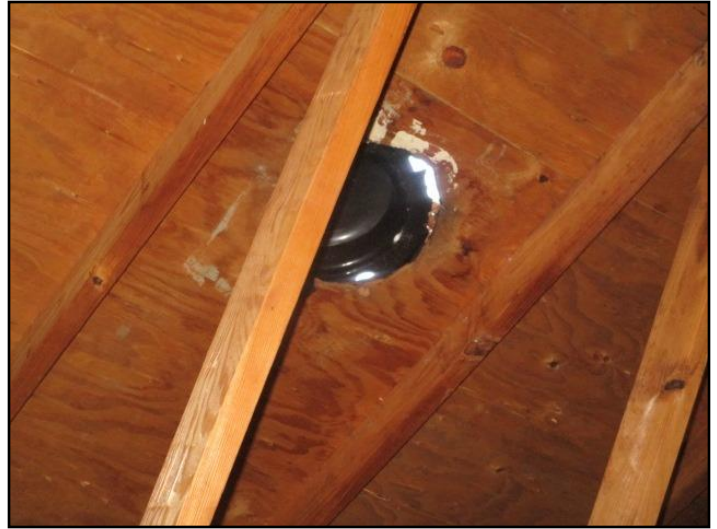
15. Condition: • Damage

26. Damage roof vent

27. Damage roof vent

Damaged roof vents should be replaced

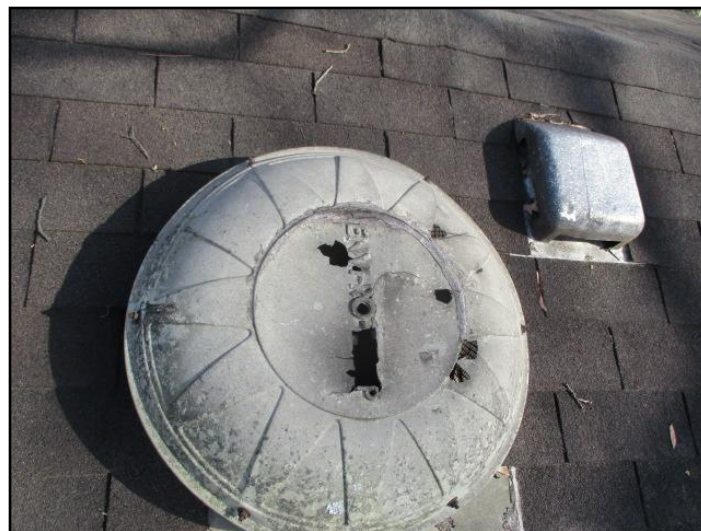
16. Condition: • Damaged power vent should be replaced

28. Damaged

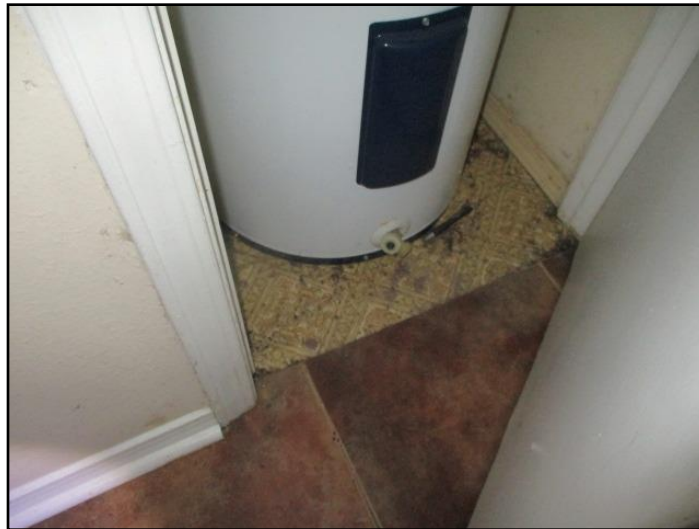
17. Condition: • Safety pan and drain missing

The absence of a safety pan with a drain to the exterior or the of the building may result in damage to interior contents and or structure if failure occurs. Recommend installation of safety pan by a licensed plumber.

29. No safety pan

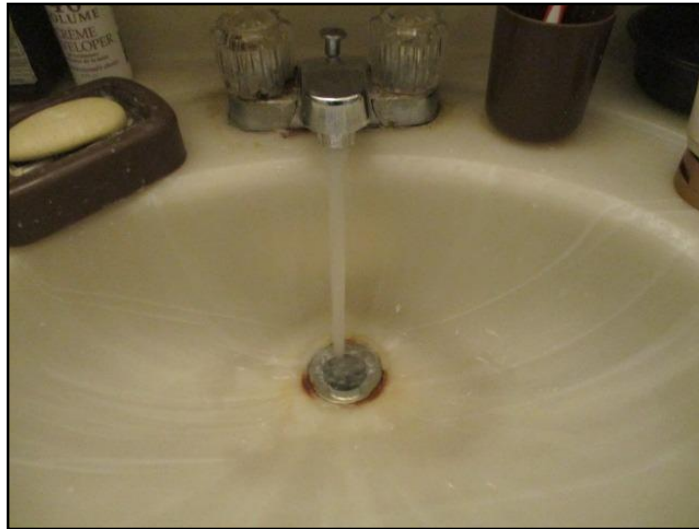
18. Condition: • Low pressure and temperature reading, recommend further evaluation with repairs as needed by licensed plumber

30. Low pressure and temperature

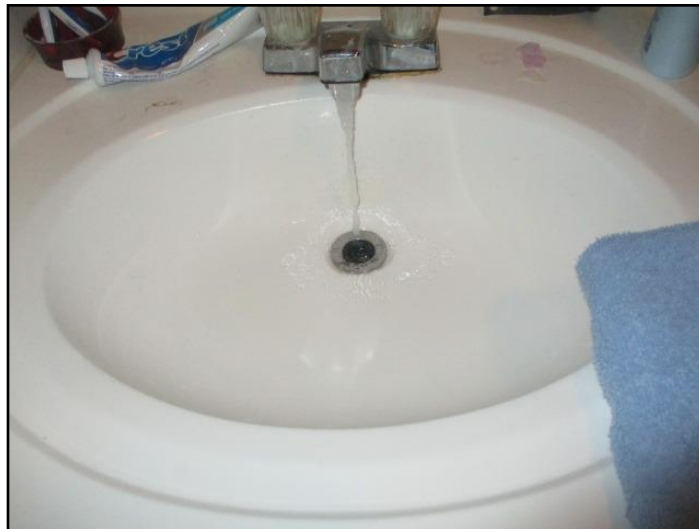
19. Condition: • Drain stop missing

31. Drain stop missing

Missing or ineffective drain stops should be repaired or replaced

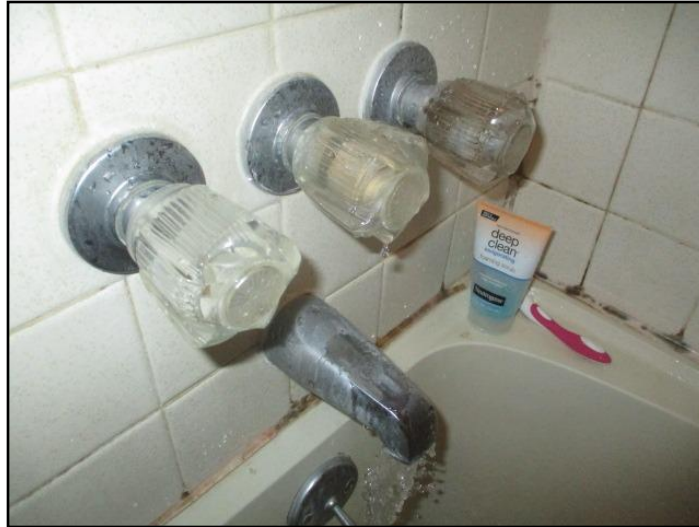
Noticeable leak when the faucet is in use, recommend further evaluation with repairs as needed by a licensed plumber.

32. Leak

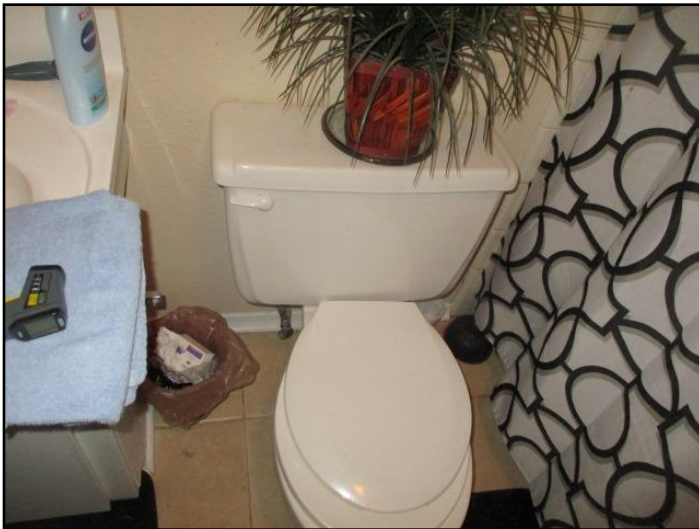
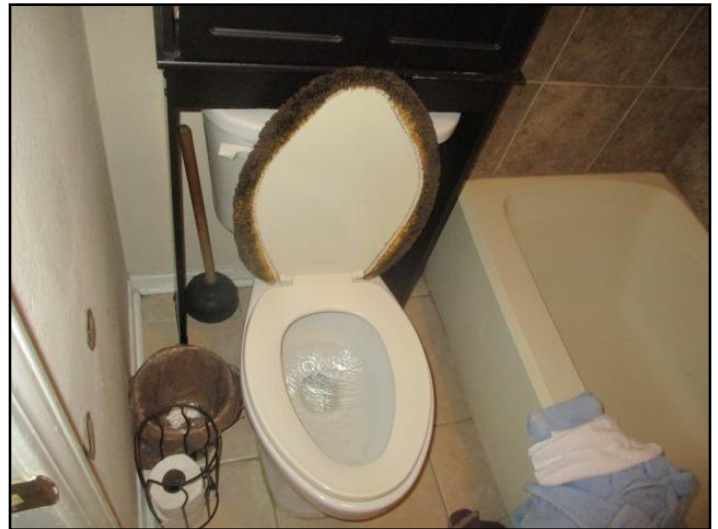
Toilets appears to be loose at the base which may allow sewer gases to enter the home. Recommend further evaluation with repairs as needed by a licensed plumber.

Loose toilet

33. Loose at the base

34. Loose at the base

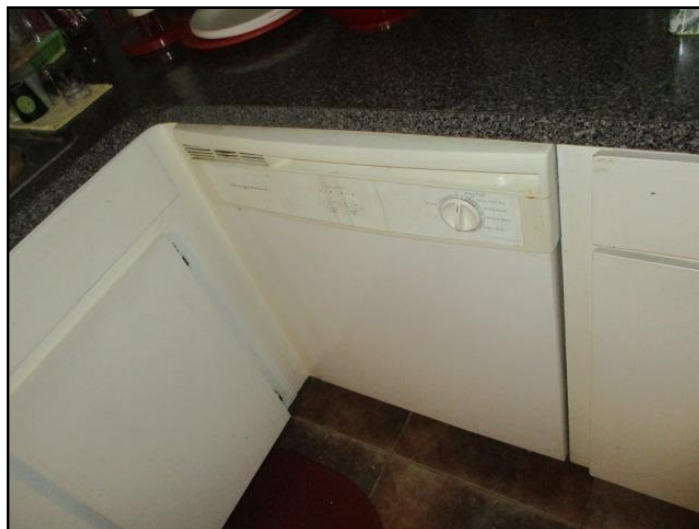
25. Condition: • Inoperative

35. Inoperative
