Your Inspection Report

1234 Somewhere
Pittsburgh, PA 15206

INSPECTION DATE:
Thursday, April 25, 2013

RE: Report No. 1062, v.4
1234 Somewhere
Pittsburgh, PA
15206

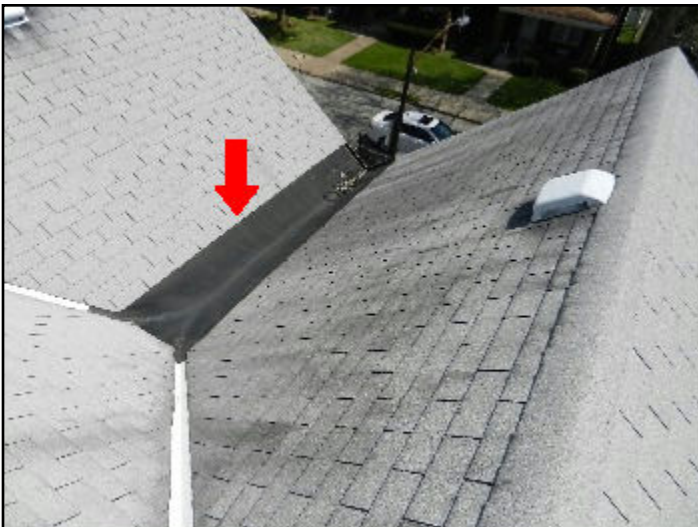
1. Valley should be monitored.

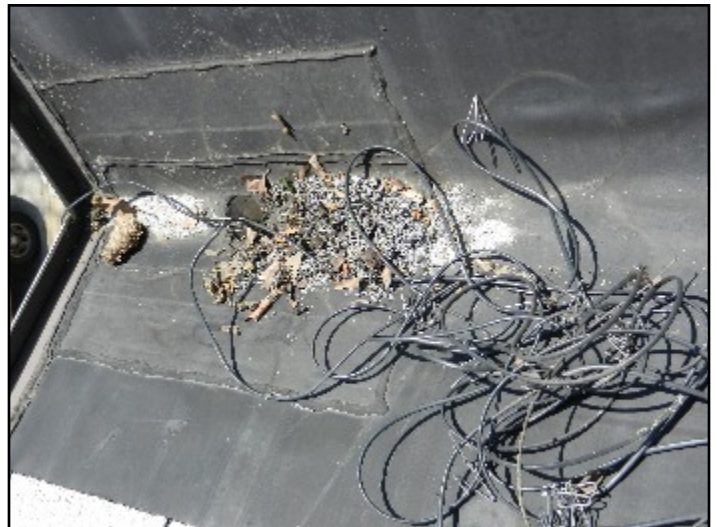
2. Valley detail--keep clear of debris

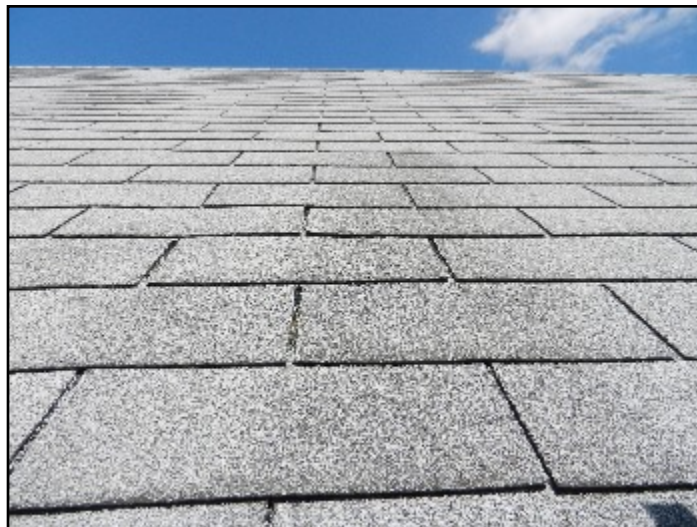
3. Some mineral loss on shingles.

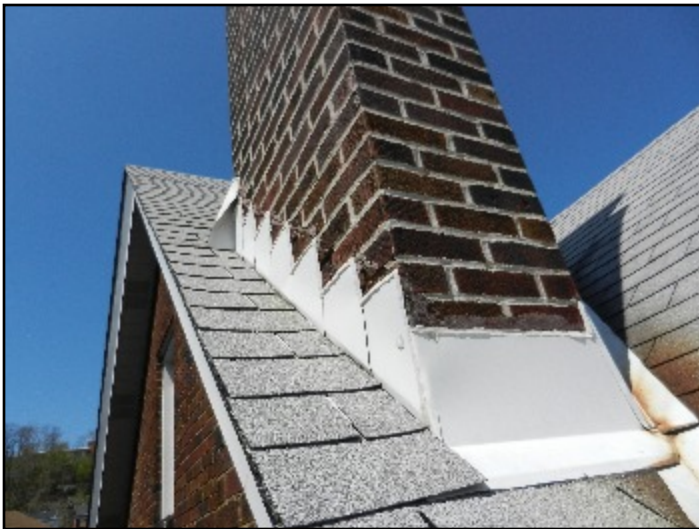
6. Not let into mortar joints

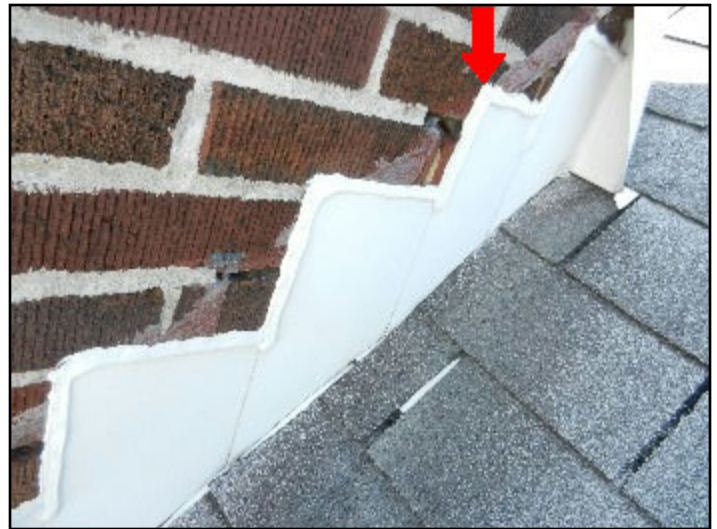
7. Not let into mortar joints

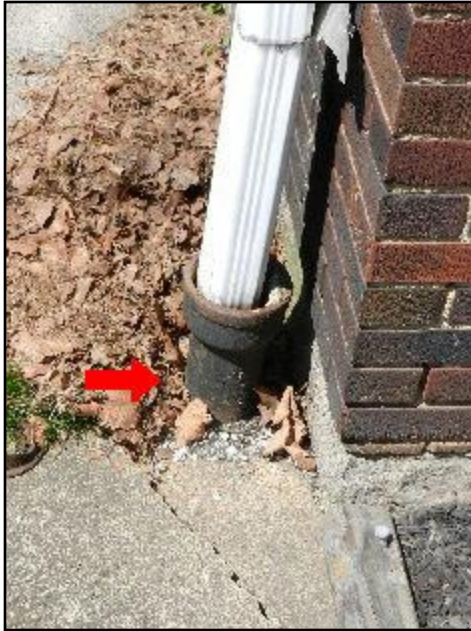
Moisture noted in basement in areas near where downspouts discharge into underground pipes. Damaged storm water pipes could contribute to moisture in basement. Recommend using camera to scope condition of pipes and/or experimenting with diverting the downspouts away from the foundation to see if moisture conditions in basement improve.

9. Downspouts discharging below grade

Task: Repair by qualified contractor

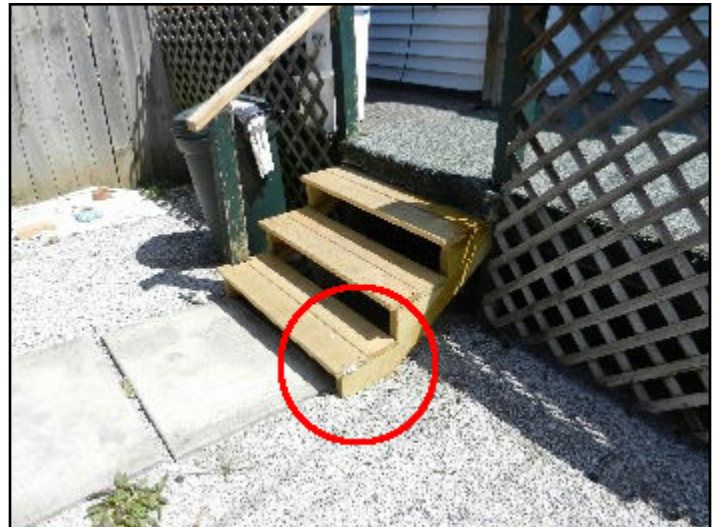
The rear deck is in need of renovation. The decking (covered with carpet and not visible) was loose/soft in places. The recently installed steps to the yard are not properly installed and are sinking. Support posts are in contact with the ground and susceptible to rot or insect damage. The ledger connecting the deck to the house is not bolted to the house framing. The railing is too low to prevent falls. (The deck stands at approximately 24-28 inches off the ground.)

16. Steps lack footer

Task: Repair by qualified contractor for safety.

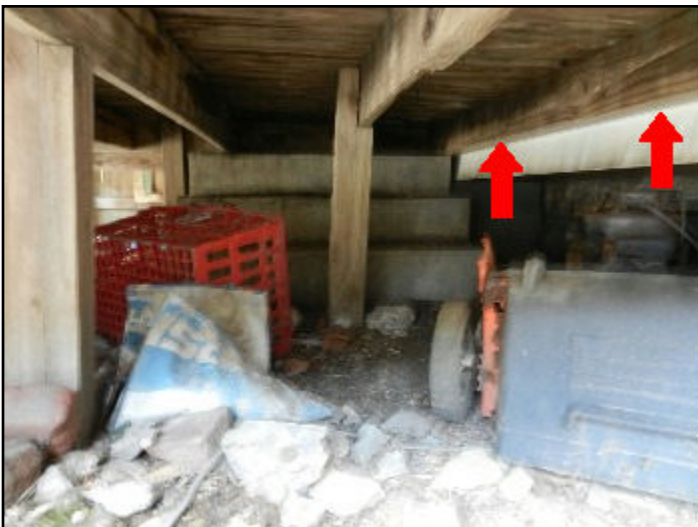
17. Ledger board not bolted to house frame

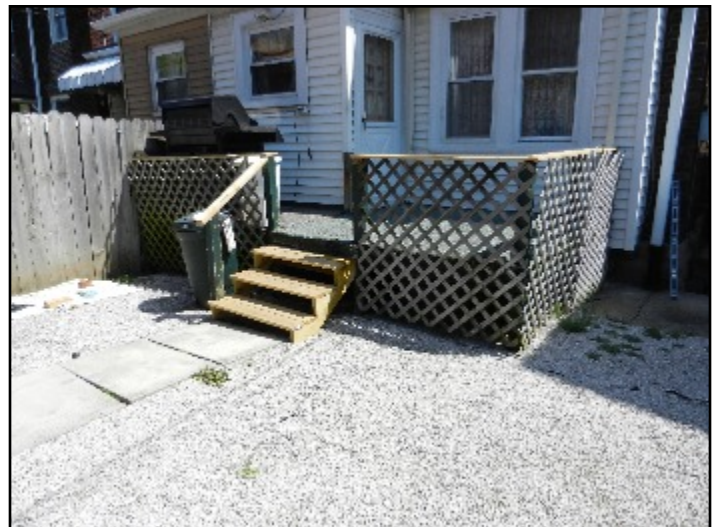
18. Disrepair, visual access only to under deck

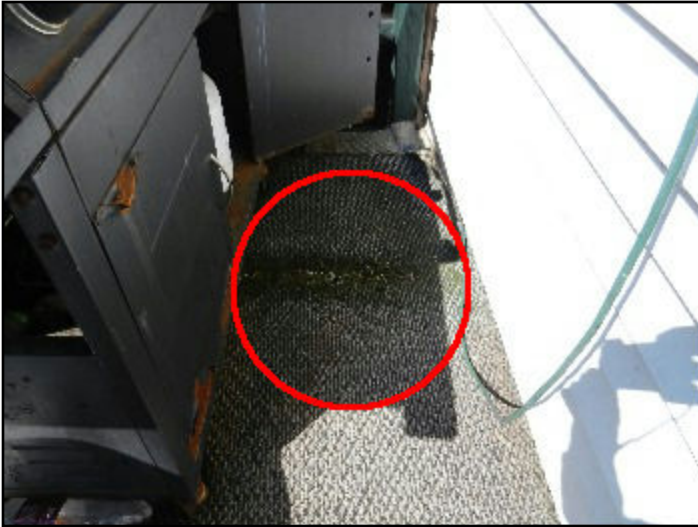
19. Sunken decking

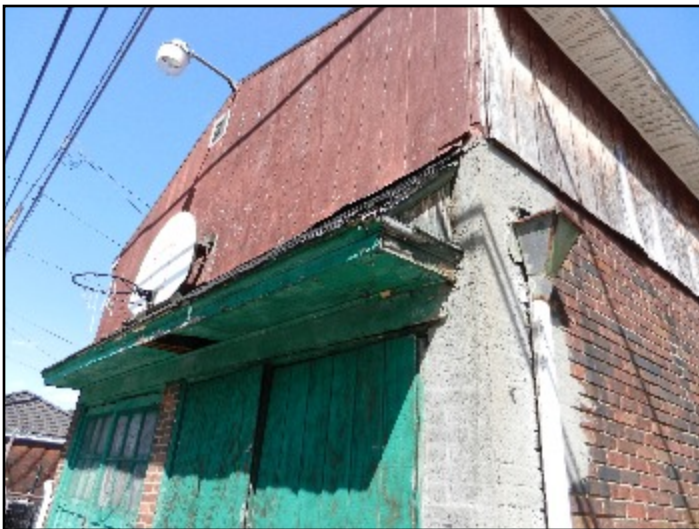
The garage is need of renovation. A new roof (10+ years ago?) and framing has been constructed on top of the old roof which was failing/ collapsing. No access was available to inspect the attic space. One corner at the alley has sustained extensive water and termite damage and is being held up by temporary wooden support post. A crack/separation of mortar joints was noted on the shared interior wall of the garage. The other side of the wall was not accessible to inspect the crack further. Mortar deterioration and erosion was noted on the exterior brick

30. Disrepair

Task: Evaluation and repair by qualified contractor

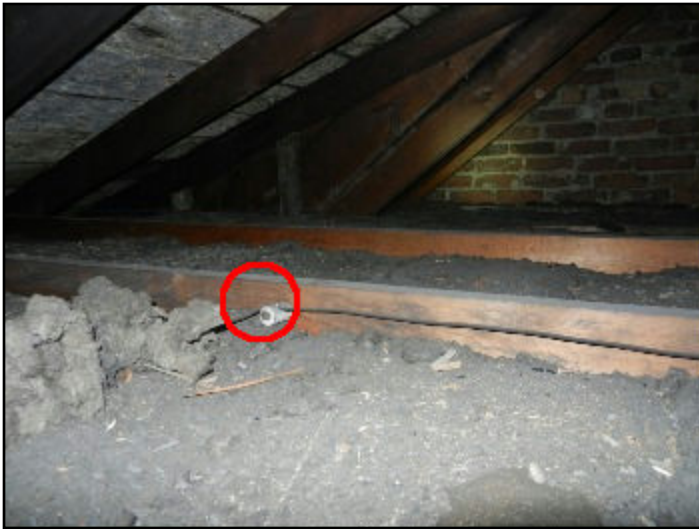
There is knob and tube wiring in the attic. This type of wiring is antiquated and should be replaced or evaluated by a qualified electrician for safety.

33. Outdated

Task: Evaluation and repair/replace as necessary for safety

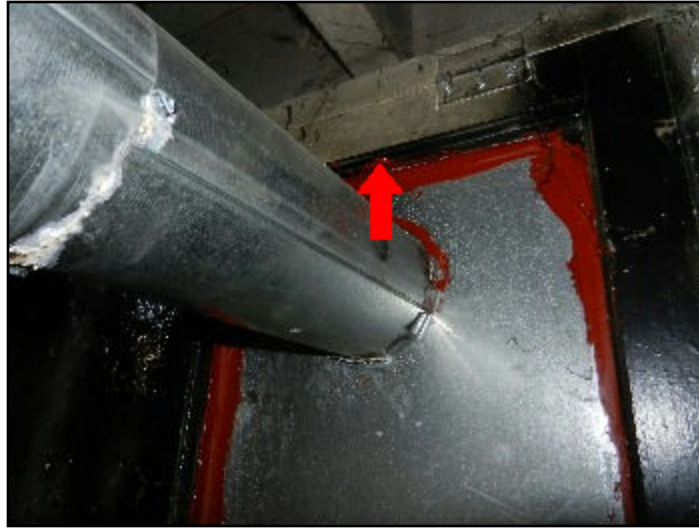
43. Combustible clearance

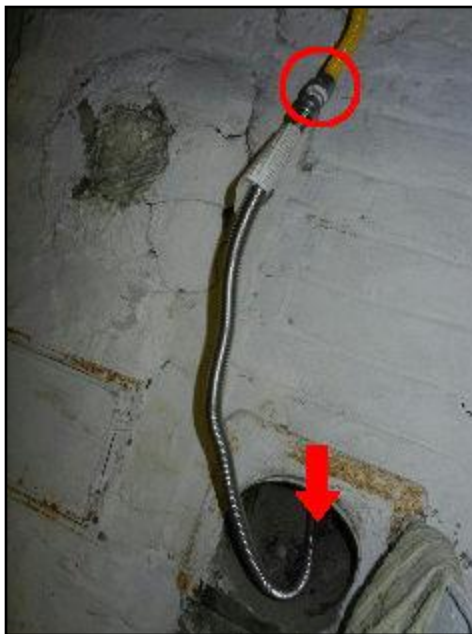
Charring noted on outside of fireplace and on inside firebox. The chimney had ash build-up and should be swept. The hearth extension is short or near the minimum depth. Owner could not get gas burner to light. The gas is supplied through flex line that should not be run through walls or floors. The gas line should be in permanent steel or CSST piping. Have a qualified fireplace technician evaluate and repair fireplace gas insert for safety before use. Damper was closed when inspected.

47. Inspect chimney, and sweep, if needed before...

Task: Evaluation and repair/replace as necessary by a qualified contractor

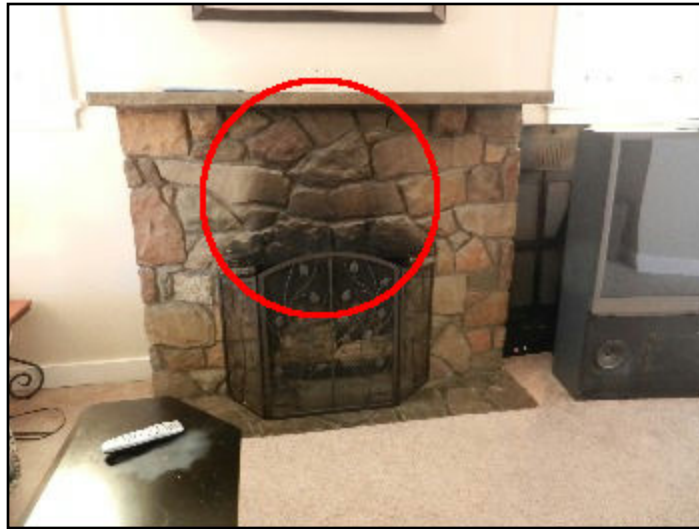
49. Soot/blackening on face for fireplace

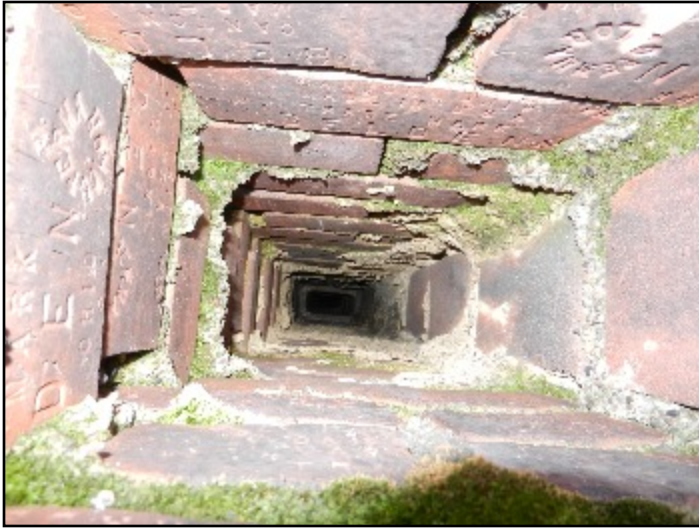
The rear chimney that serves the water heater is unlined and should have appropriate metal flue liner installed for safety and to prevent material deterioration of the masonry chimneys.

52. No chimney liner

Task: Repair by qualified contractor

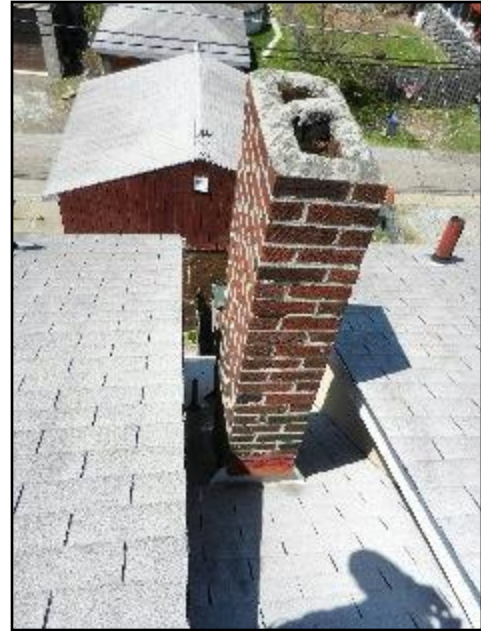
53. No chimney liner

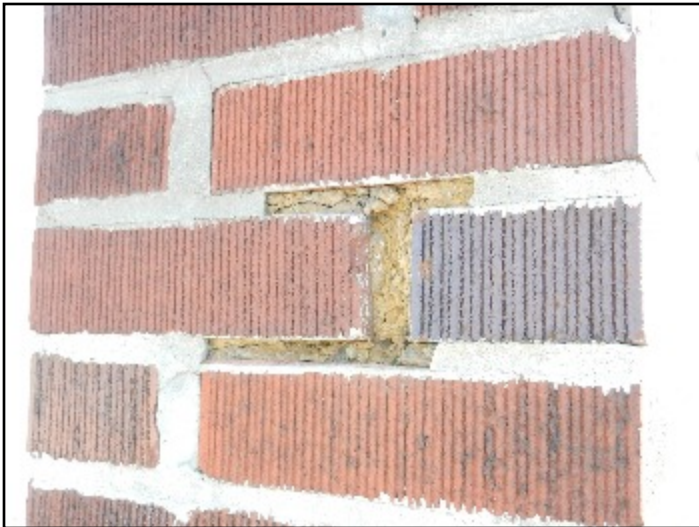
54. Thin pointing of bricks on chimney.

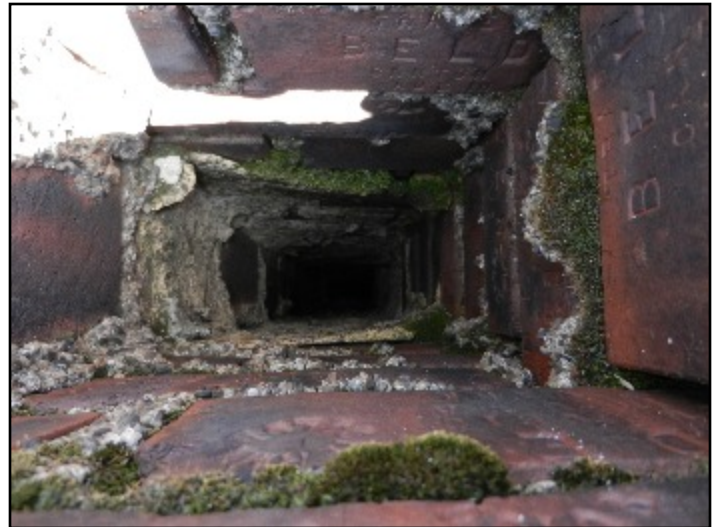
55. No chimney liner

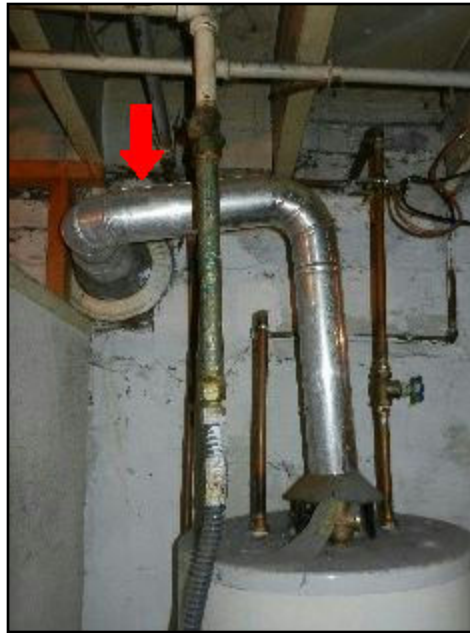
60. Vent connector slopes down.

Task: Repair by qualified plumber

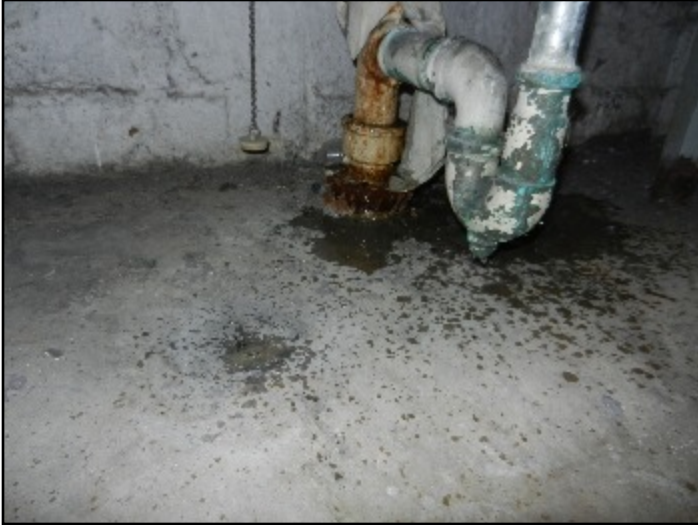
62.

38. Condition: • [Clogged](#)

The cast iron drain pipe and galvanized vent pipe under the laundry sink were clogged. The vent pipe was gone, disintegrated where it connects to cast iron drain line where water was leaking out. Also, waste water appeared to be backing up into basement shower drain. Have a qualified plumber evaluate and repair as necessary. Have the plumber further evaluate the condition of the drain lines in general for deterioration that was not accessible to inspect. Consider scoping (imaging) drain lines below house and leading to sewer for potential damage to main drain lines.

Task: Repair by qualified plumber

Time: Immediate

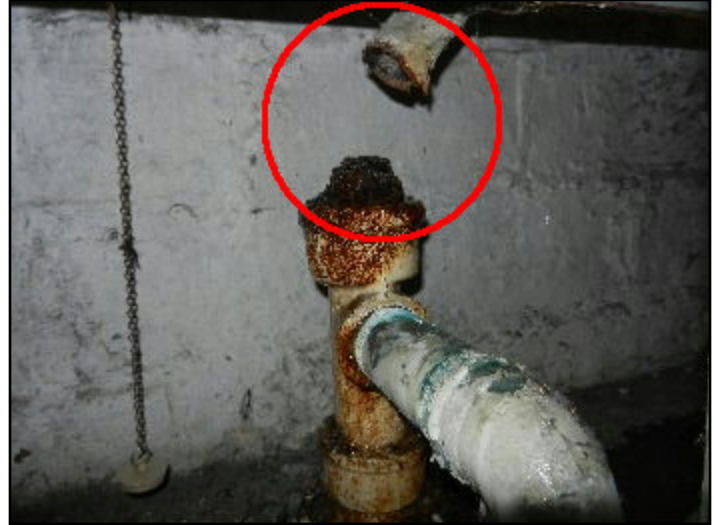
63. Vent pipe connection disintegrated

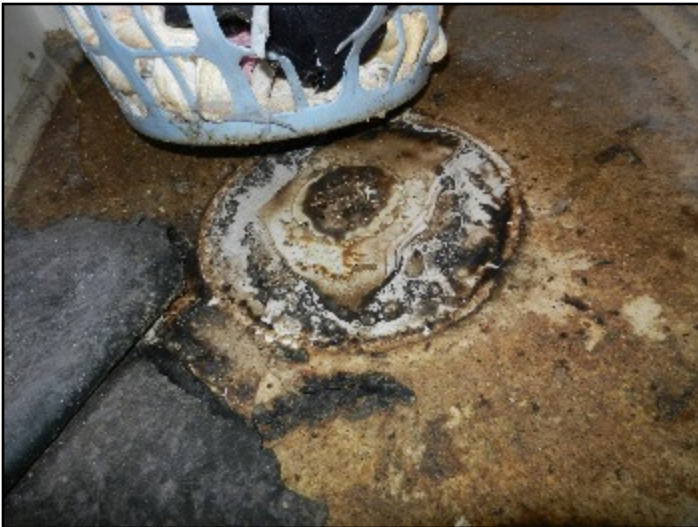
64. Water backing up into basement shower drain.

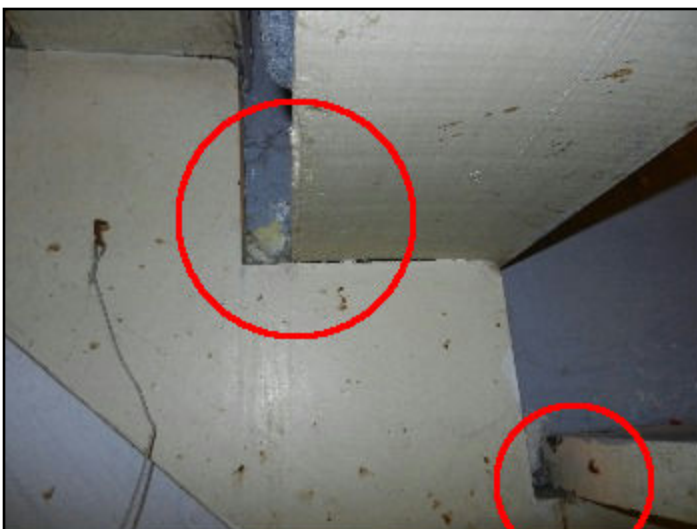
Some of the treads were loose. The treads were cut to short for the stringers and should be replaced with wider treads for safety.

73. Width too small seen from below.

Task: Repair by qualified contractor for safety

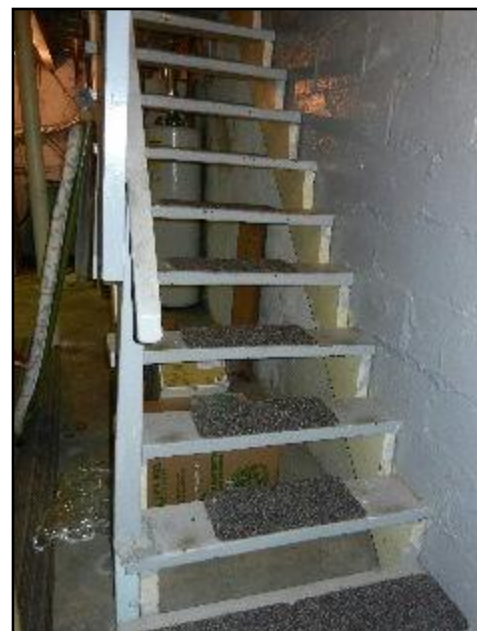
74. Width too small

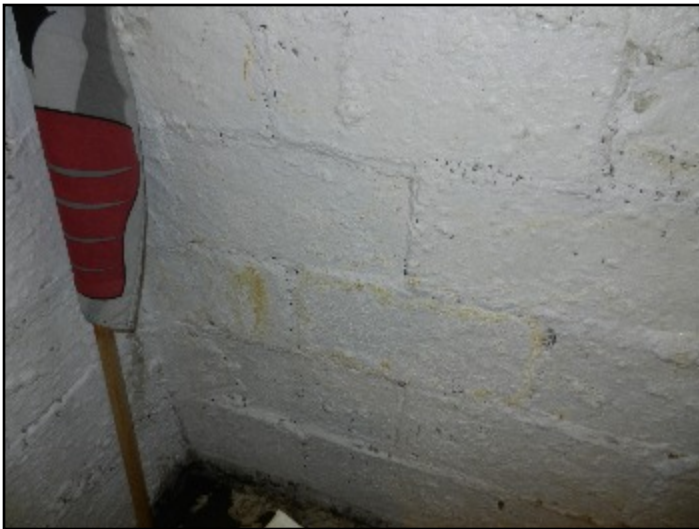
Dampness, efflorescence, staining and noted in basement floors and walls primarily on the front left side. (See exterior section for information on lot slope and downspout placement which can be major factors in basement moisture.)

Moisture and high humidity levels can promote wood decay/rot, insect damage, mold growth, rust. Monitor the moisture conditions in the basement and consult with qualified moisture intrusion specialists to evaluate and improve where possible.

75. Dampness on floor or walls

Task: Monitor, improve grading outside.

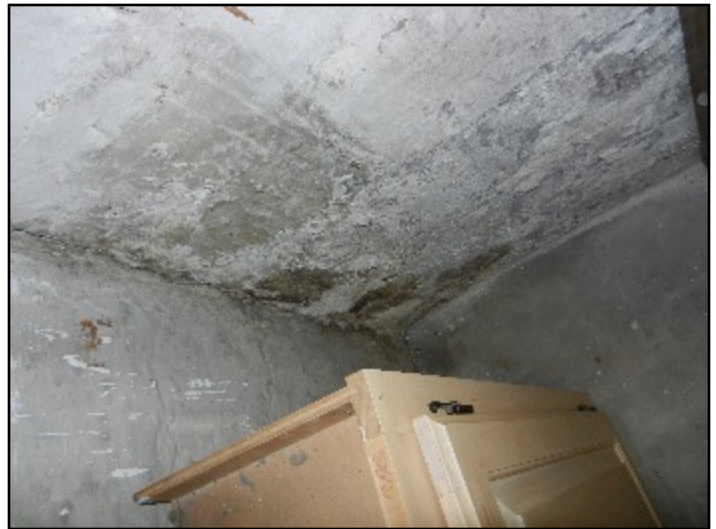
76. Dampness on floor or walls

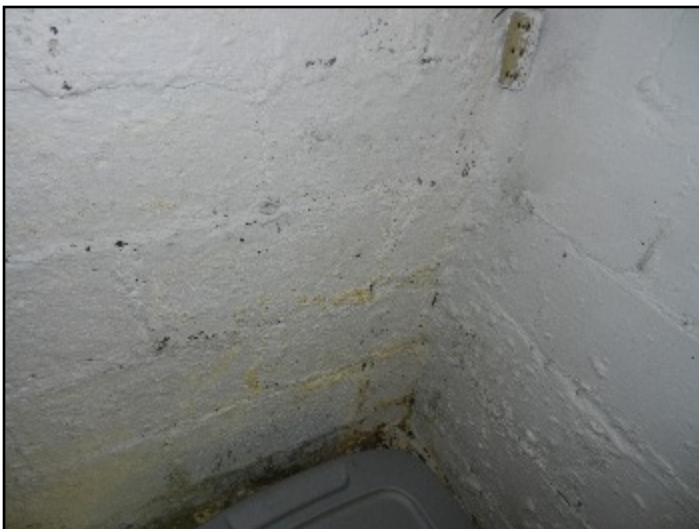
77. Dampness on floor or walls
