Your Inspection Report

123 Any Street
Any Town, TN 54321

INSPECTION DATE:
Tuesday, April 19, 2011

RE: Report No. 1343, v.2
123 Any Street
Any Town, TN
54321

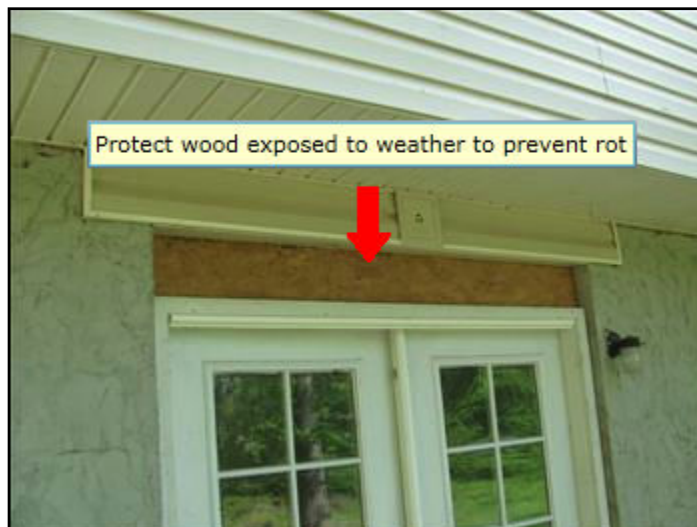
11.

Condition: • [Loose or missing pieces](#)

Implication(s): Cosmetic defects | Chance of water damage to contents, finishes and/or structure

Location: Rear Basement Exterior

Task: Improve

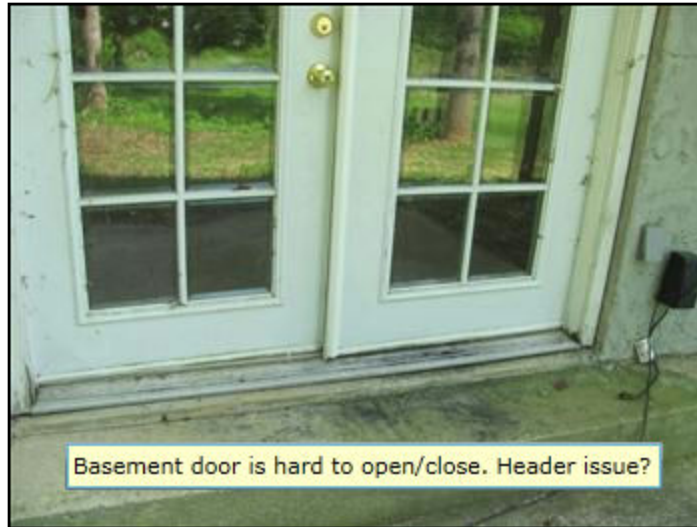
12.

Condition: • Too tight in jamb.

Task: Repair

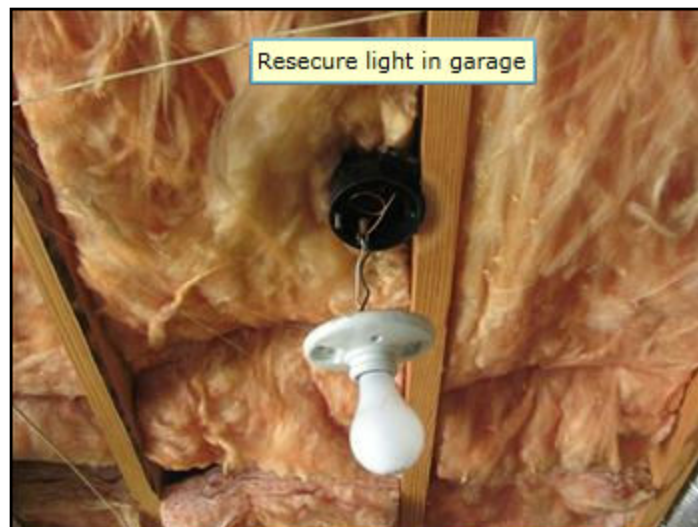
24.

Condition: • [Loose](#)

Implication(s): Electric shock | Fire hazard

Location: Garage

Task: Improve

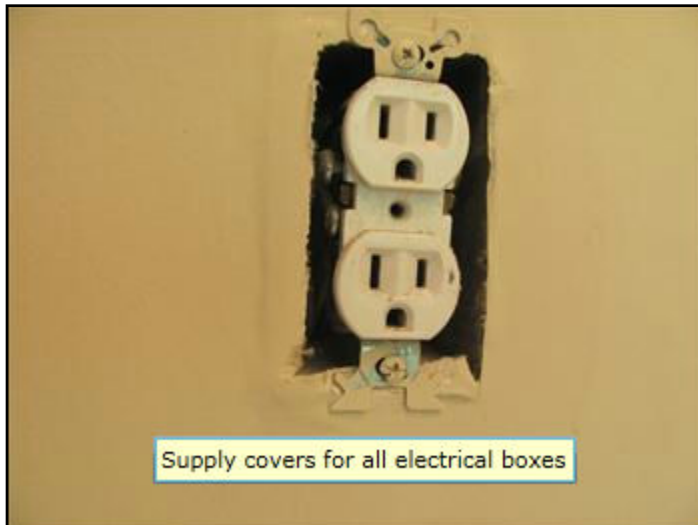
26.

Condition: • [Missing](#)

Location: Various

Task: Provide

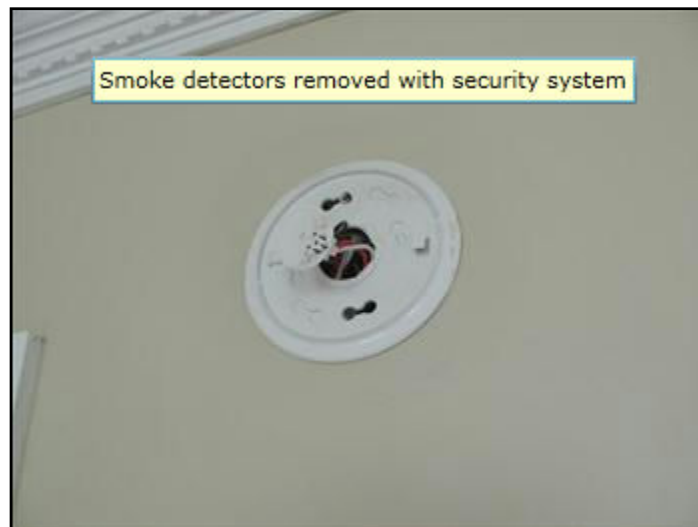
28.

Condition: • [None](#)

Implication(s): Fire hazard

Location: Throughout

Task: Provide

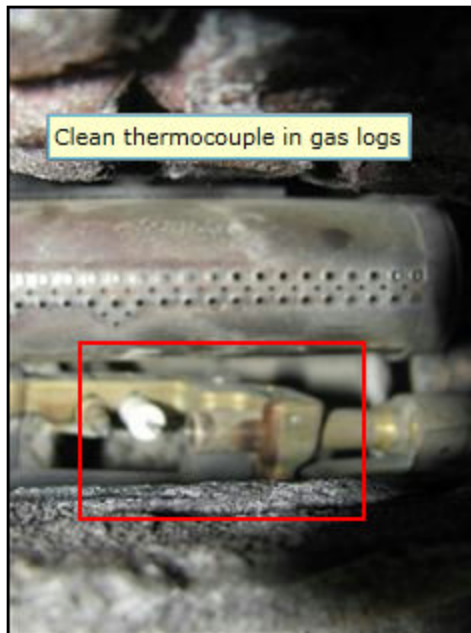
29.

Condition: • Clean logs well before trying to light.

Location: First Floor Living Room

Task: Clean

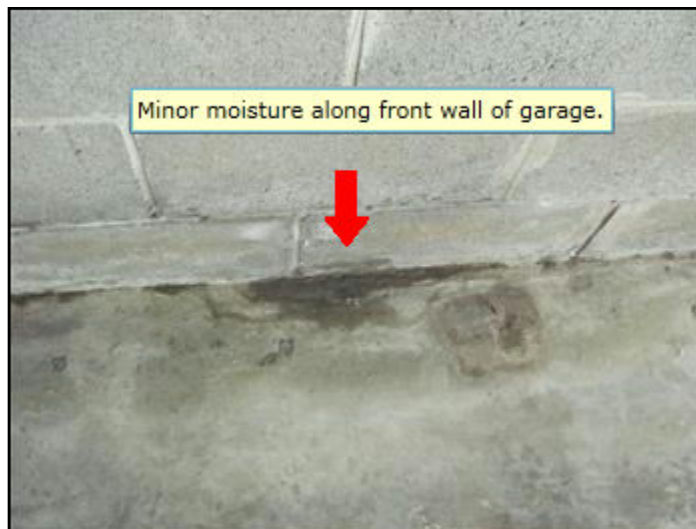
35.

Condition: • [Water on floor](#)

Implication(s): Cosmetic defects | Slip hazard

Location: Basement Garage

Task: Further evaluation Monitor

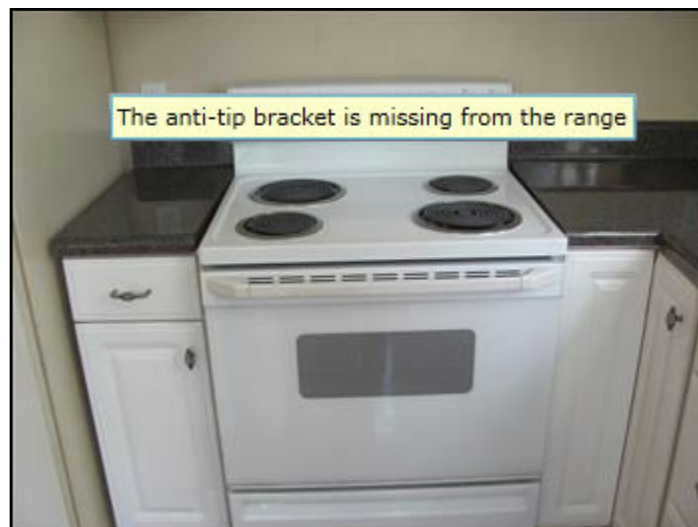
39.

Condition: • Anti-tip device missing

Implication(s): Physical injury

Task: Provide

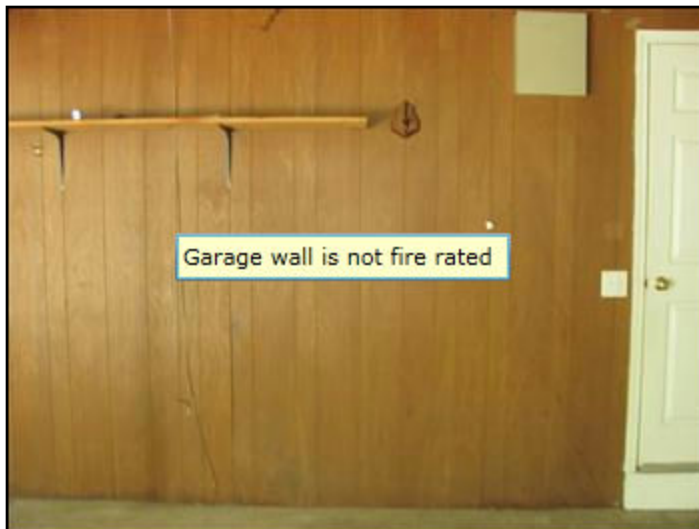
57.

15. Condition: • Not fireproof

Implication(s): Fire hazard

Location: Basement Garage

Time: Discretionary

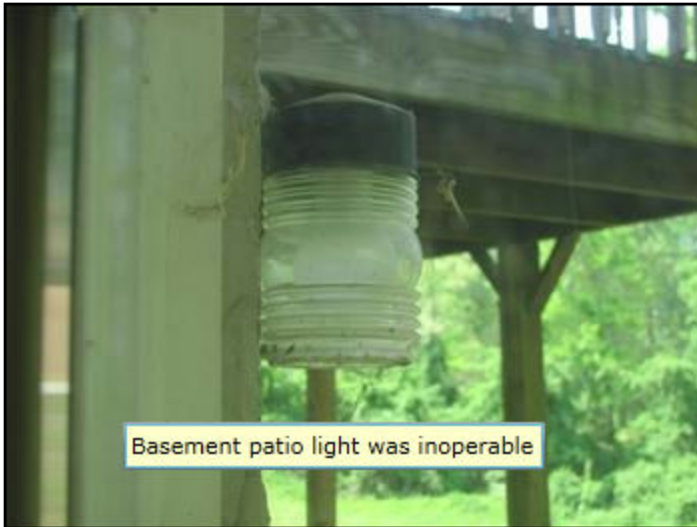
61.

18. Condition: • [Inoperative](#)

Implication(s): Inadequate lighting

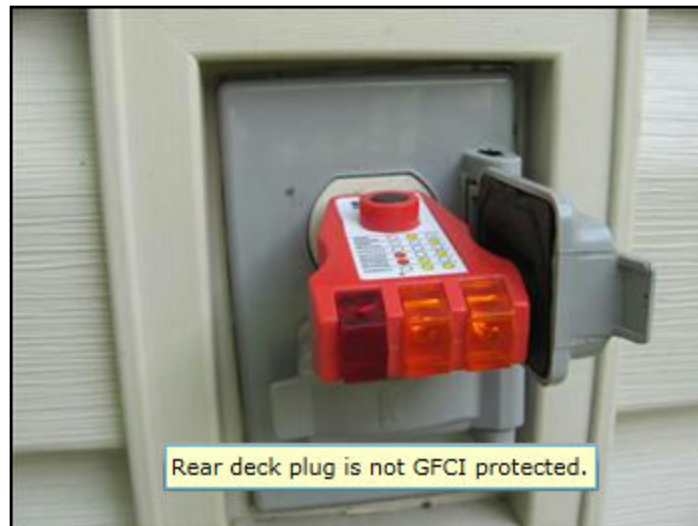
64.

20. Condition: • [No GFI \(Ground Fault Interrupter\)](#)

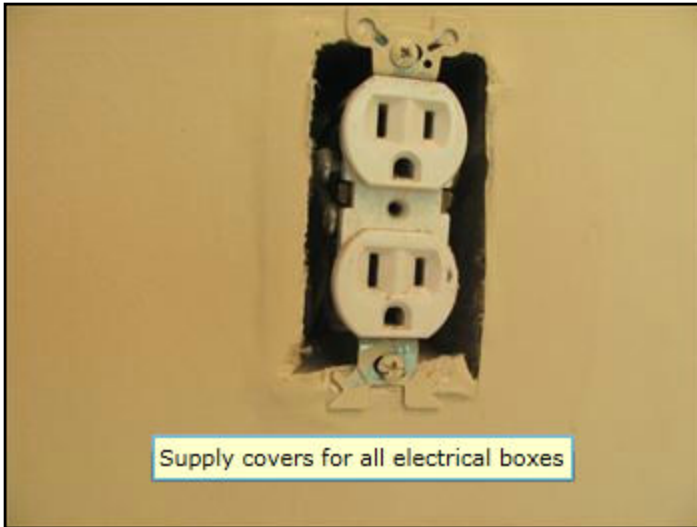
65.

21. Condition: • [Missing](#)

Location: Various

Task: Provide

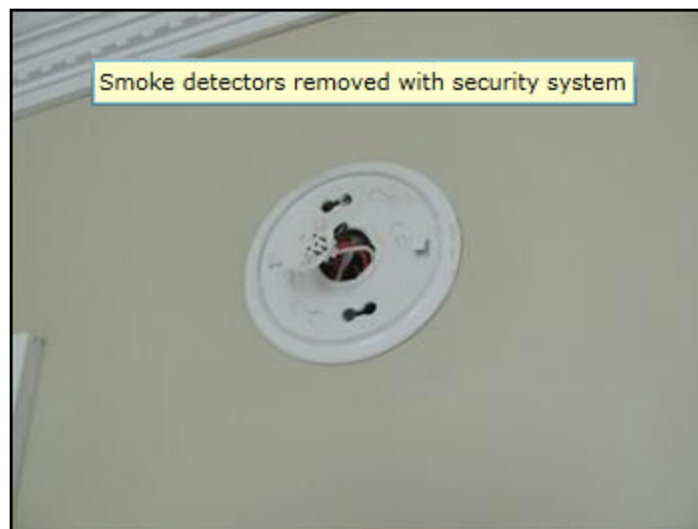
67.

22. Condition: • [None](#)

Implication(s): Fire hazard

Location: Throughout

Task: Provide

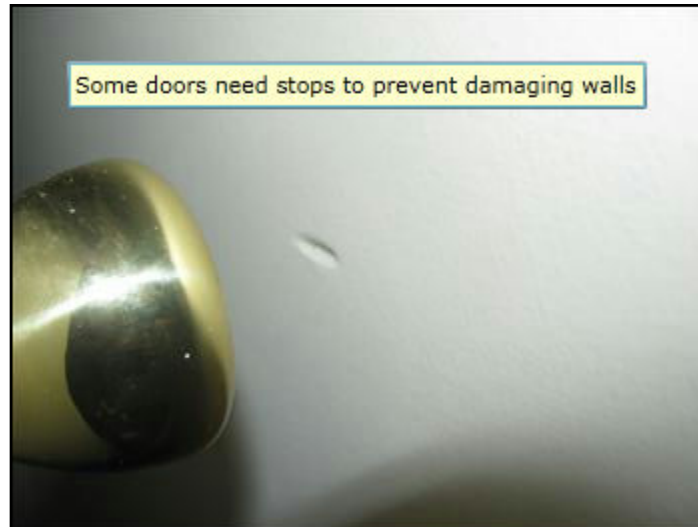
78.

29. Condition: • Door stops are missing.

Location: Various

Task: Provide

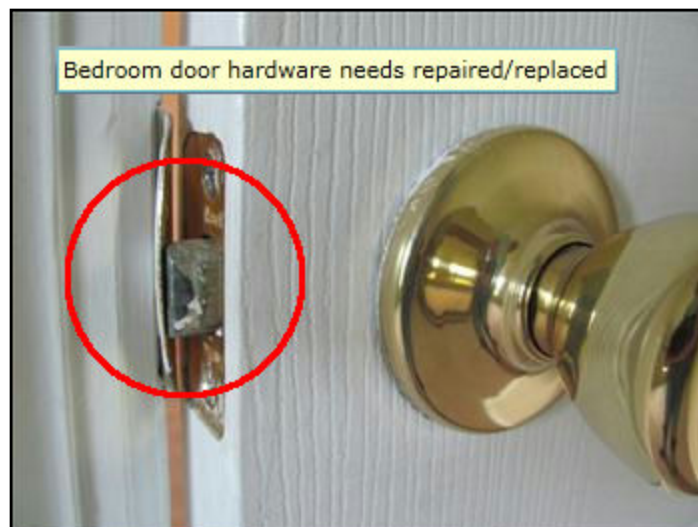
79.

30. Condition: • [Inoperable](#)

Location: Second Floor Bedroom

Task: Repair or replace

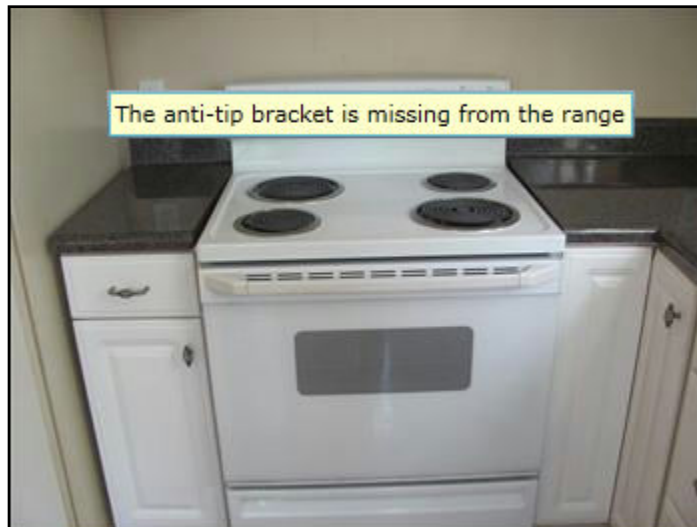
80.

31. Condition: • Anti-tip device missing

Implication(s): Physical injury

Task: Provide
