Your Inspection Report

Ontario
Sarnia, ON

INSPECTION DATE:
Monday, August 13, 2018

RE: Report No. 1920, v.4
Ontario
Sarnia, ON

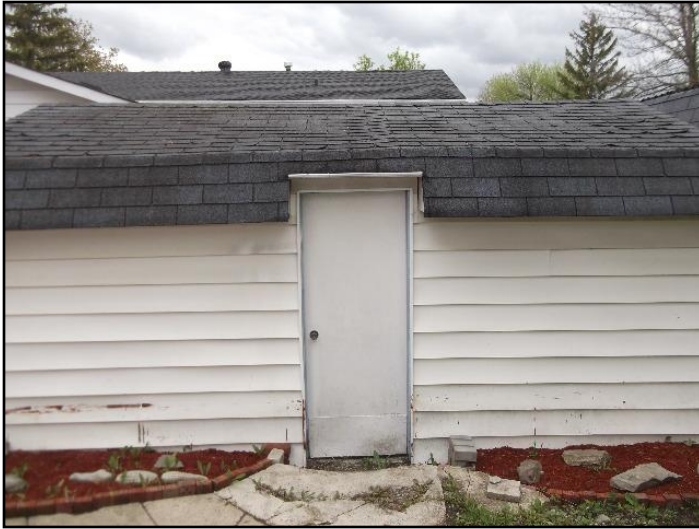
6. Asphalt shingles - west garage

- Replace the west garage roof.
- Clean and annually service the furnace by a qualified technician.
- Provide a PVC elbow on the furnace air intake.
- Regrade the east gravel driveway.

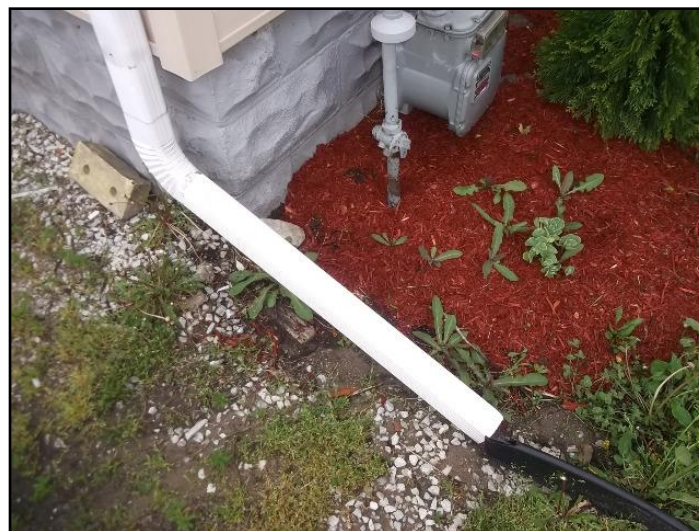
11. Above grade

- Provide bonding or grounding for the gas piping if necessary.
- Repair or replace the tripping hazards at the various walkways.
- Extend the downspouts away from the foundation.
- Secure the loose upper floor guard rail.
- Provide a hand rail to the basement stairs.
- Repair the upper windows which are painted shut.
- Repair the loose/damaged fascia, wood trim and soffit at the west garage.
- It is a possibility, not a certainty that these components will need repairs or replacement.

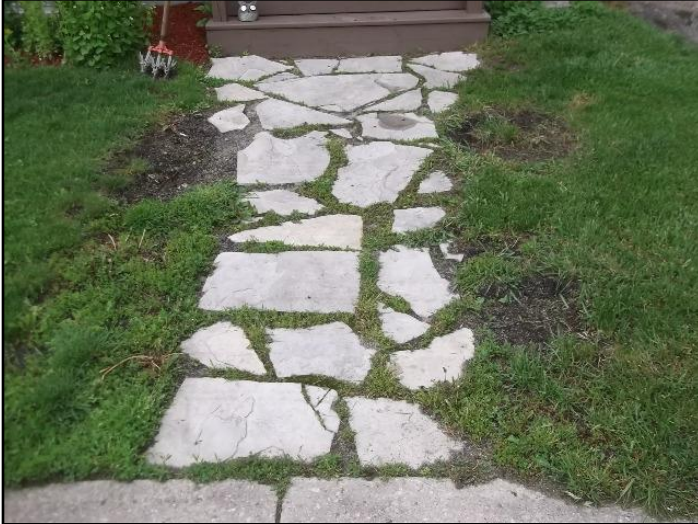
20. Walkways

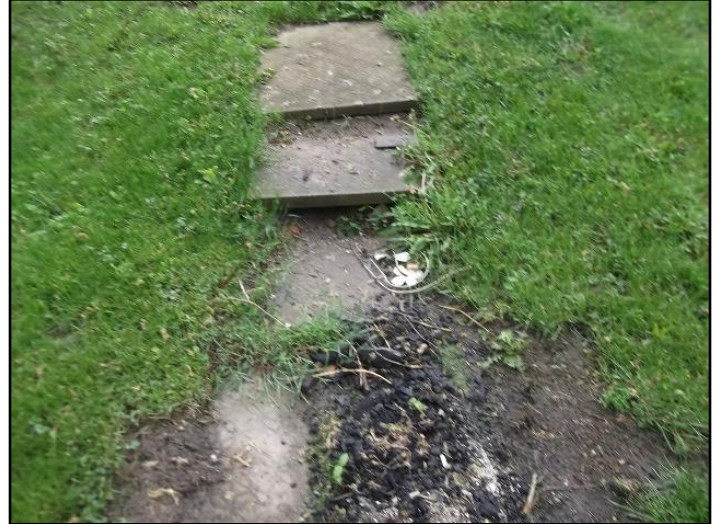
21. Walkways

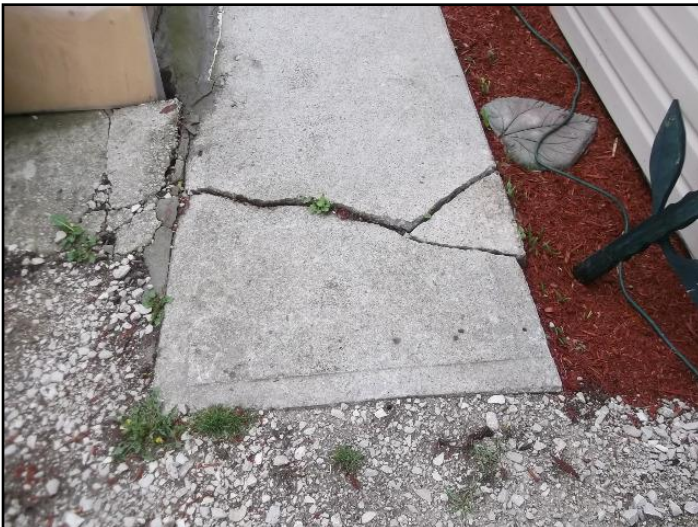
cracked providing tripping hazards. The rear yard patio stones are uneven providing a fall or tripping hazard.

22. Northeast Walkway

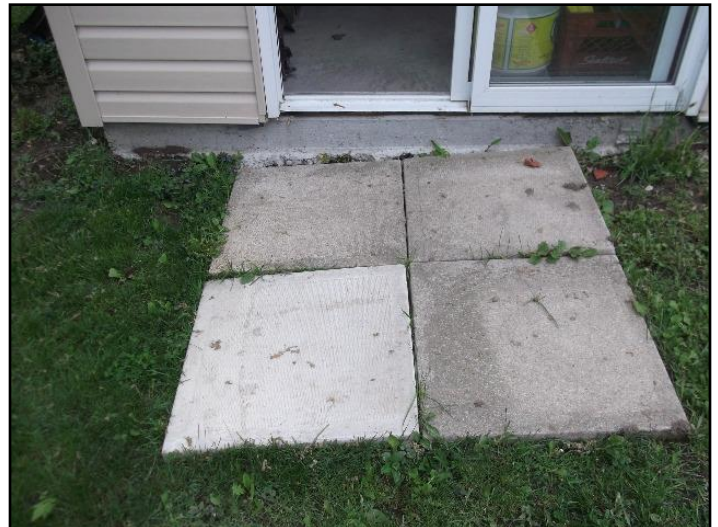
23. Walkways

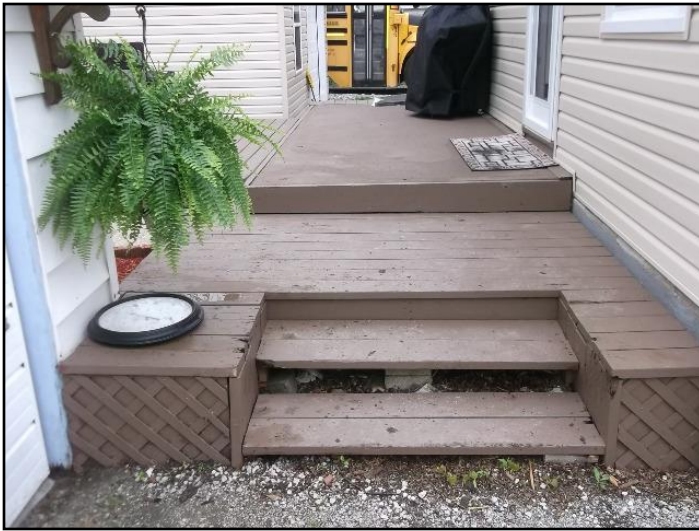
24. Deck

- Remove the satellite dish from the chimney.
- Seal the opening at the west foundation wall.
- Repair/replace the moisture-damaged wood at the rear deck.

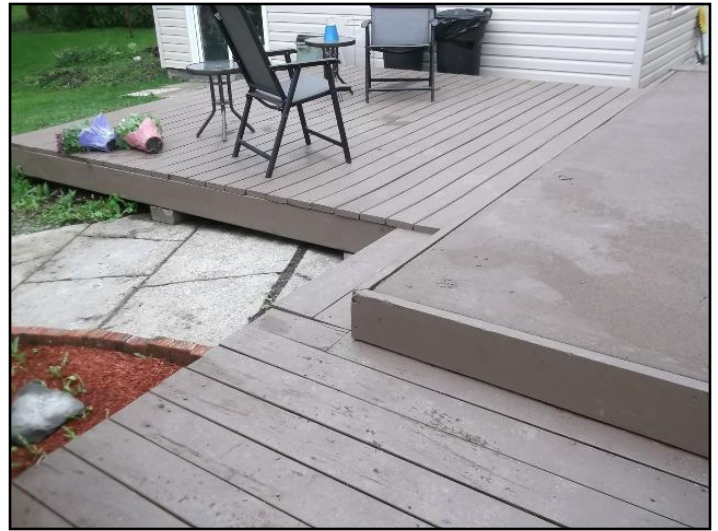
25. Deck

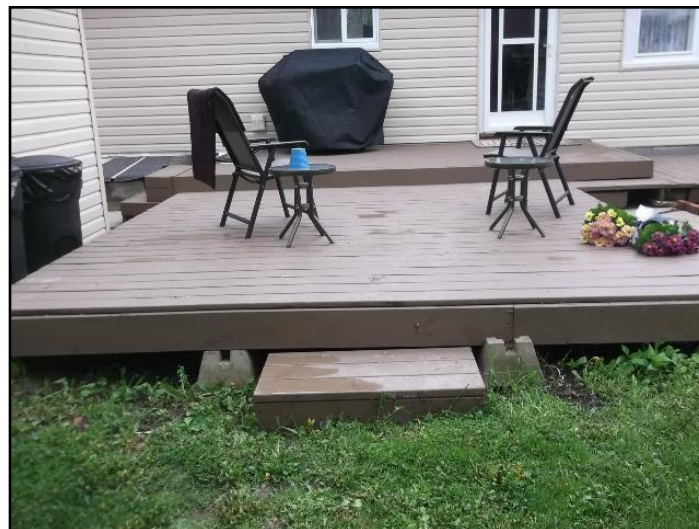
26. Deck

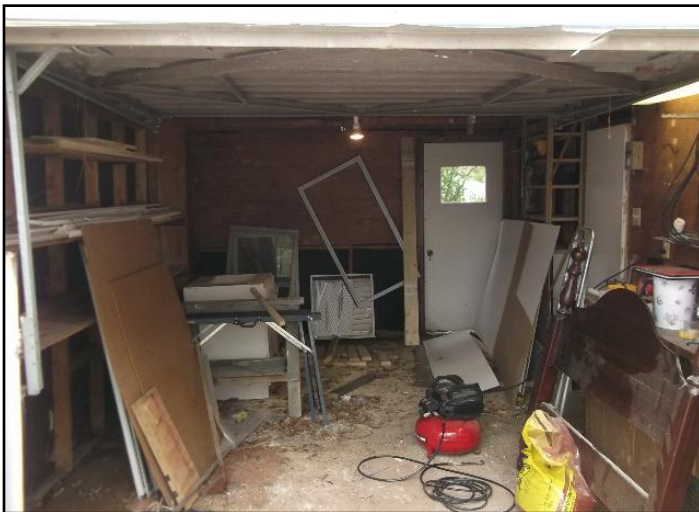
28. Garage

Note: West garage

Note: Repairs are required on the west garage exterior.

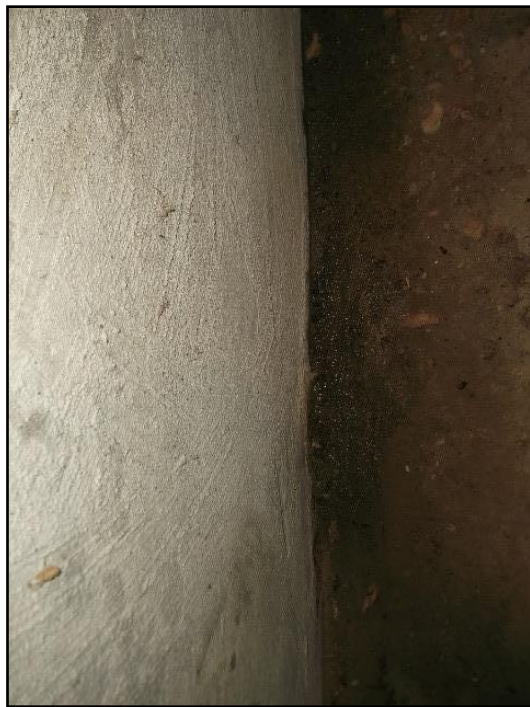
39. Basement Moisture comment:

Note: Moisture was present in the south east basement possibly due to poor grading. Cracks and staining in the parging of the east and south bench footing was also present possibly due to moisture intrusion. We recommend a basement contractor specializing in waterproofing or interior drainage systems is consulted in case improvements and repairs are required to help prevent future moisture intrusion and interior damage. Examples of such contractors are Advanced Basement Systems, Basement Boss, Melo Concrete, Never Leak.

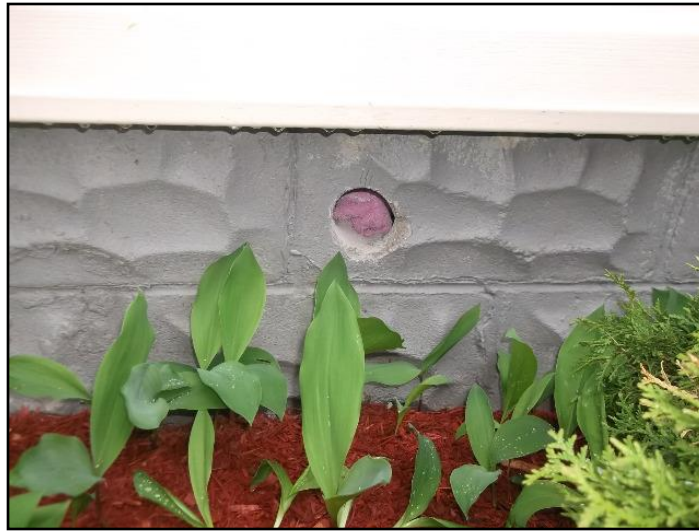
50. Unsealed openings

12. Condition: • Unsealed openings

Implication(s): Chance of entry by vermin, interior damage.

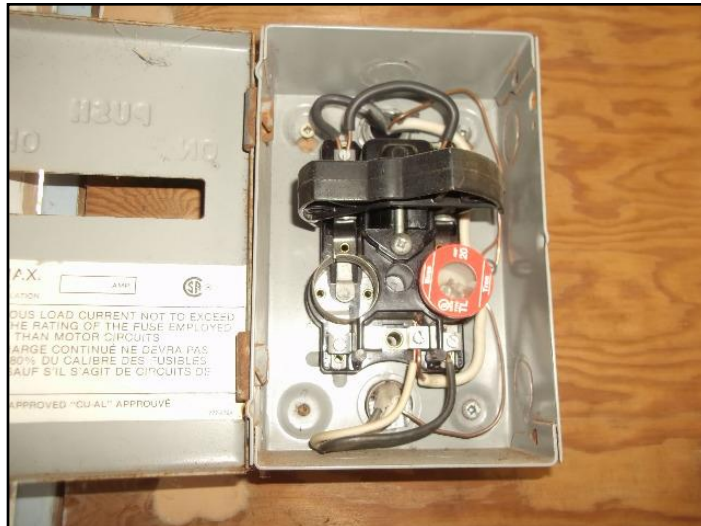
53. Fuses - garage

West garage.

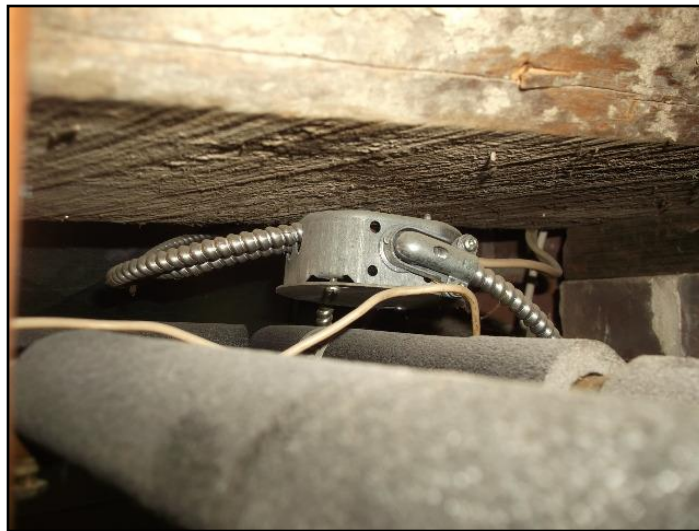
62. Missing, loose

26. Condition: • [Missing, loose](#)

Implication(s): Electric shock | Fire hazard

Task: Repair

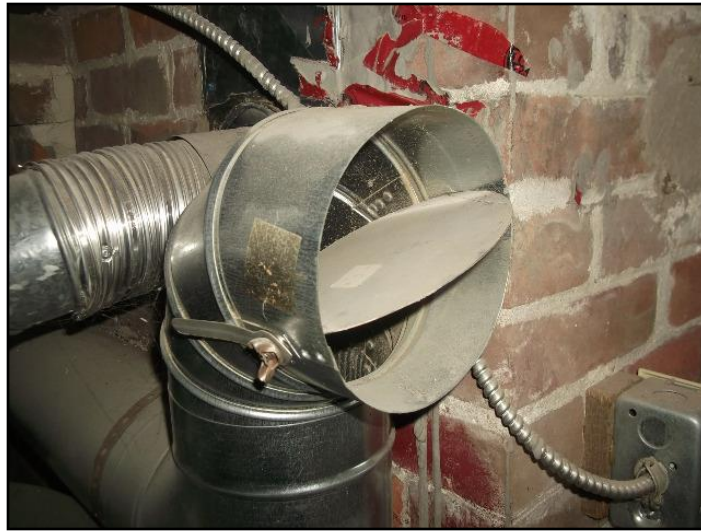
74. Poor location

37. Condition: • [Poor location](#)

Task: Correct

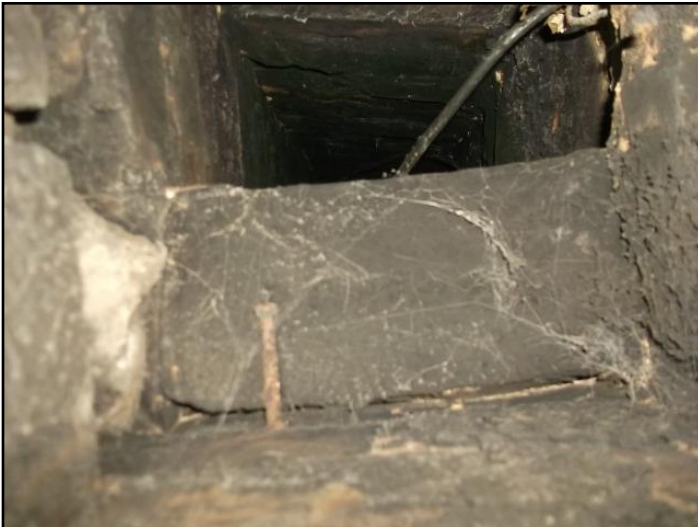
75. Open chimney flue

38. Condition: • The flue which is open at the top of the chimney is also open in the basement and should be sealed to prevent entry by vermin or water.

Task: Improve

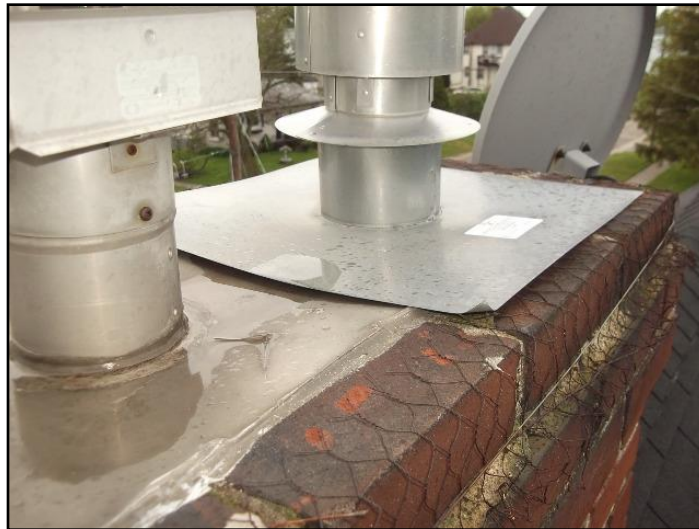
77.

40. Condition: • The top of the chimney was not sealed which may allow vermin or moisture entering the chimney and causing interior damage. We recommend either a qualified and licensed mason or other related specialist complete any necessary repairs.

Implication(s): Chance of interior damage.

Task: Correct

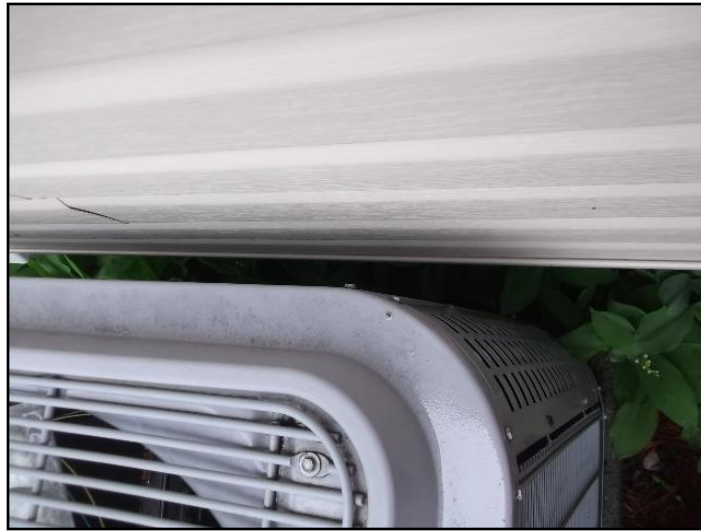
79.

41. Condition: • The current location of the condenser fan is considered too close to the exterior wall and should be located farther for proper airflow and cleaning of the fins.

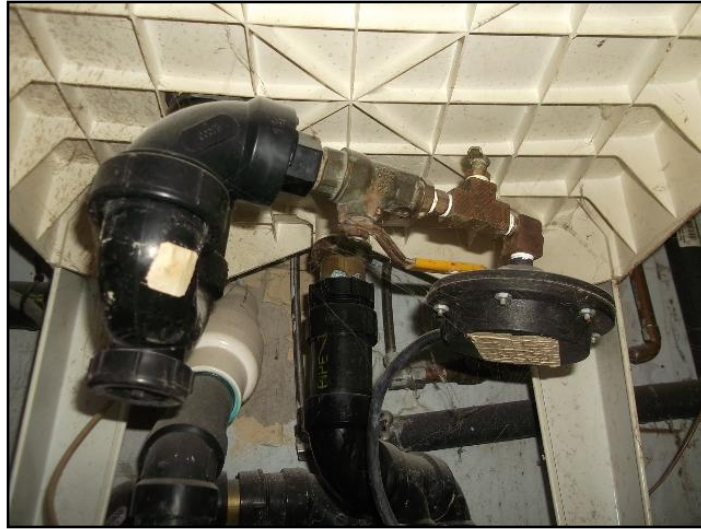
87. Laundry tub pump

The laundry tub did not appear to have the water supply activated. The pump could not be tested.

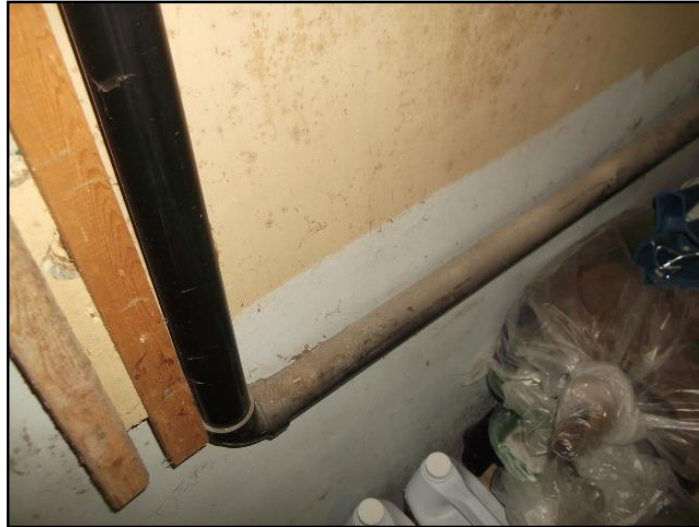
90. Poor support

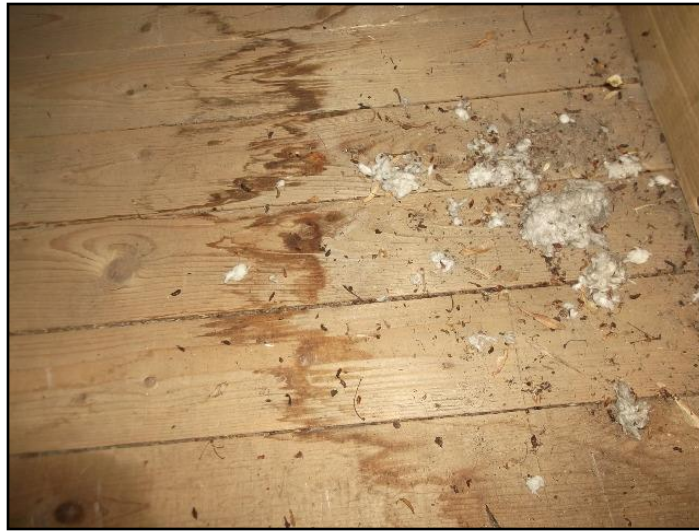
104.

Unknown feces was present in the south knee wall space. We recommend a specialist (Possibly Orkin or other professional pest control company) review the condition, remove the feces and seal all possible entry points for the vermin to enter the interior space.
