Your Inspection Report

123 Main Street
Tampa, FL 33619

INSPECTION DATE:
Wednesday, July 6, 2016

Report No. 2396, v.3

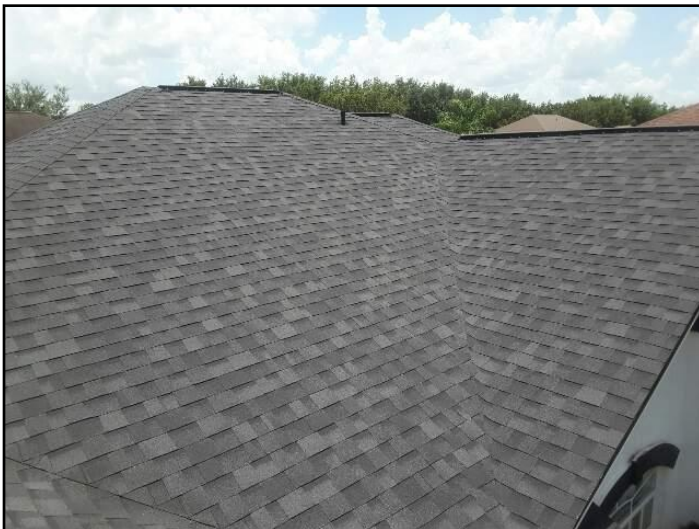
19. Asphalt shingles

Complete new re-roof 2015, permit #ROF03532

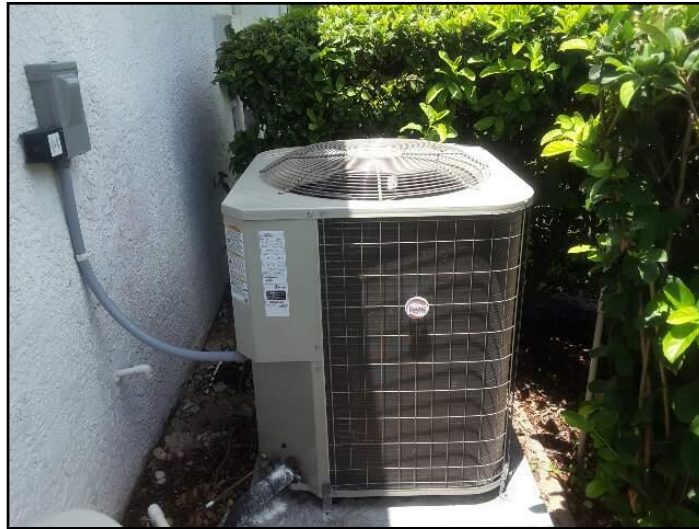
41. Payne

Heat pump was operating at a marginal level. Recommending a service call by a licensed HVAC professional. Outside air intake noted in attic space. Fresh air intake is bringing in extreme hot attic air. May be the cause of the performance issues.

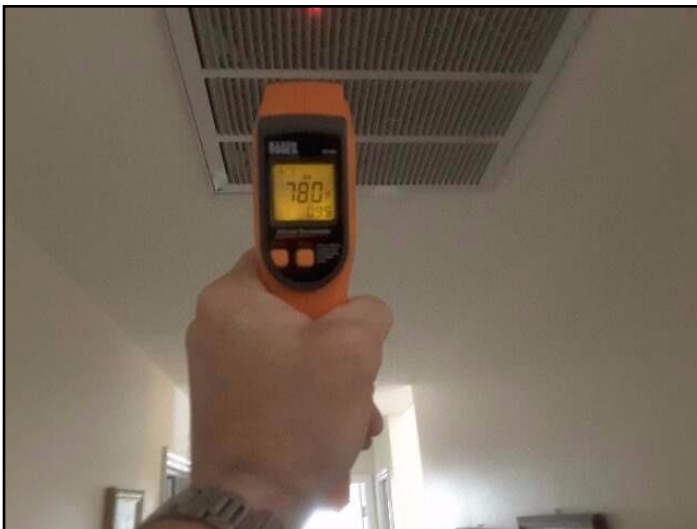
44. 78 Deg.

Return temperature: • 78

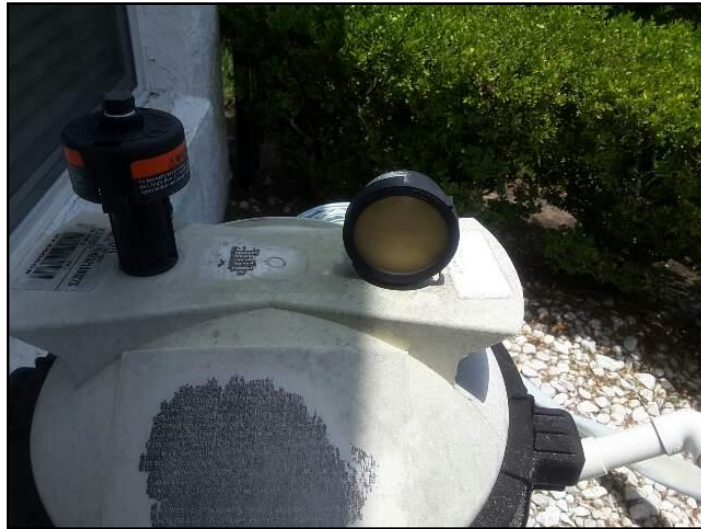
69. Appears serviceable

WATER FILTER \ Pressure gauge

24. Condition: • Appears serviceable

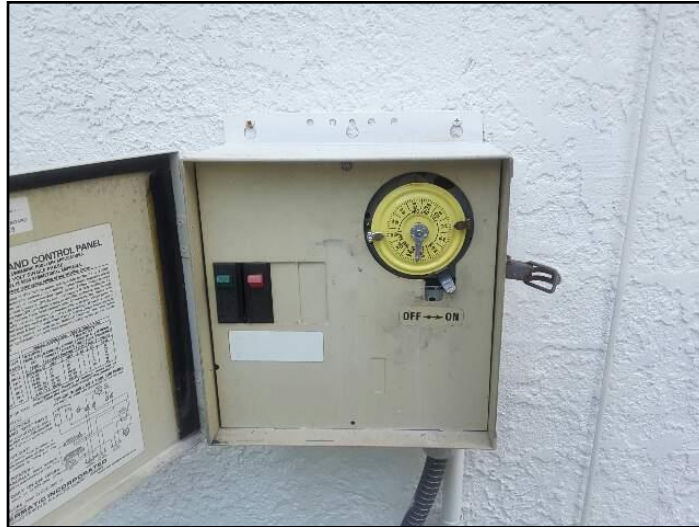
70. *Appears serviceable*

ELECTRICAL \ Circulation pump timer

29. Condition: • Appears serviceable
