INSPECTION REPORT

Sample Home Inspection Report

SAMPLE REPORT

Inspection Date: Wednesday, May 29, 2019

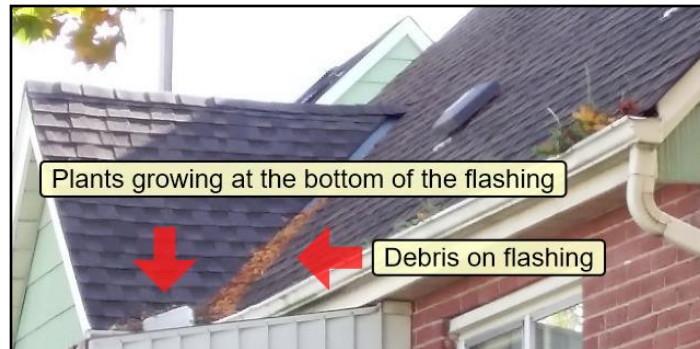
2. Condition: • Covered with debris/plants growing at the bottom of the flashing.

Debris & plants growing on flashing

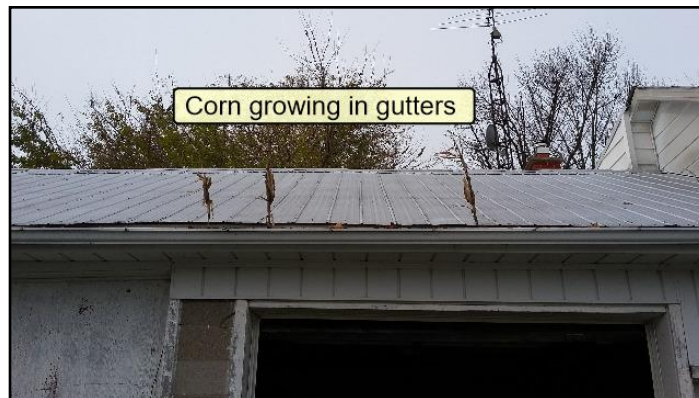
8. Condition: • Dirty/debris

Implications: Dirty clogged gutters and downspouts can cause water to over flow from the gutter causing water to drain adjacent to the foundation.

Dirt, debris & corn growing in gutters

Task: Clean

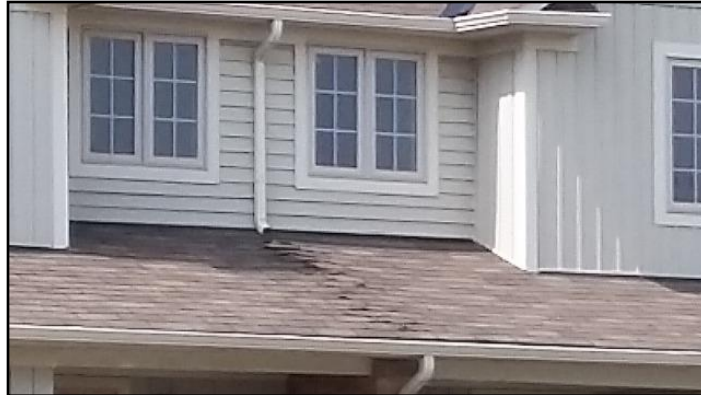
9. Condition: • [Discharge onto roofs](#)

Implications: Upper roof downspout discharging onto the lower roof has caused premature wear to the asphalt shingles. Chance of water damage to contents, finishes and/or structure. Continued damage to asphalt shingles.

Downspout discharging onto roof

installing a downspout (from the secondary roof to the main gutter below) helps prevent localized roof wear

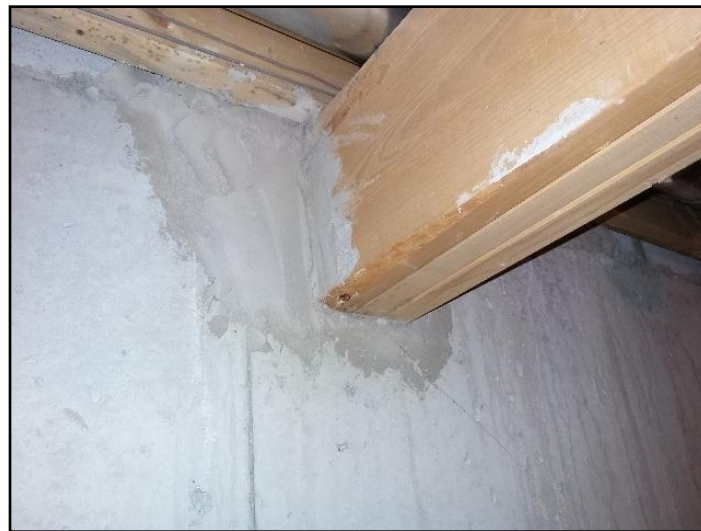
No air gap at the end of wood beam

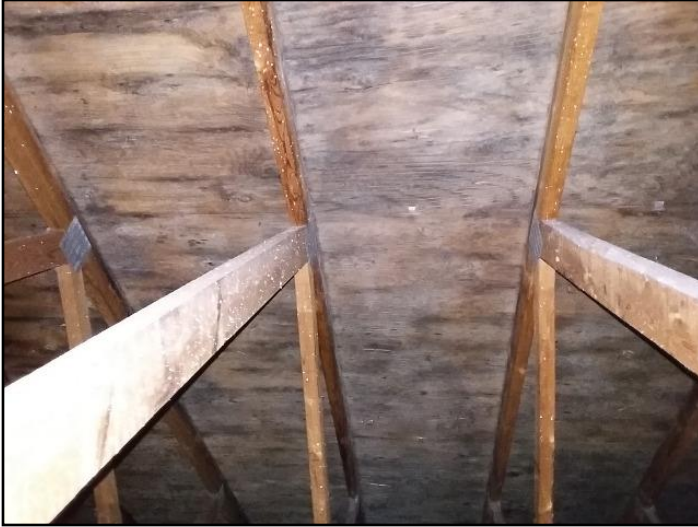
Apparent mold growth

Task: Further evaluation by a mold remediation company.

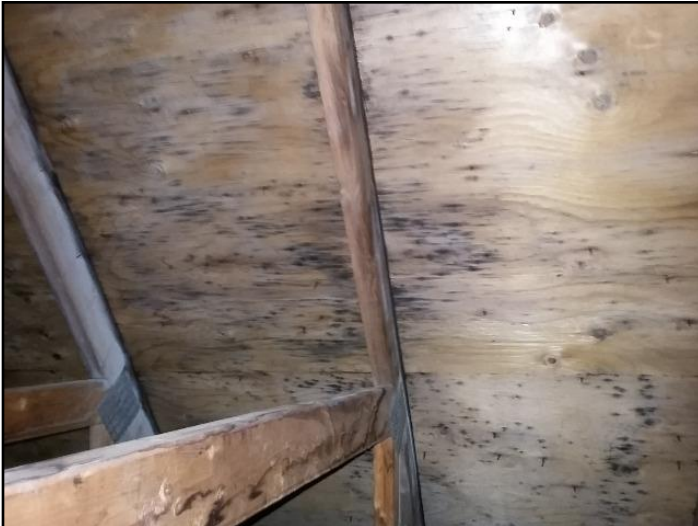
Apparent mold growth

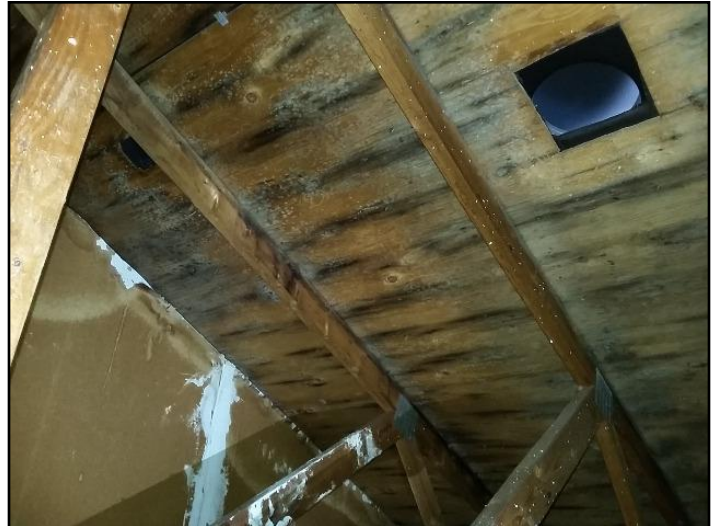
Apparent mold growth

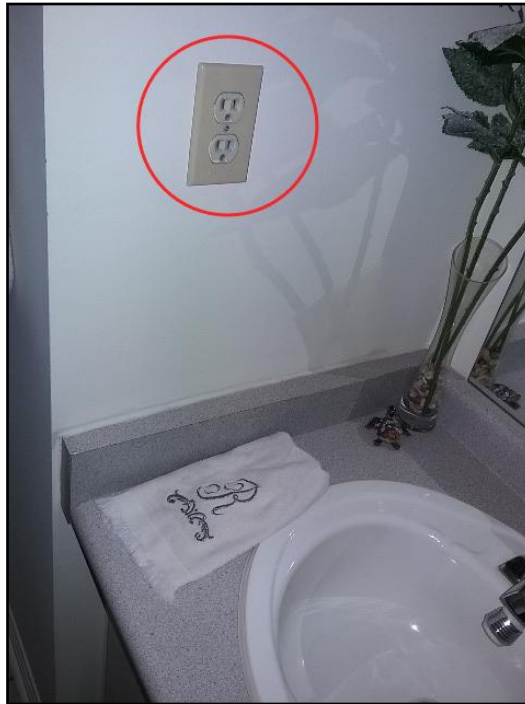
No GFCI/GFI in bathroom

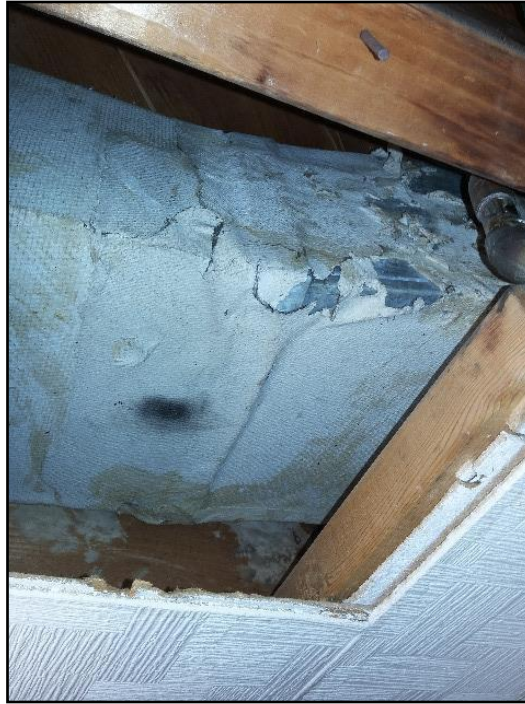
Suspected asbestos

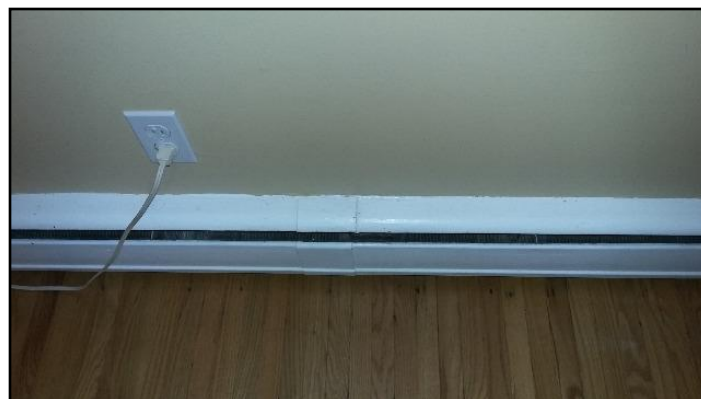
Electrical receptacle above baseboard heater

Task: Move electrical outlet away from the baseboard heater.

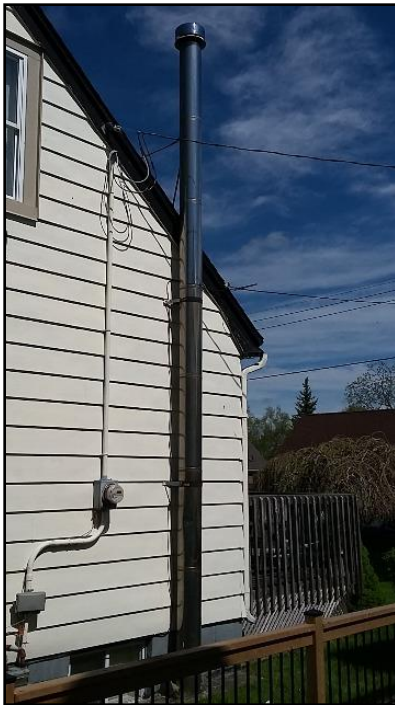
Metal chimney

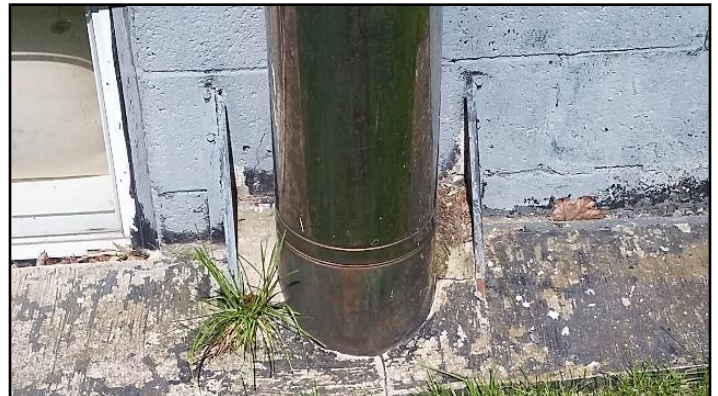
Chimney cleanout buried below ground

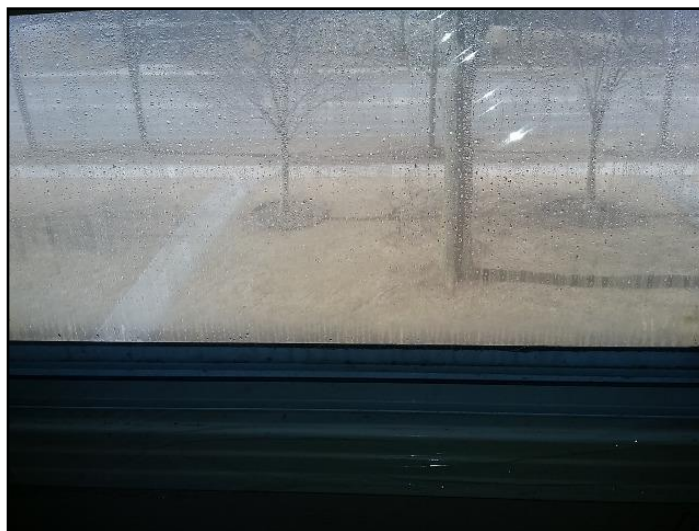
63. Condition: • Condensation on windows

Implication(s): All of the second-floor windows have been covered with plastic which has contributed to excessive amounts of condensation to form on the windows. There is also apparent mold growth on the bottom of the windowsills. Moisture from condensation can cause damage to structure and finishes.

Condensation on windows

Task: Remove plastic/Let windows dry out

Time: Immediately
