INSPECTION REPORT

For the Property at:
208 SAMPLE STREET
NASHVILLE, TN 37214

Prepared for: SAMPLE REPORT
Inspection Date: Wednesday, December 13, 2023
Prepared by: Chris Cutrell, 2207

RE: Report No. 1536, v.4
208 Sample Street
Nashville, TN
37214

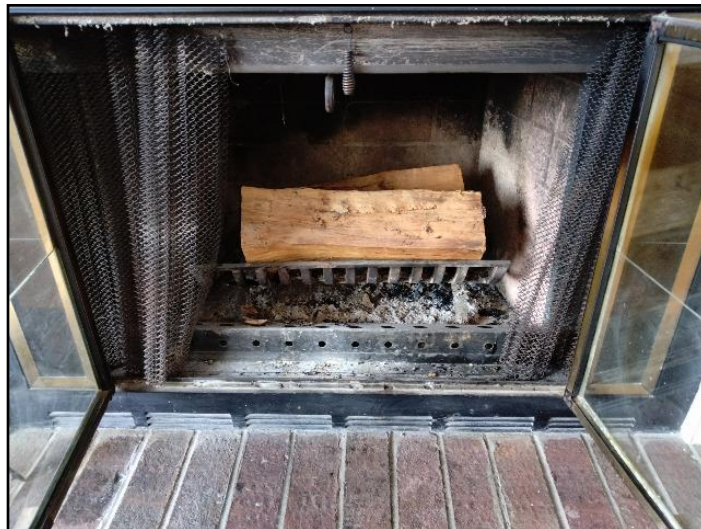
Wood-burning fireplace

Have fireplace serviced and cleaned prior to using.

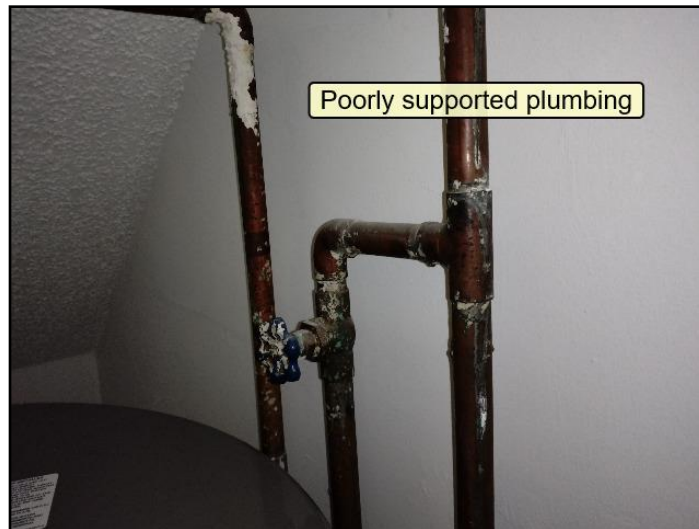
Condition: • Poor support

Implication(s): Chance of water damage to structure, finishes and contents | Leakage

Poor support

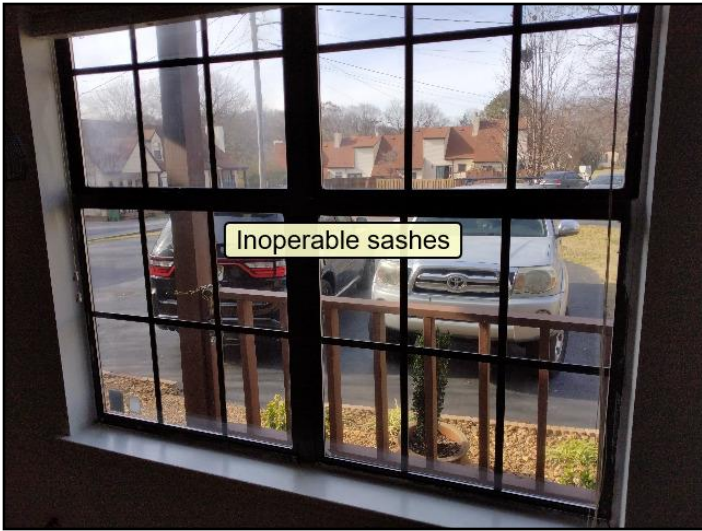
Condition: • Inoperable

Inoperable

Repair windows for normal operation.

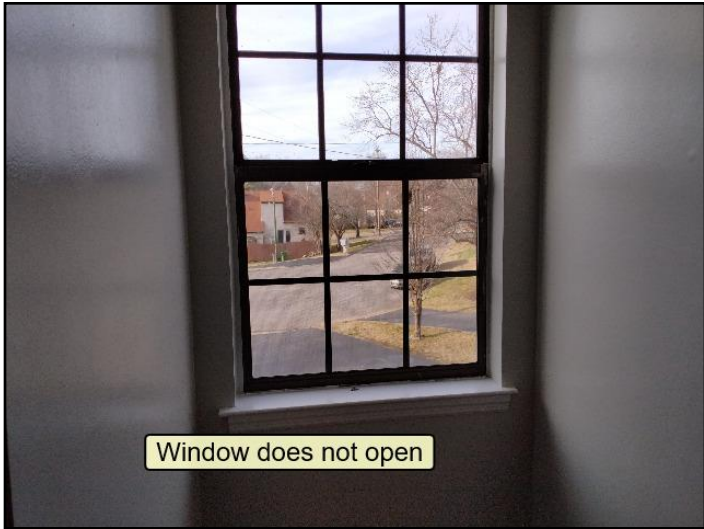
Inoperable

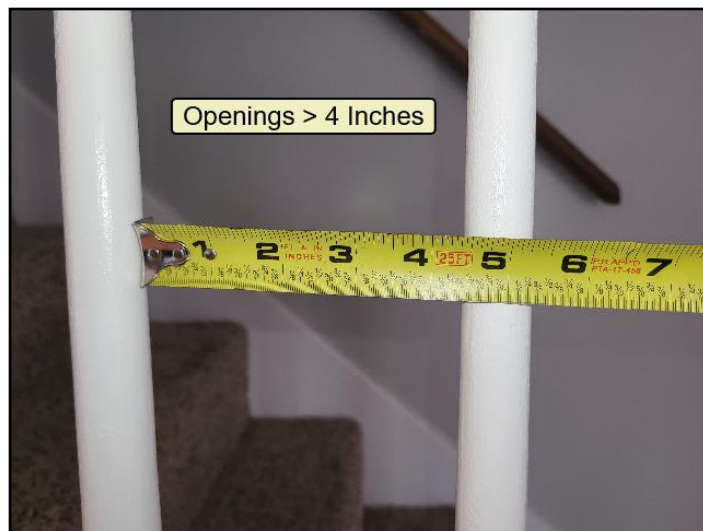
Condition: • Too far apart

Implication(s): Fall hazard

Too far apart
