# INSPECTION REPORT

For the Property at:  
**1800 YOUR STREET**  
NEW ORLEANS, LA 70119

Prepared for: YOUR HOUSE  
Inspection Date: Tuesday, September 27, 2016  
Prepared by: Turk Schexnayder LHI Lic.10679

RE: Report No. 1575, v.3  
1800 Your Street  
New Orleans, LA  
70119

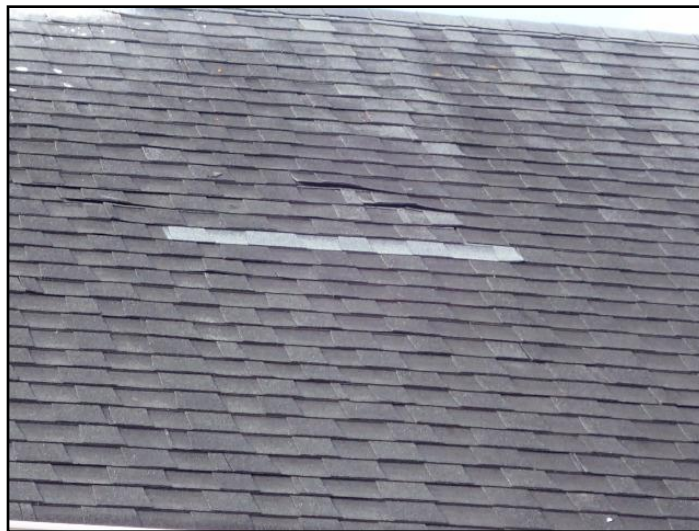
Patch with raised or cupped shingles above were noted.

7. Patched

**Task:** Further evaluation

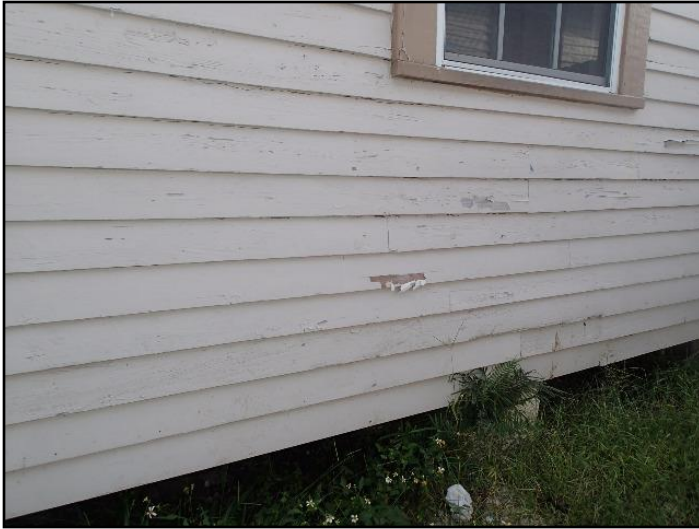
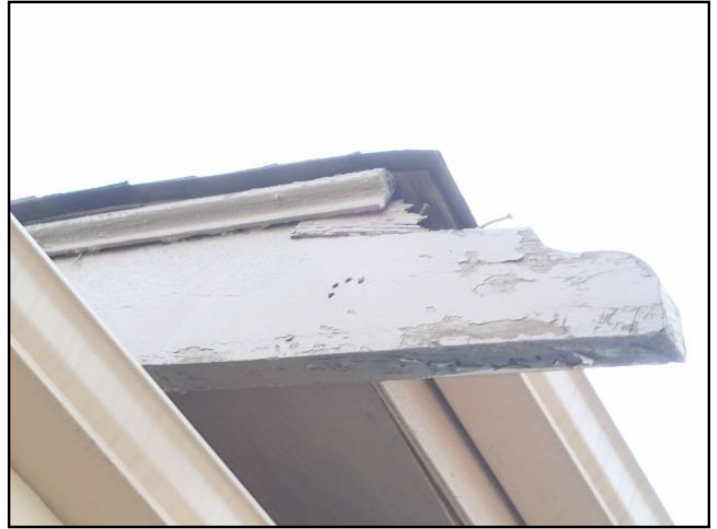
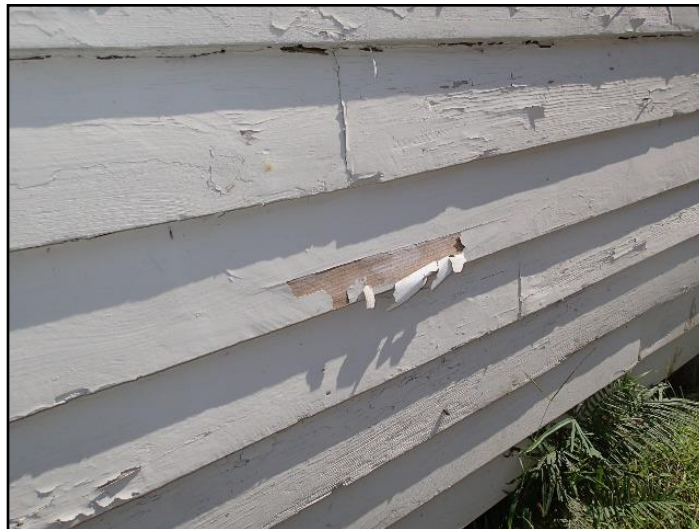
Moisture intrusion through openings will cause exterior wood damage. Peeling paint and open seams should be addressed before material deterioration occurs.

9. Peeling paint on exterior wood surfaces....

**Task:** Replace any damaged wood, seal open seams and paint as needed.

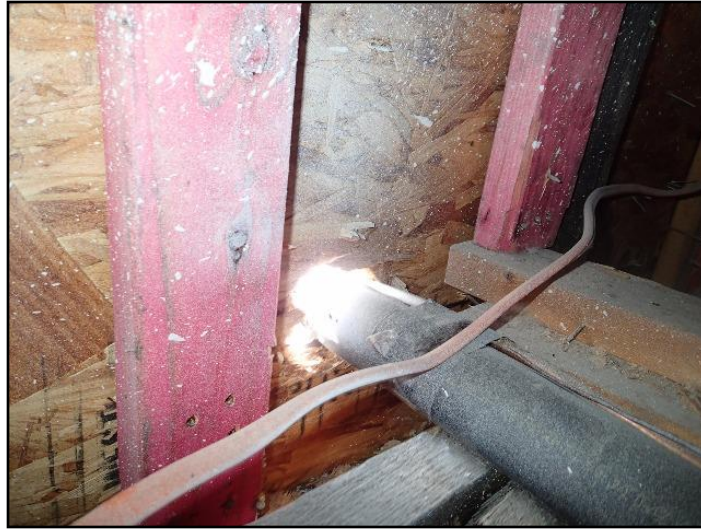
12. Condition: • Opening in wall where HVAC refrigerant passes through.

17. Opening

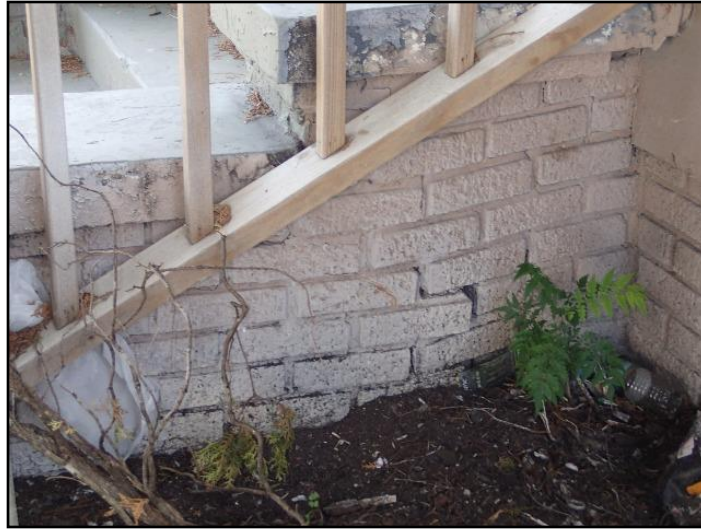
**14. Condition:** • Possible settlement of left side front steps.

19. Possible settlement

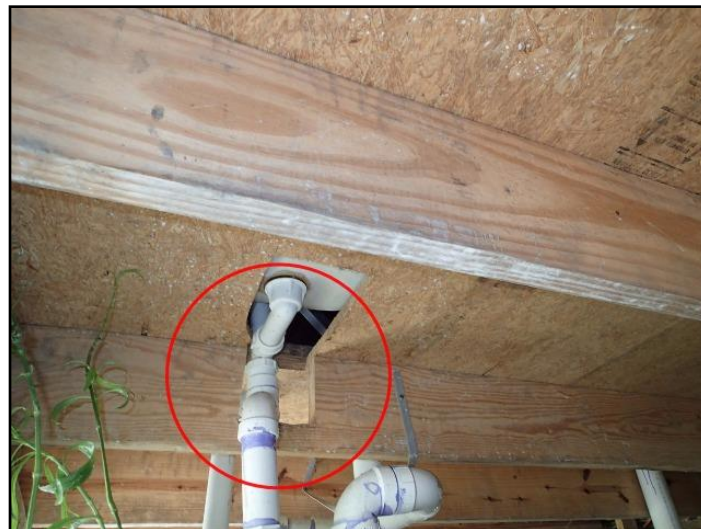
27. Condition: • [Notches or holes](#)

37. Notches or holes

**Task:** Further evaluation

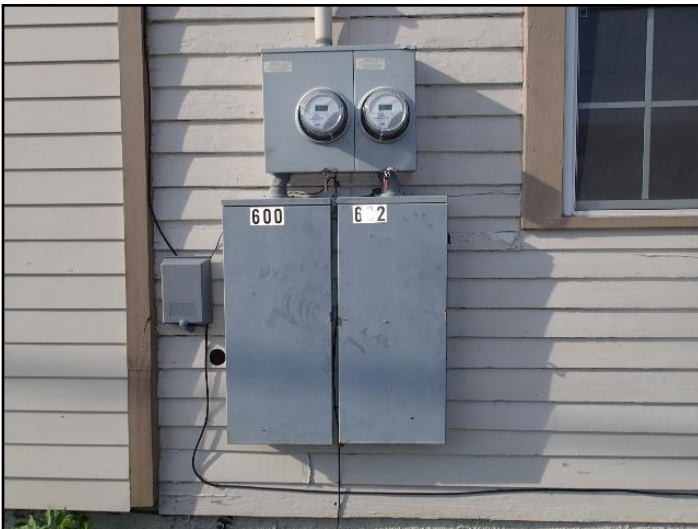
38. Combination panel - cover on

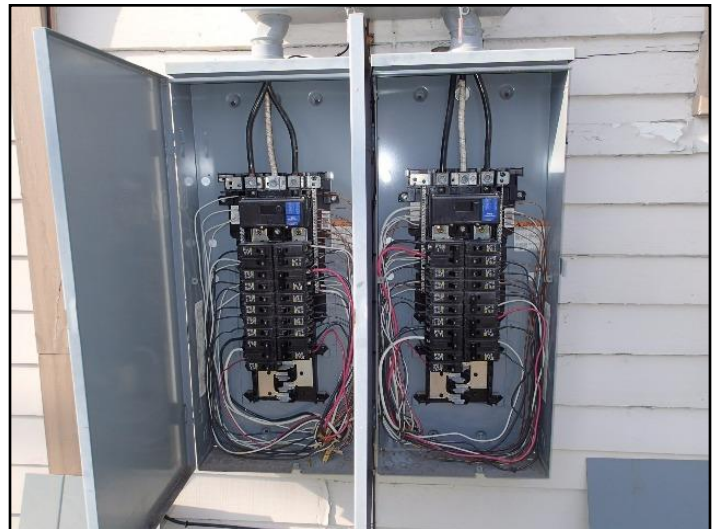
39. Combination panel - Cover removed

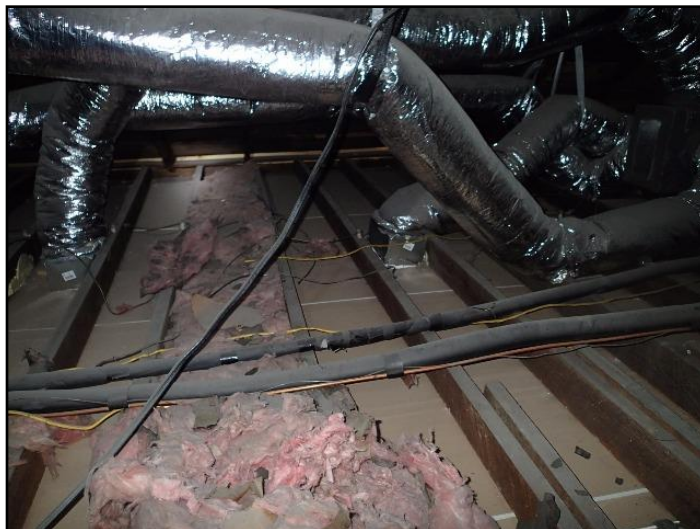
Minimal insulation found in isolated areas.

66. Glass fiber

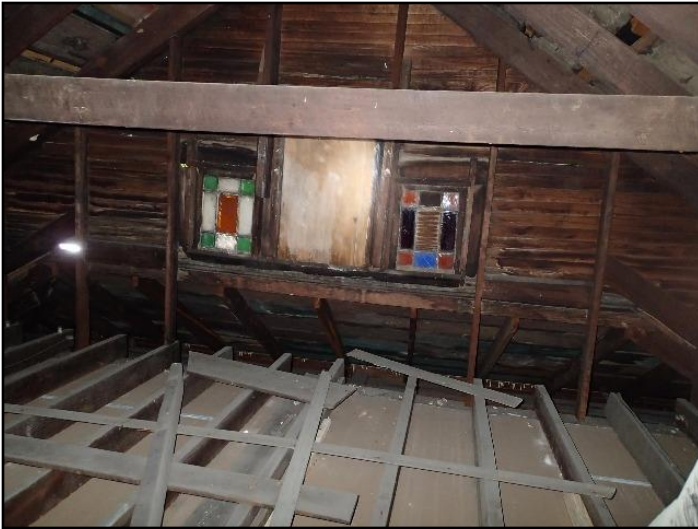
67. Amount less than current standards

**Task:** Improve

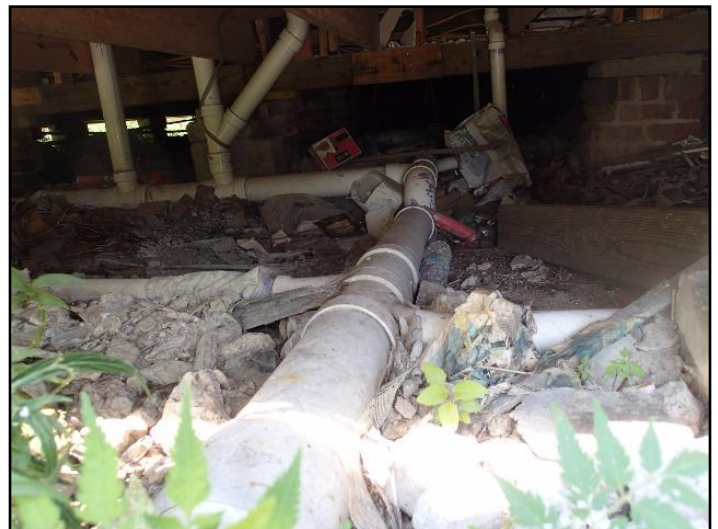
75. Poor support

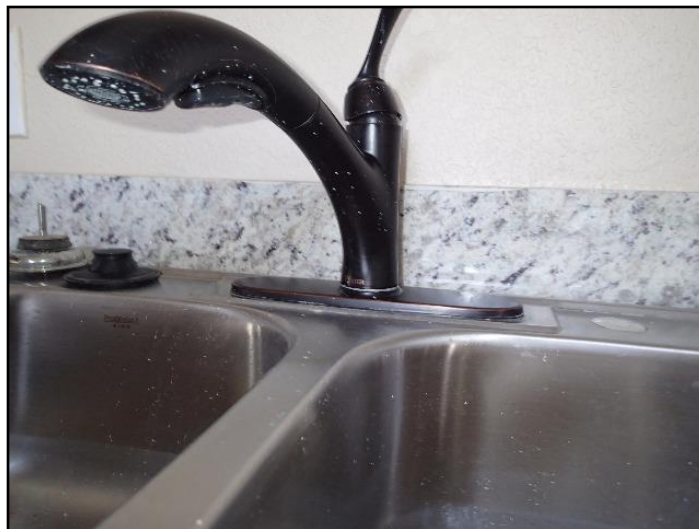
Faucet on right side did not work when tested.

77. Stiff or inoperative

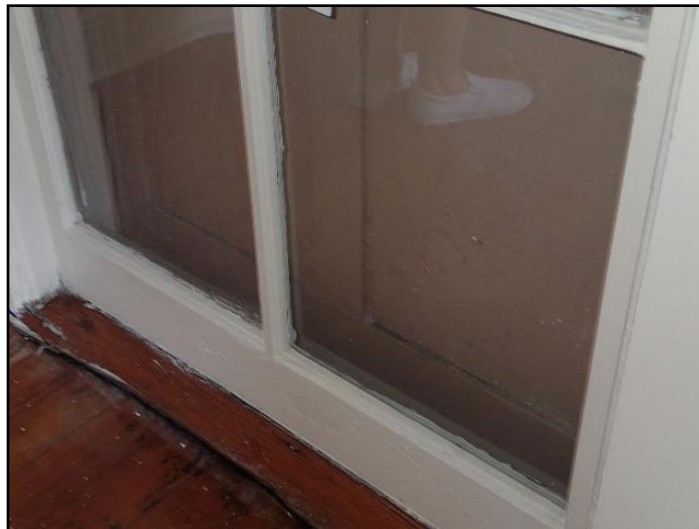
Tempered glass is required to be permanently identified by the manufacturer. Identification can be acid etched, sand blasted, ceramic fired, laser etched, embossed or of a type that once applied, cannot be removed without being destroyed.

**81.** *Low windows*

**Task:** Improve

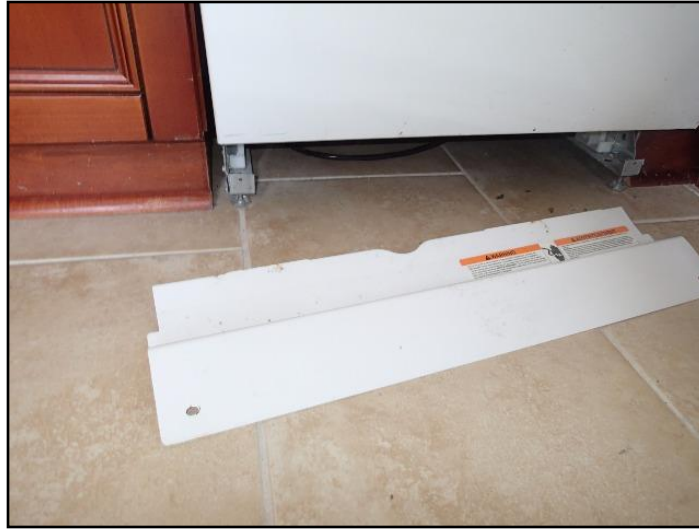
88. Kick plate not installed.

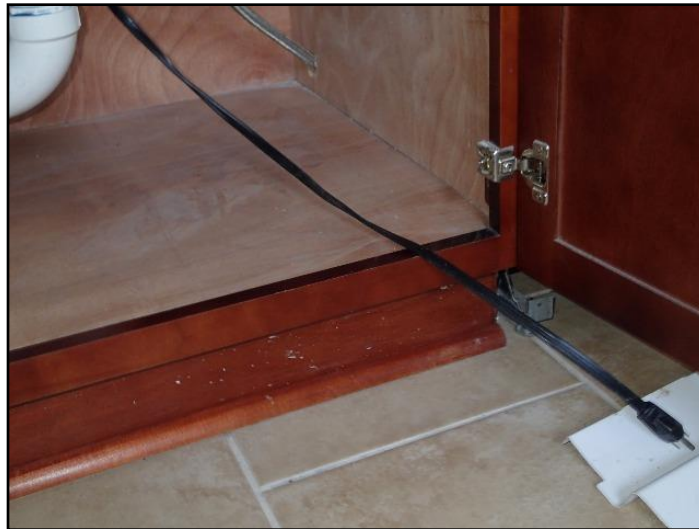
Left side disposal did not function when tested. Hummed but did not turn on. Right side disposal had no power source. Unable to test.

89. No power source.

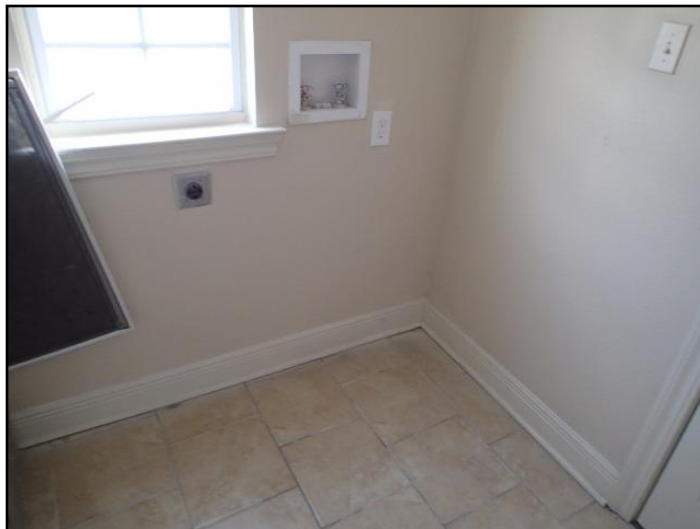
**92.** *Dryer not vented to exterior*

71. Condition: • Dryer not vented to exterior
