# Your Inspection Report

57 Kenneth Ave  
Toronto, ON M6P 1J1

**PREPARED BY:**  
Jim Gibson, P.Eng.

RE: Report No. 73954, v.2  
57 Kenneth Ave  
Toronto, ON  
M6P 1J1

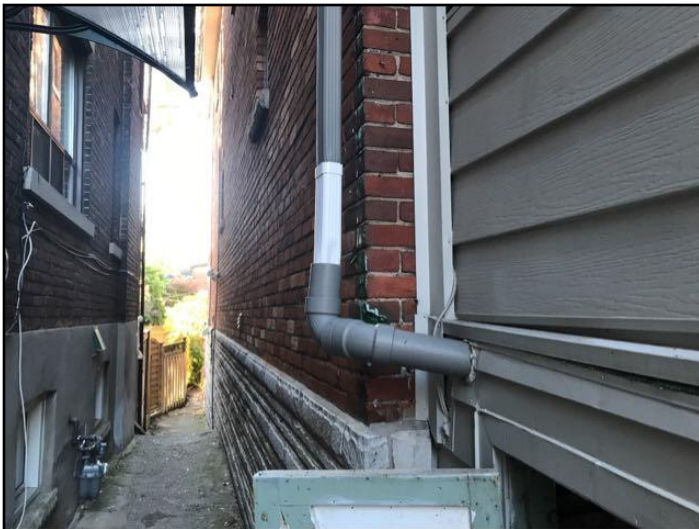
Connections poor, leak

*Connections poor*

**Task:** Discharge above grade more than 2 m from building

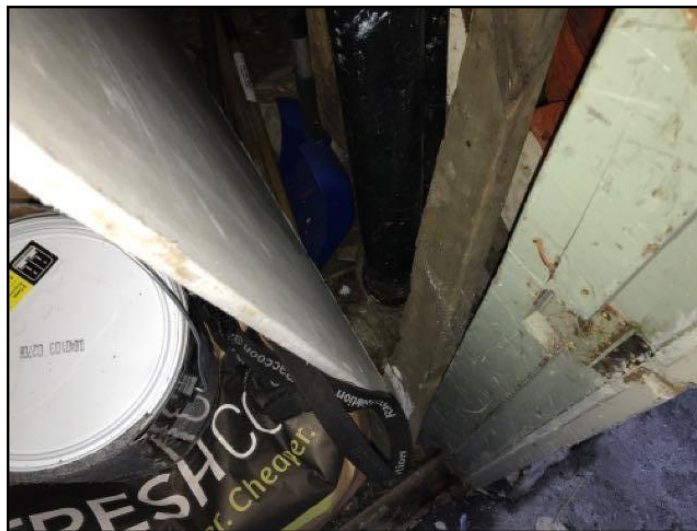
*Routed into below-grade drain*

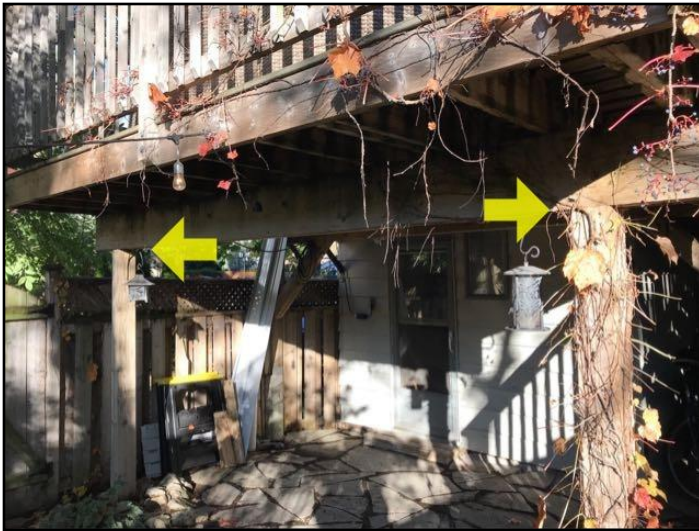
Connections weak

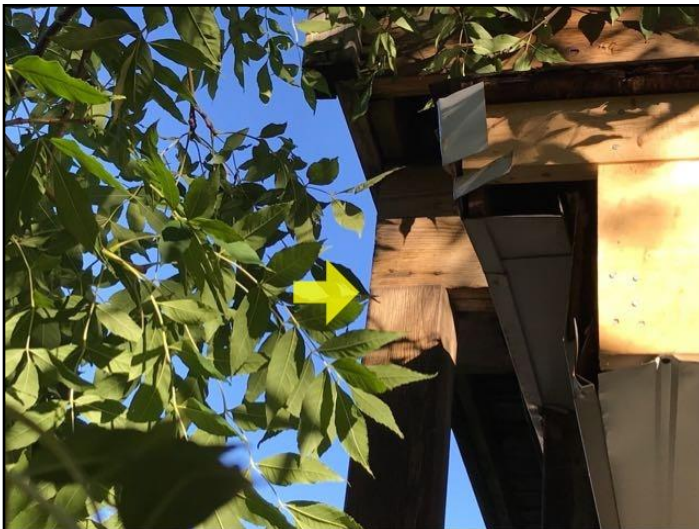
Connections weak

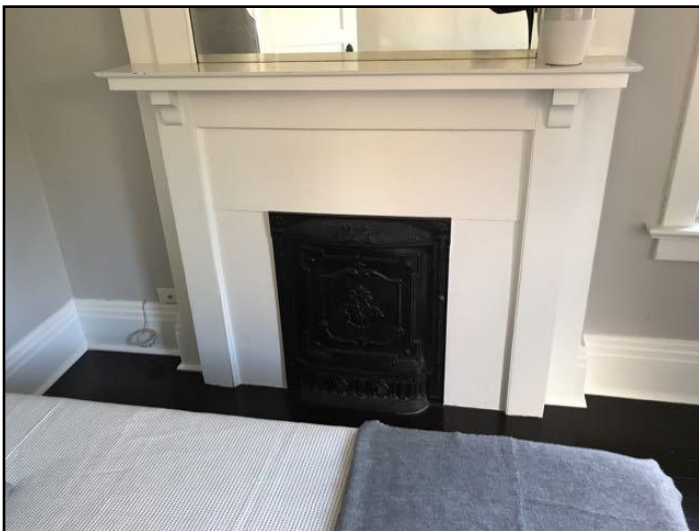
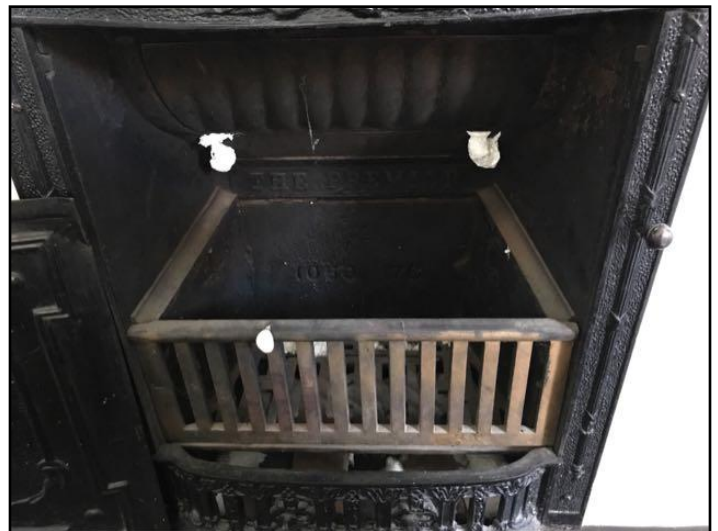
• Non-functional

At front second floor

Non-functional

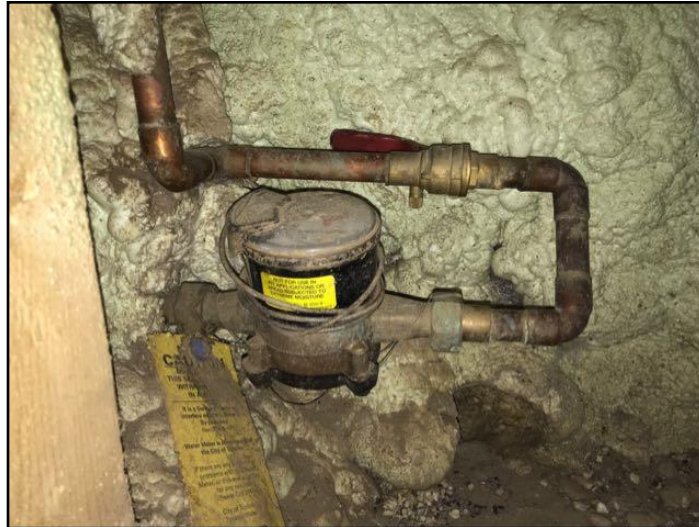
*Not visible*

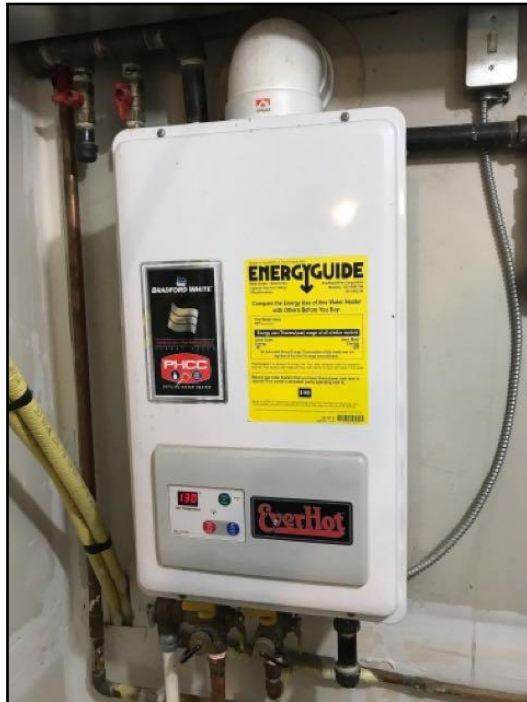
Tankless/On demand

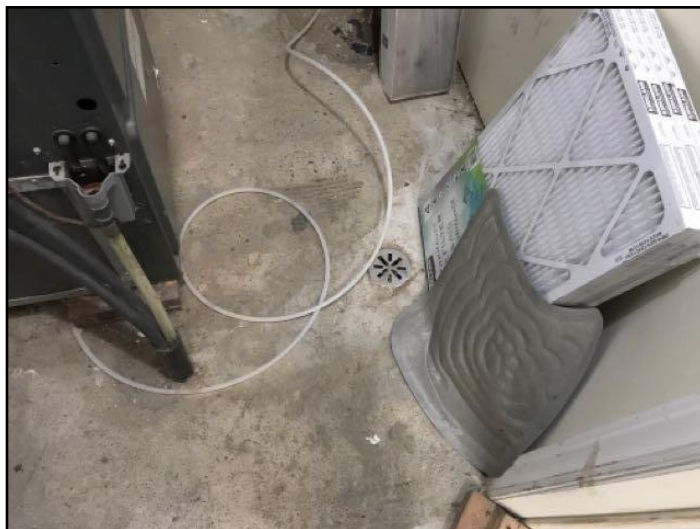
**Floor drain location:** • Right rear basement (near water heater)

*Floor drain*
