# Your Inspection Report

1234 Main Street  
Whoville, MI 98098

RE: Report No. 1810, v.2  
1234 Main Street  
Whoville, MI  
98098

# ROOFING

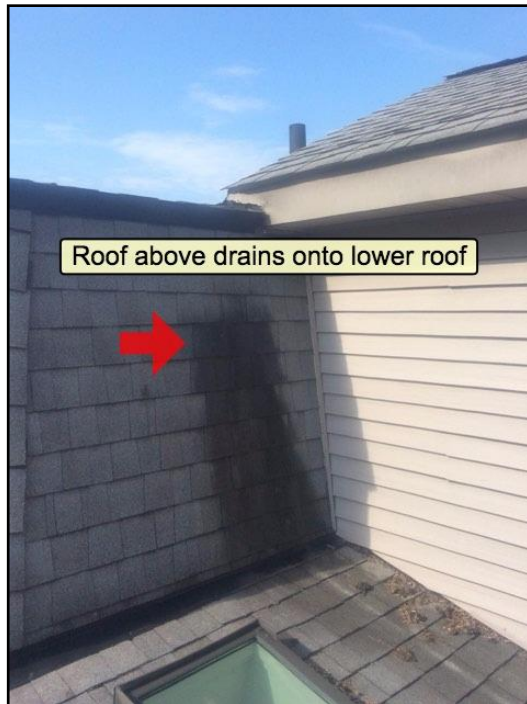
4. Poor drainage arrangement

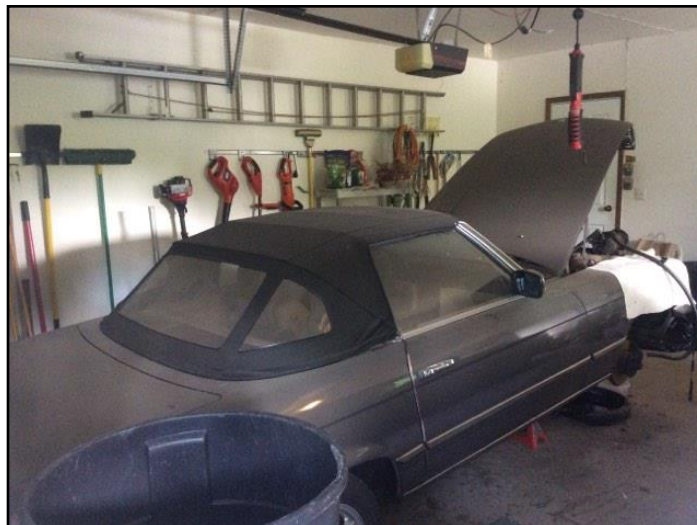
6. Car/storage in garage

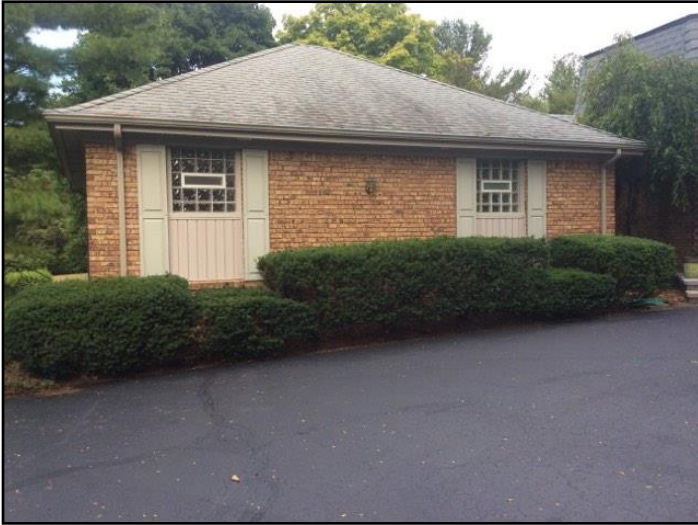
7. Vines/shrubs/trees against wall

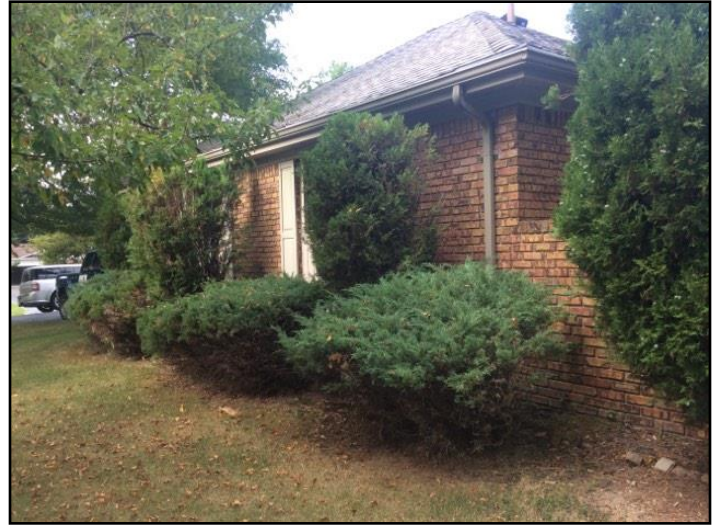
8. Vines/shrubs/trees against wall

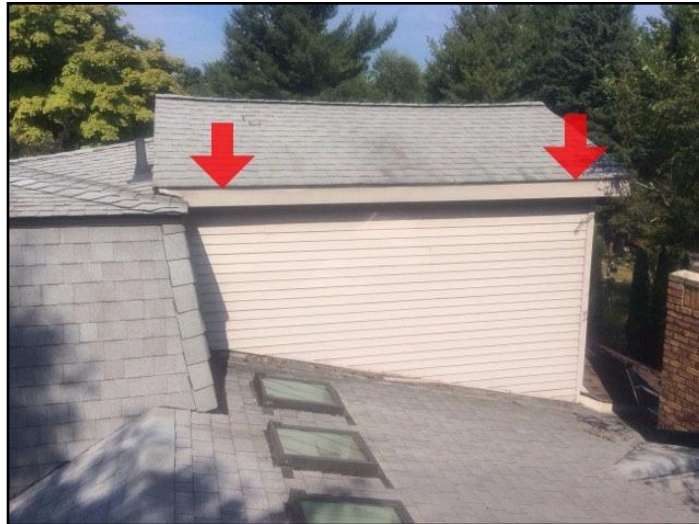
4. Condition: • [Missing](#)

Implication(s): Chance of water damage to contents, finishes and/or structure

11. Missing

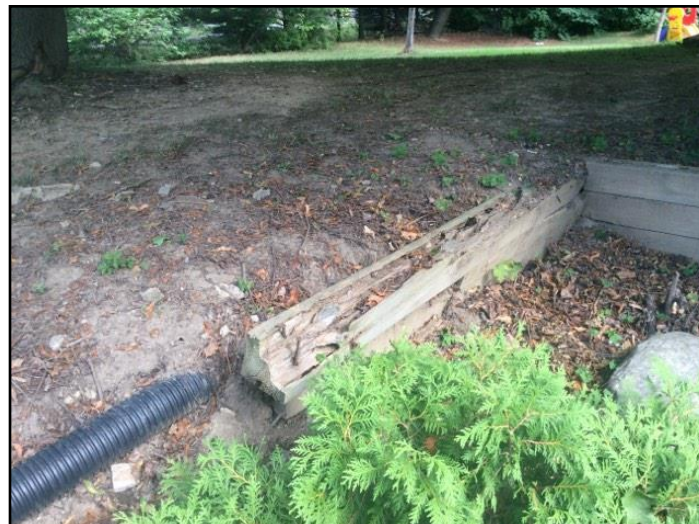
17. Condition: • [Leaning](#)

21. Leaning

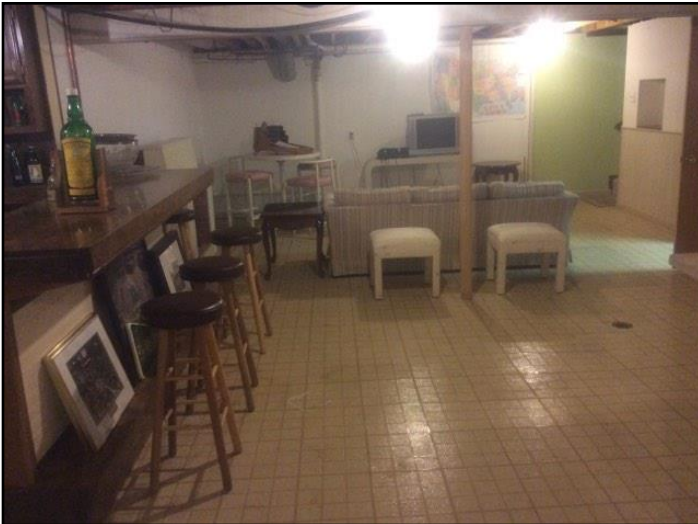
23. Wall, floor and ceiling coverings

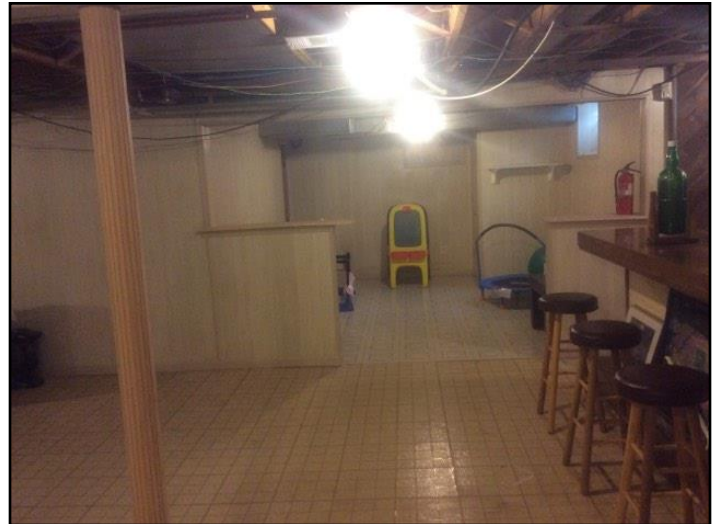
24. Wall, floor and ceiling coverings

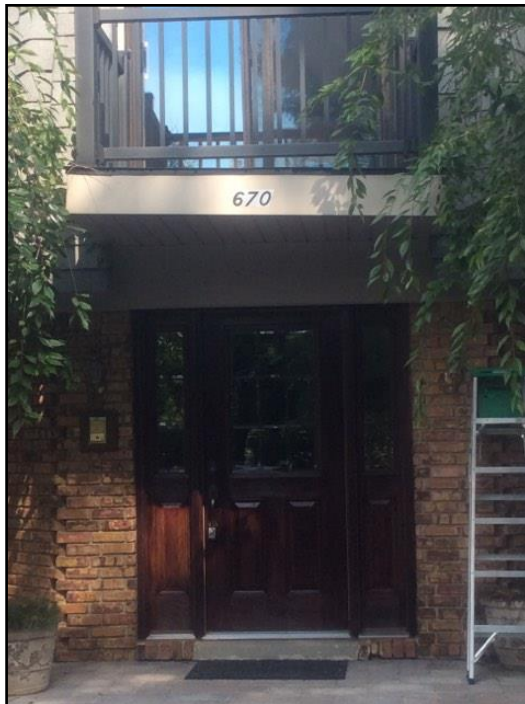
**19. Condition:** • [Weak cantilevers](#)

**Implication(s):** Weakened structure | Chance of structural movement

25. Weak cantilevers

Structural balcony concerns need to be evaluated by a qualified contractor. Floor is not level

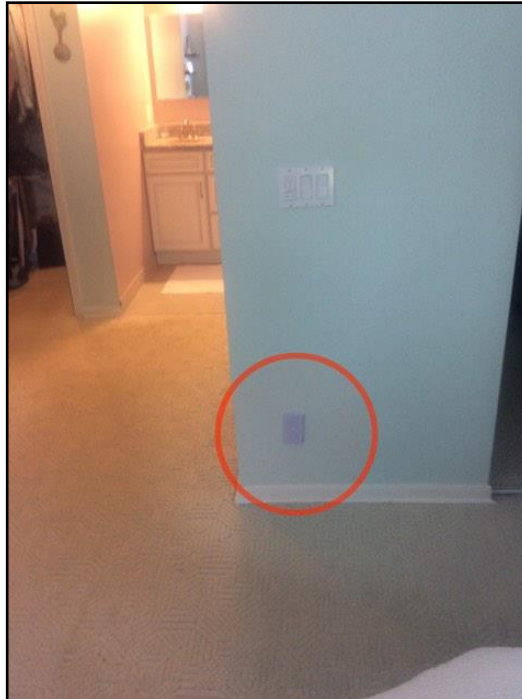
31. Condition: • [Loose](#)

Implication(s): Electric shock | Fire hazard

34. *Loose*

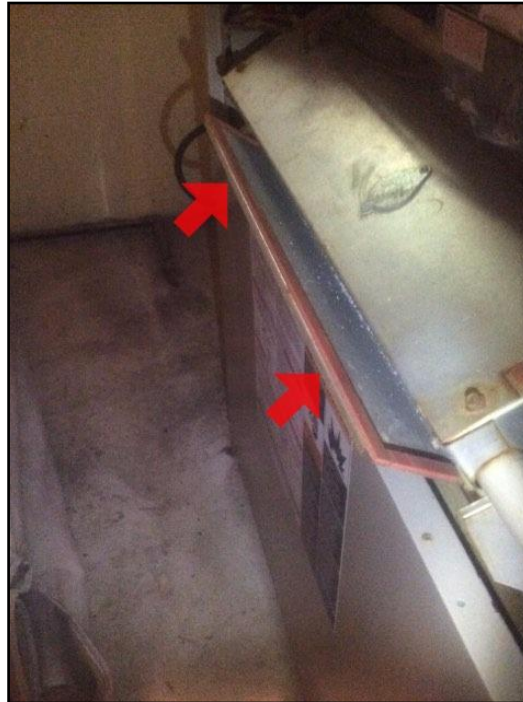
39. Condition: • [Vent damper stuck](#)

Implication(s): Equipment not operating properly | Hazardous combustion products entering home | Increased heating

costs | Reduced comfort

40. Vent damper stuck

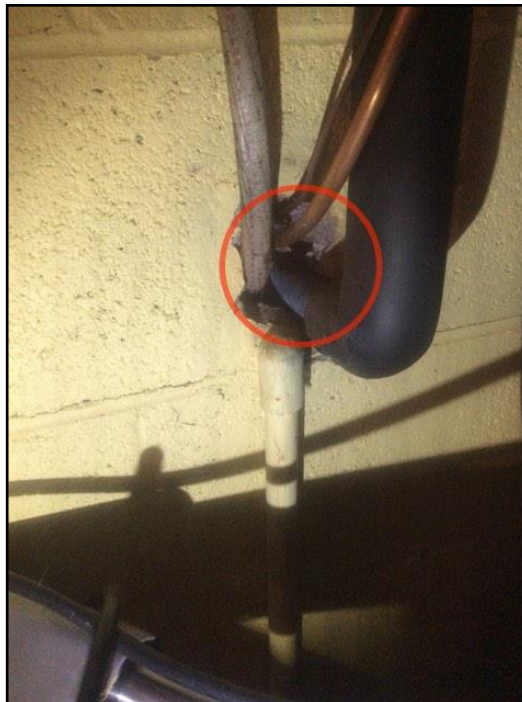
**47. Condition:** • [Poor seal at building](#)

**Implication(s):** Chance of water entering building | Chance of pests entering building

**43. Poor seal at building**

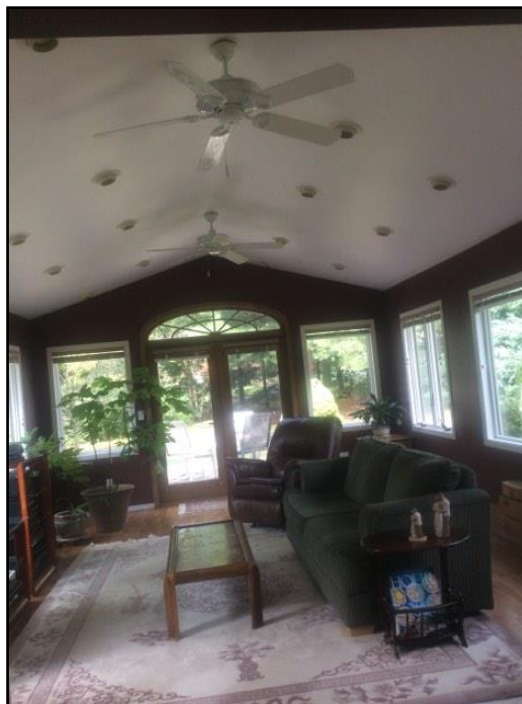
Over family room addition

44. Attic

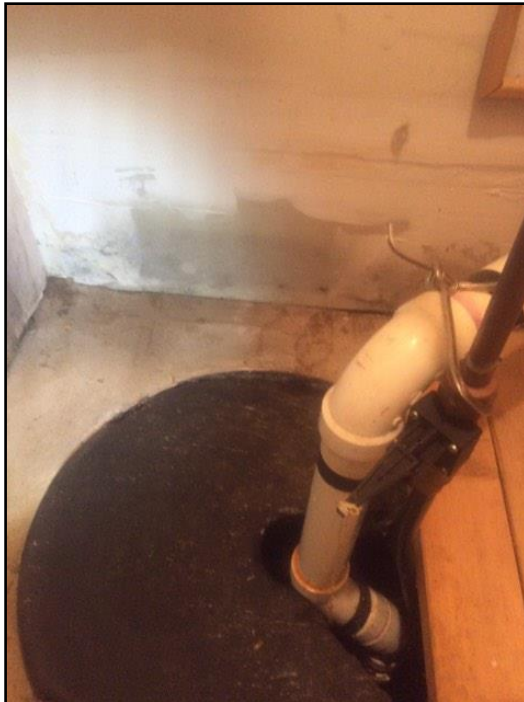
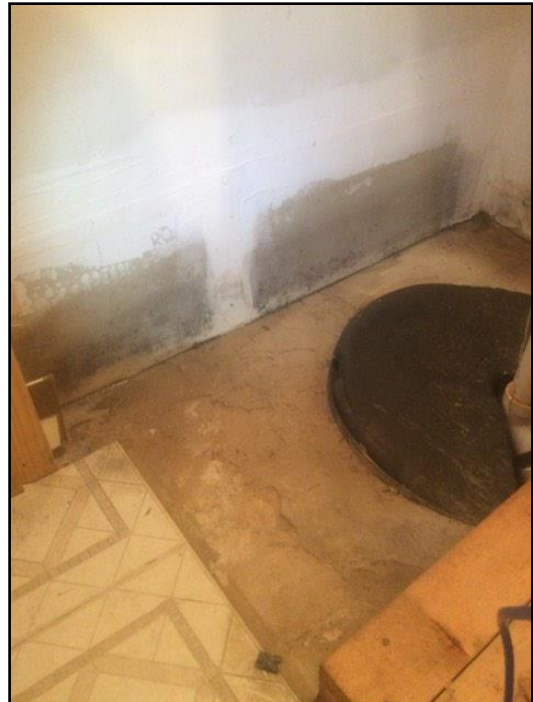
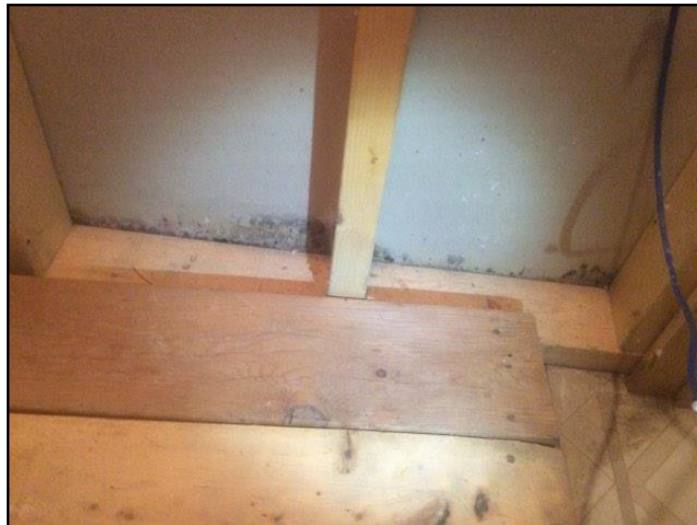
56. Mold in sump closet

**63.** • Mold-like substance found. The mold on the drywall should be removed by removing the drywall. Moldy drywall should never be cleaned, always replace the drywall. Do not use bleach. Reference these two sites <http://www.nyc.gov/html/doh/html/environmental/mold.shtml> and <http://www.epa.gov/mold>

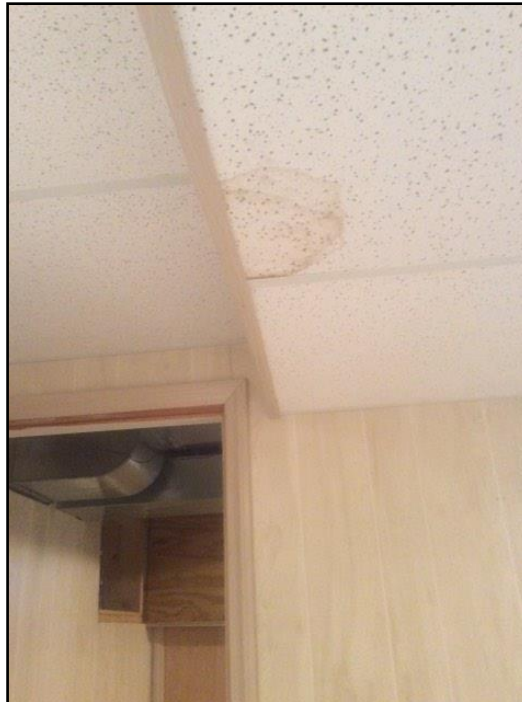
64. Condition: • Stains

Implication(s): Cosmetic defects

59. Stains

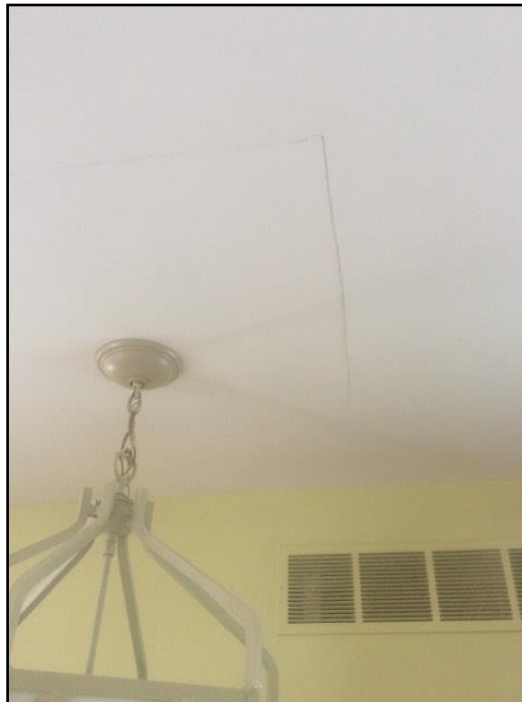
65. Condition: • [Cracked](#)

Implication(s): Cosmetic defects | Damage or physical injury due to falling materials

Location: Second Floor, above spiral staircase

60. Cracked

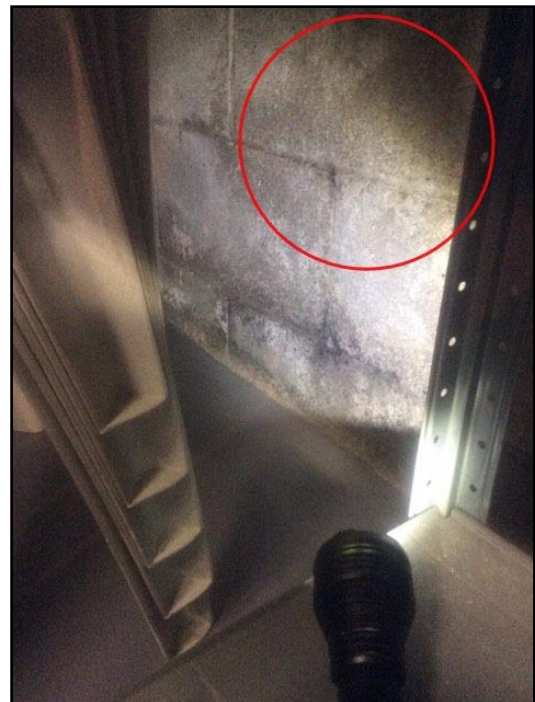
69. Condition: • [Mold](#)

**Implication(s):** Cosmetic defects | Chance of water damage to contents, finishes and/or structure | Contaminants may enter building air

64. Mold

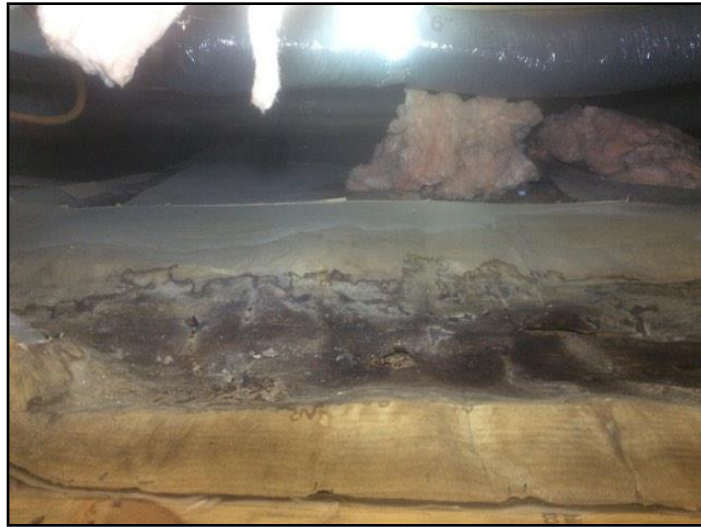
72. Condition: • [Mold](#)

**Implication(s):** Cosmetic defects | Chance of water damage to contents, finishes and/or structure | Contaminants may enter building air

70. *Mold*
