# INSPECTION REPORT

For the Property at:  
**123 ANY STREET**  
ANY TOWN, TN 12345

Prepared for: JOHN SMITH  
Inspection Date: Monday, February 19, 2018  
Prepared by: Melanie Moore

RE: Report No. 4176, v.5  
123 Any Street  
Any Town, TN  
12345

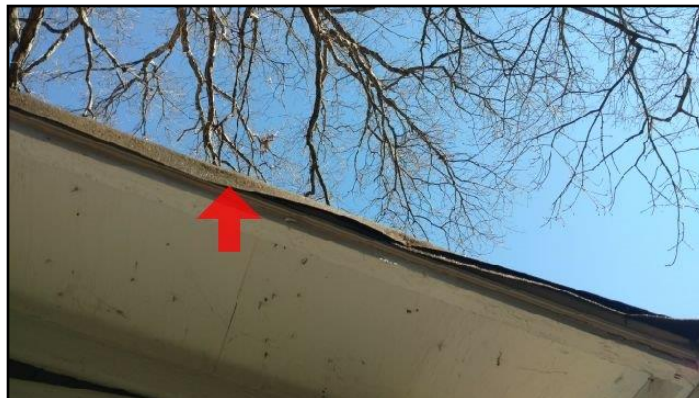
**Condition:** • Overhangs too big or small

Asphalt roofing is designed to overhang the edge of the roof from 1-1 ½" without breaking when installed properly with starter strip and drip edge. This length allows the roofing to propel the water well over the edge of the structure preventing water damage. Overhangs that are left too short fail to do this. Just as bad however is leaving the overhang weighty and, when the tar based material heats and softens, allow it to bend under the weight and break where it folds and the roofline.

1. Overhangs too big or small Asphalt roofing...

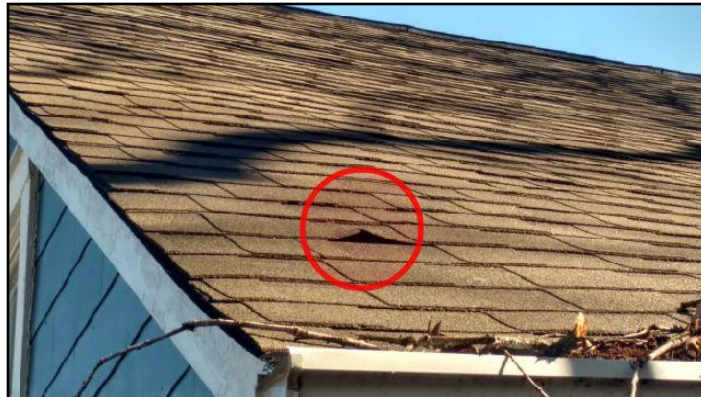
**Condition:** • Raised fasteners under roofing - When you see shingle humped up, usually that means a nail/fastener has backed out under it. This can cause a leak to form on top of the nail head due to weather deteriorating the high point faster than surrounding material. To correct this, you can use a flat wide piece of thin metal, like a flat bar. Gently lift the shingle only as high as necessary to see to place the metal on top of the head, then lay the shingle on the metal. Take a small bloc of wood and lay it on top of the shingle sandwiching the roofing between the metal and wood, then strike the wood with a hammer reseating the nail. This will spread the blow and lessen damage to the shingle we are trying to protect.

2. Raised fasteners under roofing - When you...

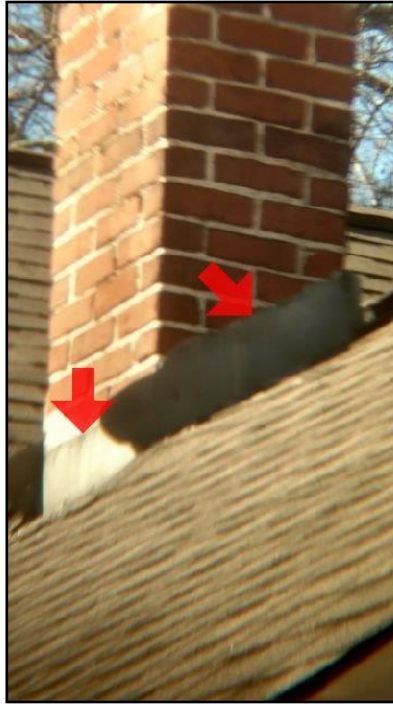
Condition: • [Not let into mortar joints](#)

Implication(s): Chance of water damage to contents, finishes and/or structure

3. Not let into mortar joints

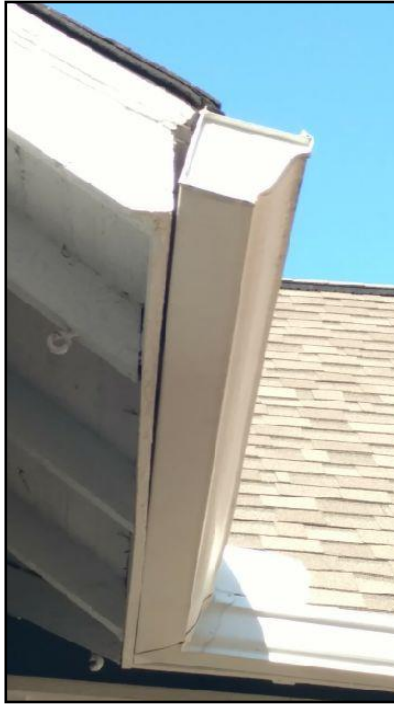
**Condition:** • Loose

4. Loose

**Task:** Repair

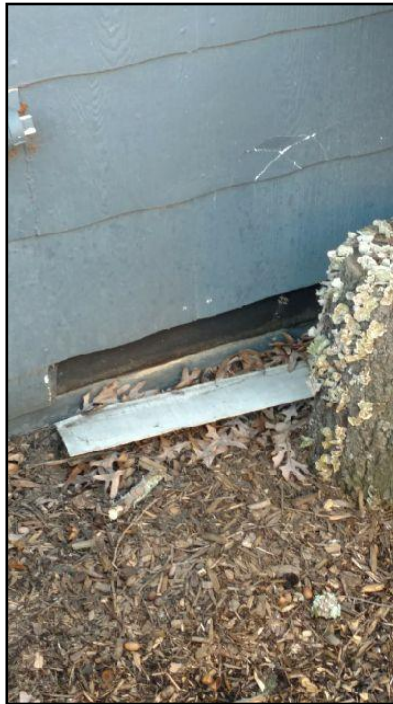
Condition: • [Mechanical damage](#)

Implication(s): Chance of water damage to contents, finishes and/or structure

6. Mechanical damage

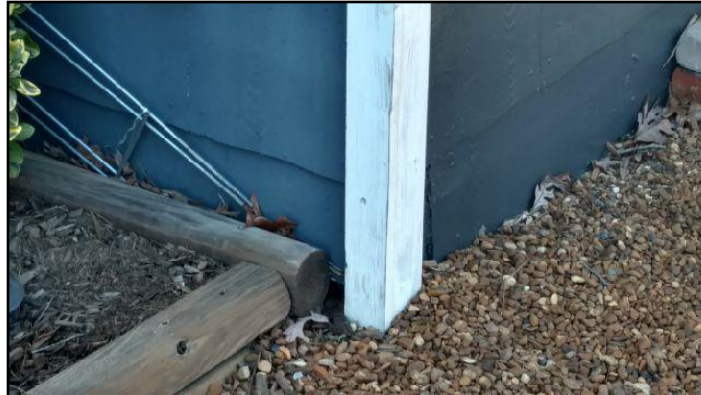
Condition: • [Too close to grade](#)

Implication(s): Chance of water damage to contents, finishes and/or structure | Rot

7. Too close to grade

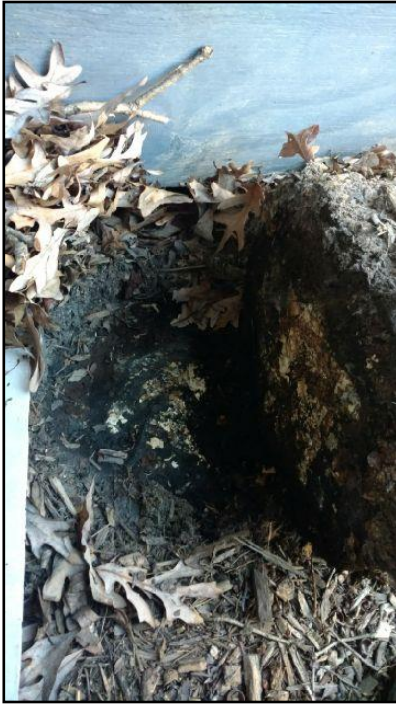
**Condition:** • Debris encourages rodents.

13. Debris encourages rodents.

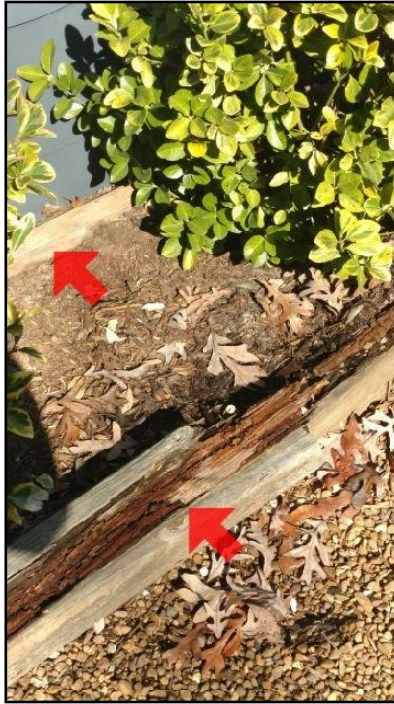
## Condition: • Wood touching foundation

There are some landscape Timber framed Planters beside the home that appear to have insect damage that are touching the foundation of the home where the siding is too close to grade. This is a perfect environment to allow wood-boring insects into the structure. I highly recommend this wood be removed and this area thoroughly inspected by termite inspector.

15. Wood touching foundation

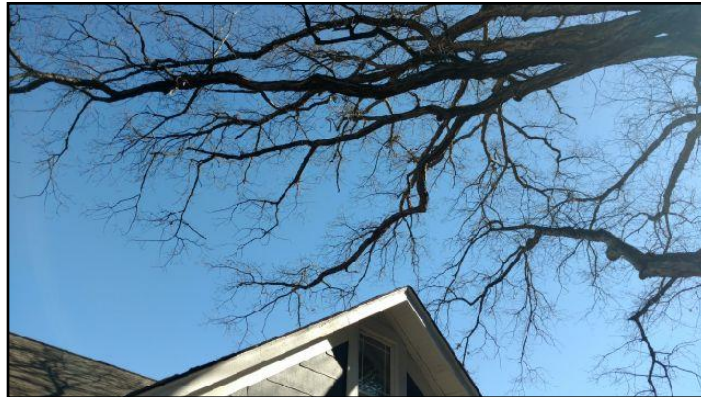
**Condition:** • Trees overhanging roof can speed roofing deterioration and fill gutters.

16. Trees overhanging roof can speed roofing...

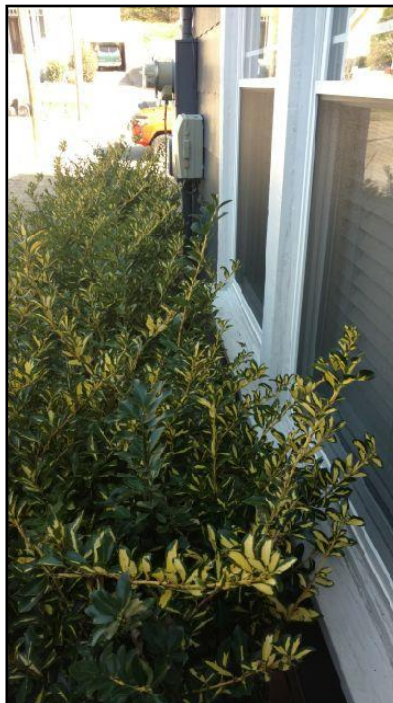
**Condition:** • [Trees or shrubs too close to building](#)

**Implication(s):** Chance of water damage to contents, finishes and/or structure | Chance of pests entering building | Material deterioration

17. Trees or shrubs too close to building

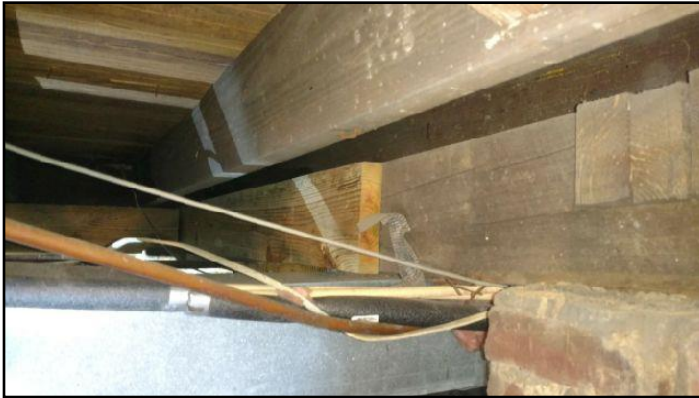
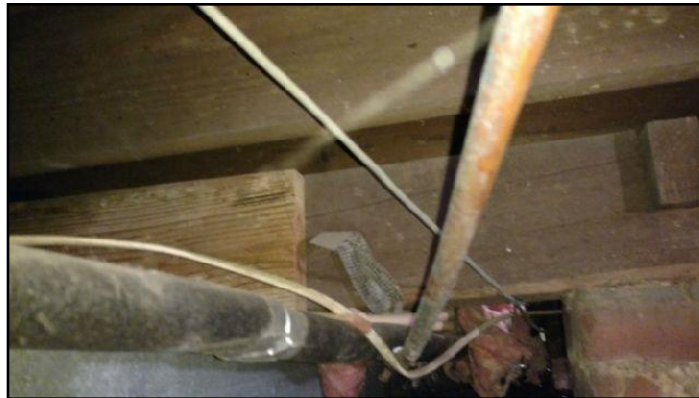
### Condition: • [Prior repairs](#)

While a 2x8 has been scammed to a property of what appears to be a wood boring insect damaged beam, the board does not real a load bearing point not reach the full length plus some of the damaged beam.

22. Prior repairs

24. Prior repairs

26. Prior repairs

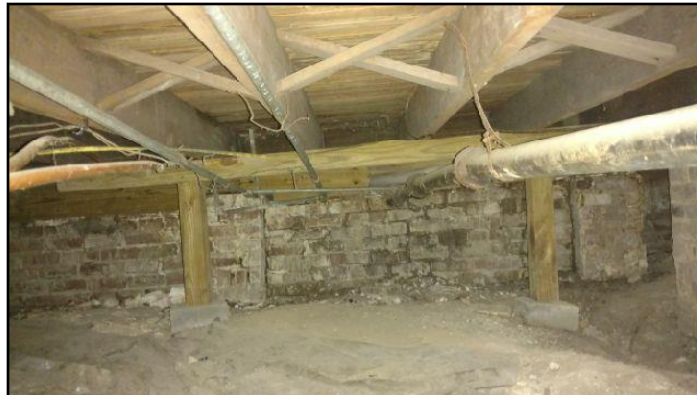
Condition: • [Prior repairs](#)

27. Prior repairs

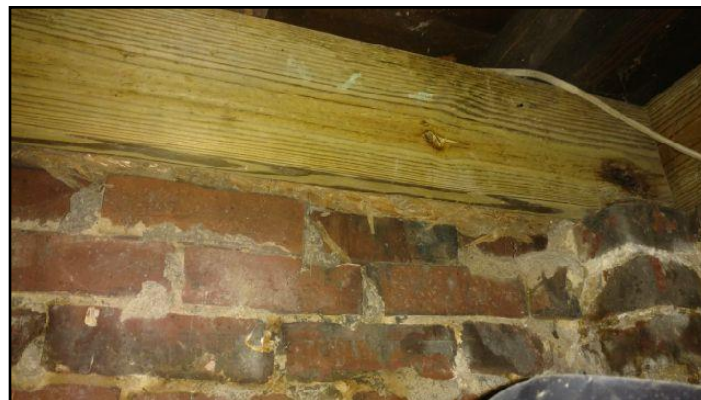
Condition: • [Rot or insect damage](#)

Implication(s): Weakened structure

28. Rot or insect damage

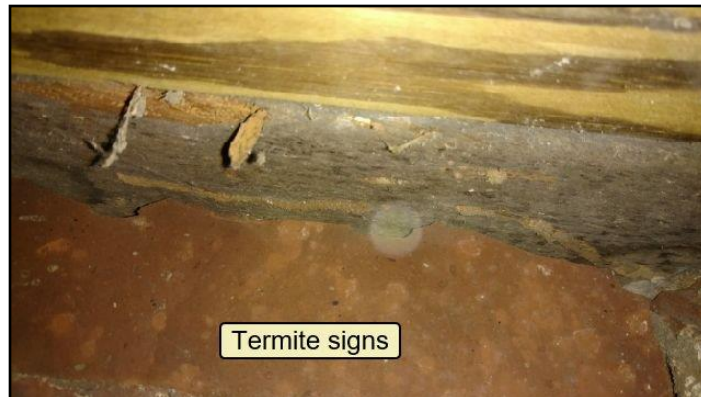
Condition: • [Insect damage](#)

29. Insect damage

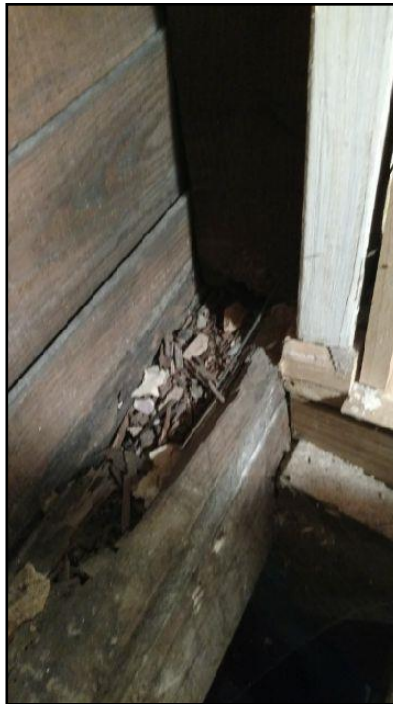
Damaged area is by Stellar access and does not appear to be jeopardizing the structure.

**Implication(s):** Weakened structure

40. Rot, insect or fire damage

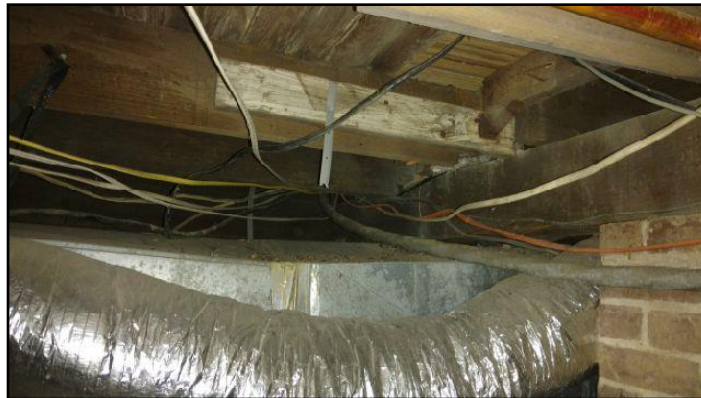
41. Not well secured

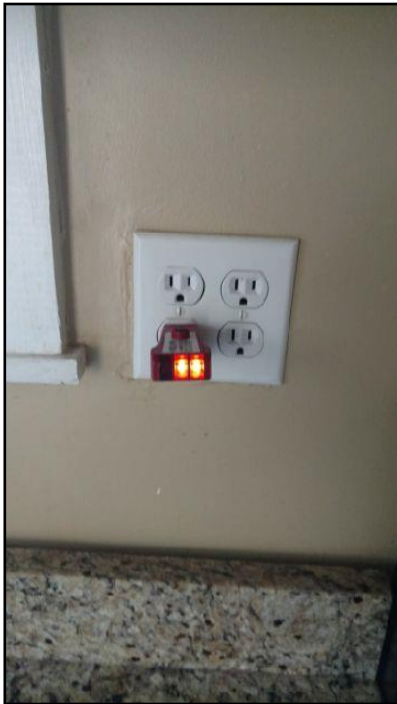
42. Open Ground

43. Open Ground

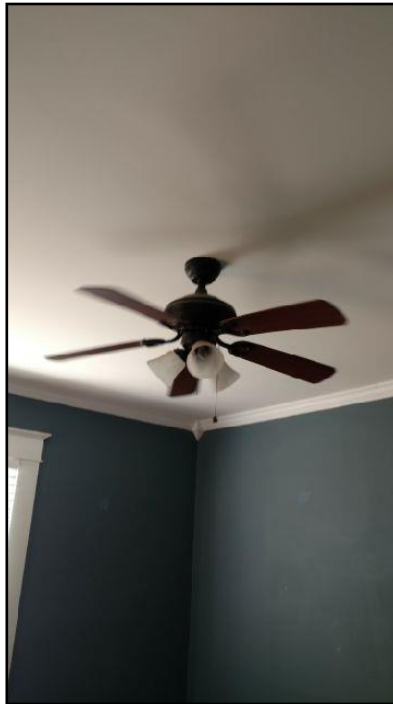
44. Inoperative

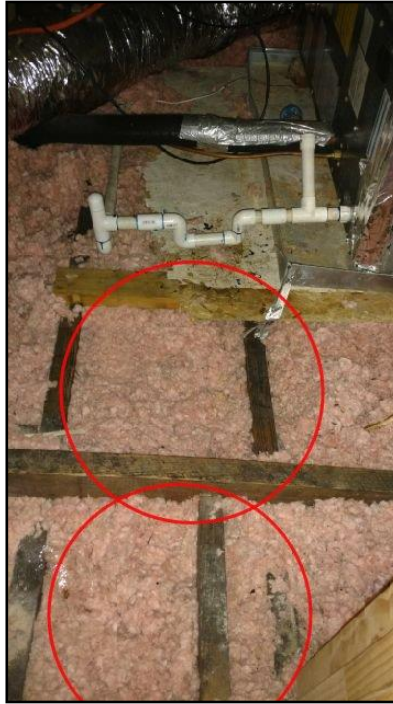
45. Equipment placed in the attic over finished...

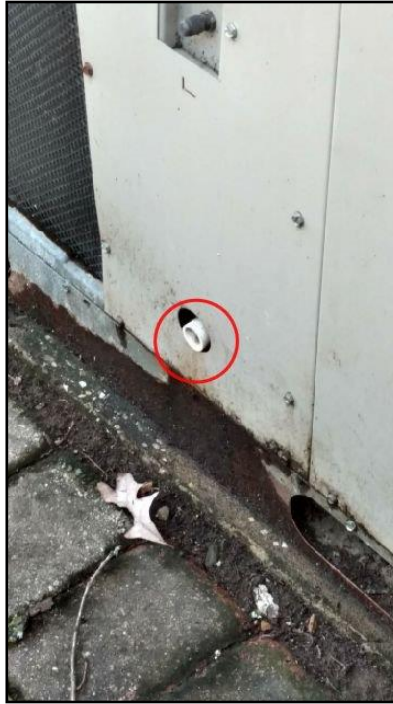
46. Missing

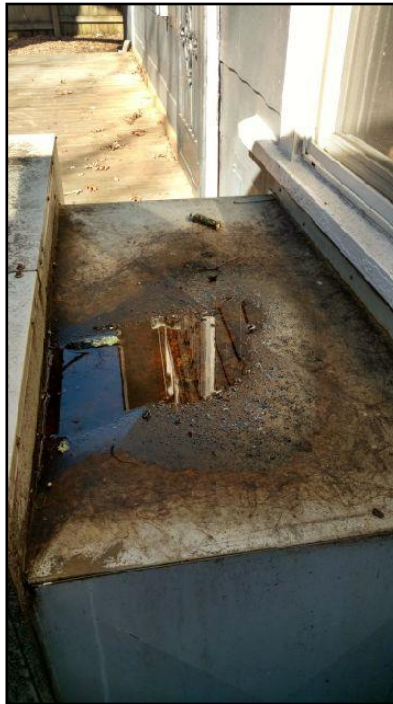
48. Cowling is sagging and retaining water and...

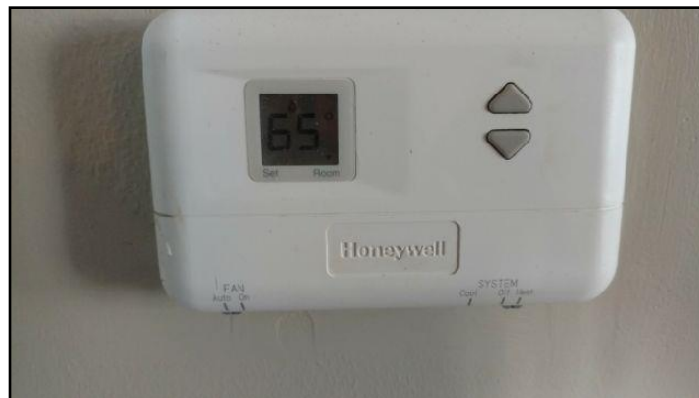
49.

**Condition:** • This inspector could not get the first floor thermostat to change temperature and was unable to test the downstairs unit. I highly recommend that a HVAC professional be consulted during the inspection period To evaluate this equipment. This inspector also placed the thermostat fan in the on position rather than the auto position and could not get the unit fan to come on.

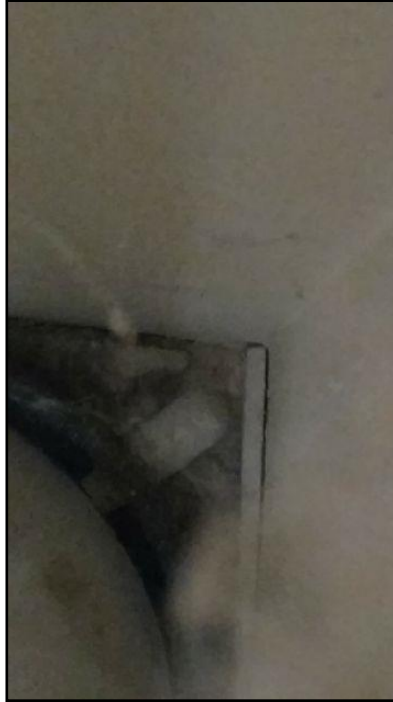
**Condition:** • Drainline to exterior from water heater safety pan was missing  
The drain line from the pan is emptying into the crawl space

50. Drainline to exterior from water heater...

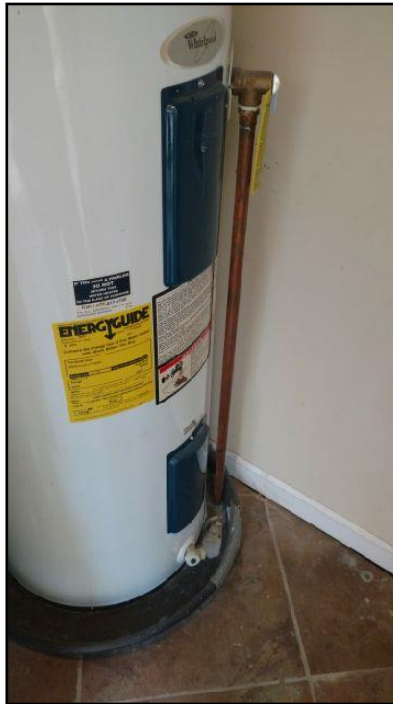
**Condition:** • TPR Drainline draining in to pan instead of out of home on it's own line.

51. TPR Drainline draining in to pan instead of...

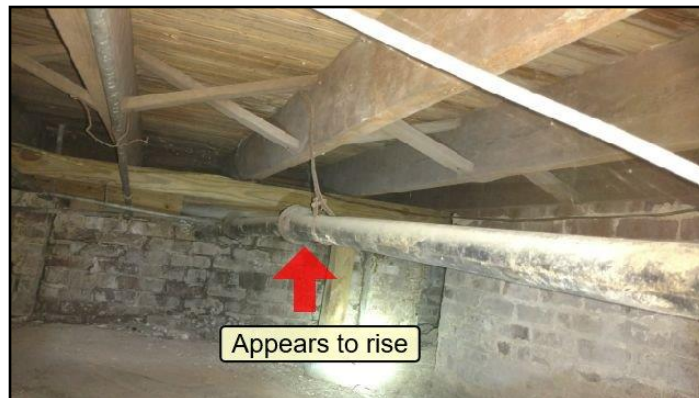
**Condition:** • Fall on drain line is not sufficient

52. Fall on drain line is not sufficient

**Task:** Improve

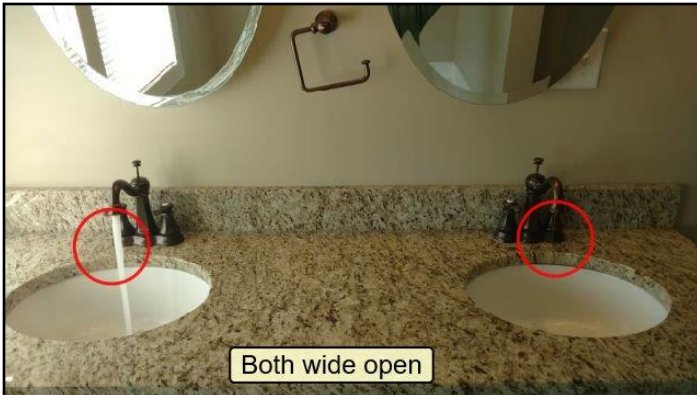
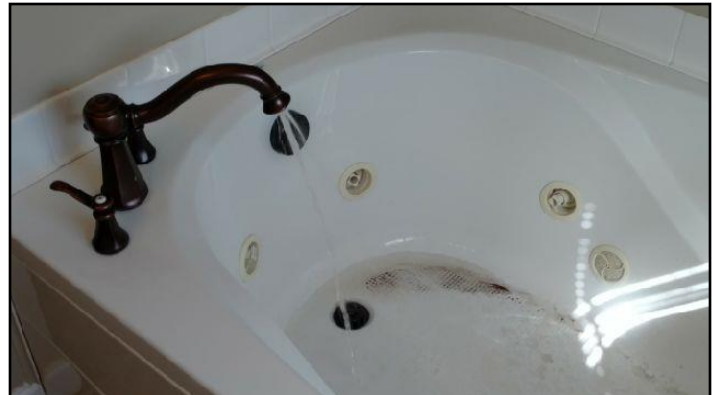
**Condition:** • Flow lower than balance of home

53. Flow lower than balance of home

54. Flow lower than balance of home

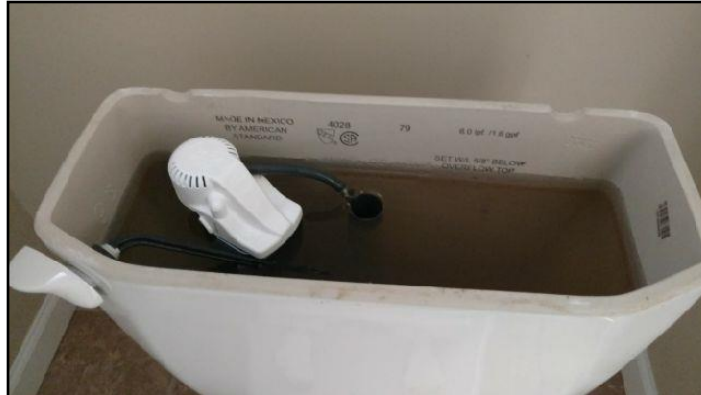
Condition: • [Running continuously](#)

**Implication(s):** Chance of condensation damage to finishes and/or structure | Increased water consumption

55. Running continuously

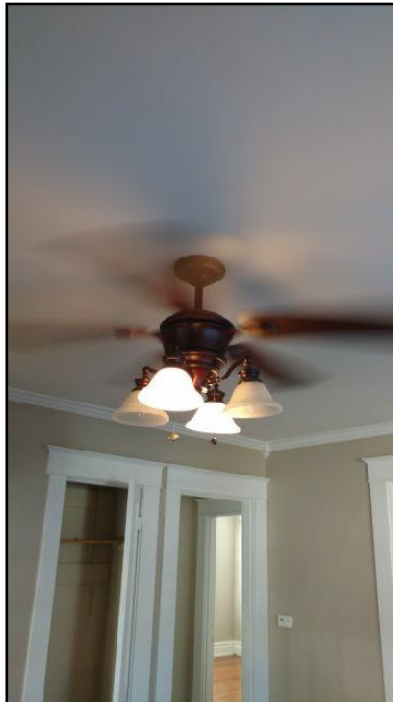
**Condition:** • Noisy

**Implication(s):** Noise nuisance

56. Noisy

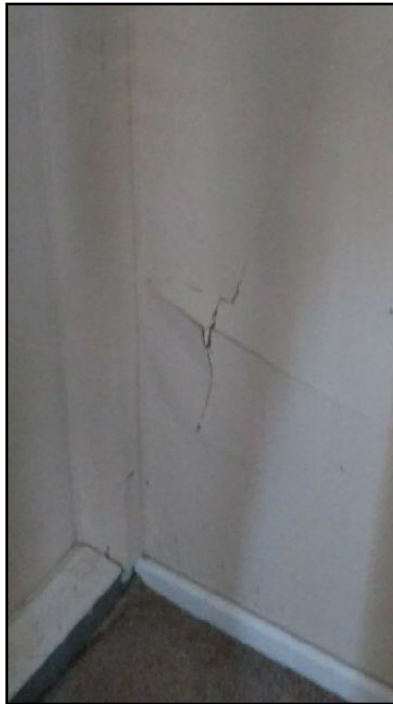
**Condition:** • Damaged

**Implication(s):** Damage or physical injury due to falling materials

57. *Damaged*

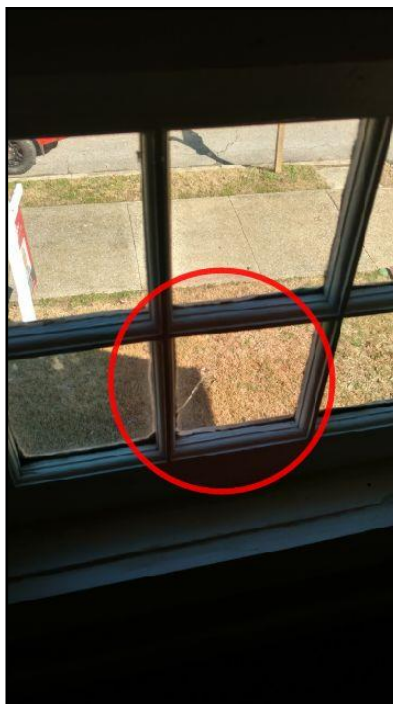
Condition: • [Cracked](#)

Implication(s): Physical injury

58. *Cracked*

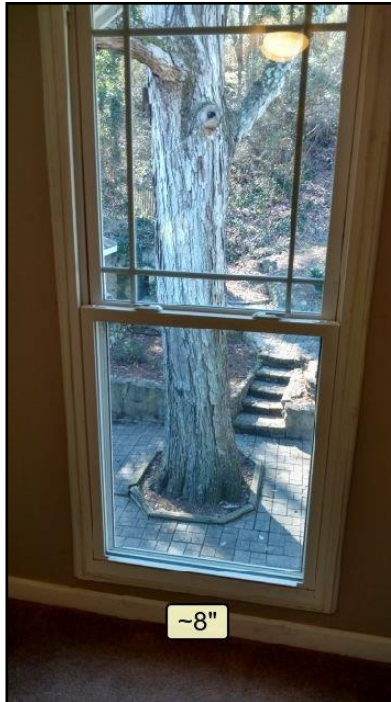
## Condition: • Safety glass not installed

When a window is less than 16 inches from the ground it is normally required that this glass be tempered. The window in the bonus area upstairs is approximately 8 inches from the floor. I recommend checking with the building inspector to see if this is okay according to the code as they enforce or having this bottom sash changed to a tempered glass for safety sake. It does appear with the amount of remodeling that has been done on this structure a building permit would have been required and the areas that were affected would be subject to current code AS of the date that permit was pulled

59. Safety glass not installed

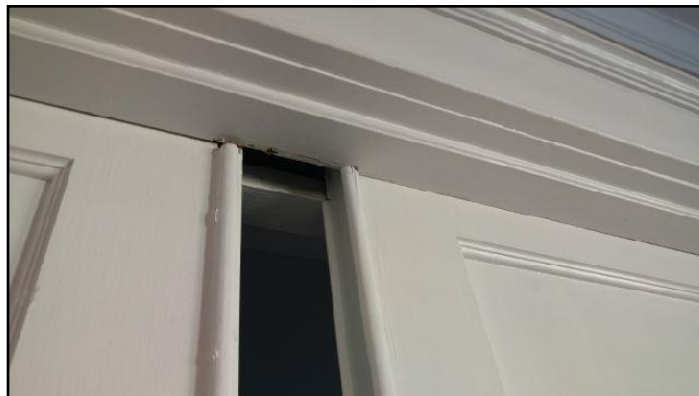
60.

**Condition:** • The right hand pocket door between the living room and dining room was hard to open and close. I recommend it be adjusted

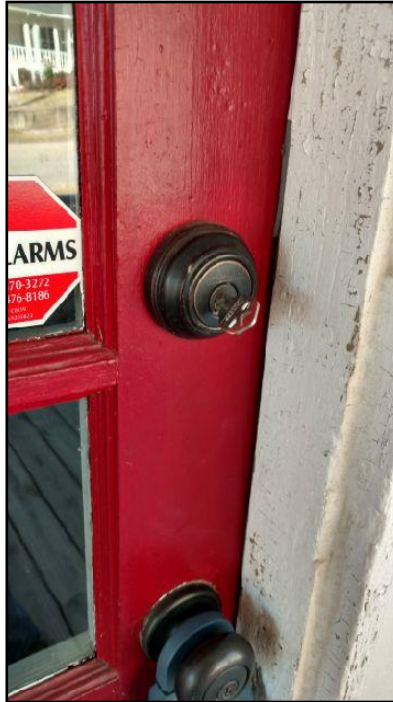
**Condition:** • Stiff operation

While this inspector could get the deadbolt to latch from the inside using the thumb turn while applying pressure to the door she could not get the deadbolt to latch using the key from the outside. I recommend this be adjusted

62. Stiff operation

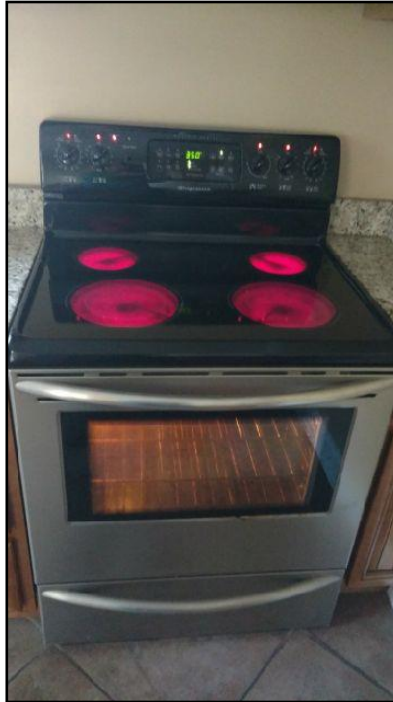
**Condition:** • Missing Anti-tip bracket on range - The anti-tip bracket is provided by the manufacturer to prevent the unit from being pulled over in certain conditions, such as a child using the oven door for a step. This is a severe injury/life-safety issue. This bracket is in the owner's manual packet when a range is purchased. If it is not available, you can contact the manufacturer, provide the model number of the appliance that can normally be found on a label in the pan drawer, and they will normally provide one for you. They can also be purchased after-market on line or at some hardware stores.

67. Missing Anti-tip bracket on range - The...

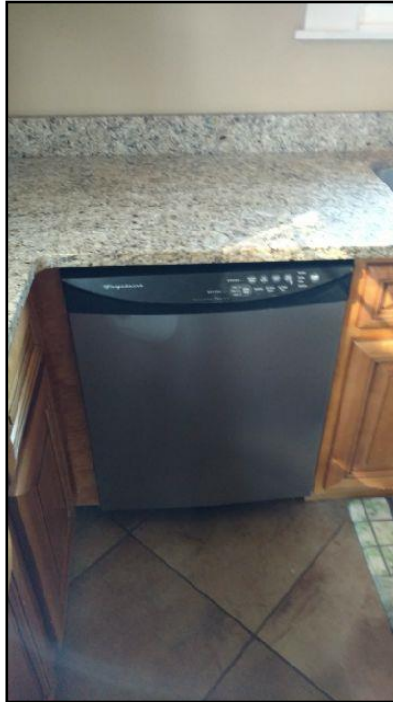
**Condition:** • Inoperative

**68.** *Inoperative*

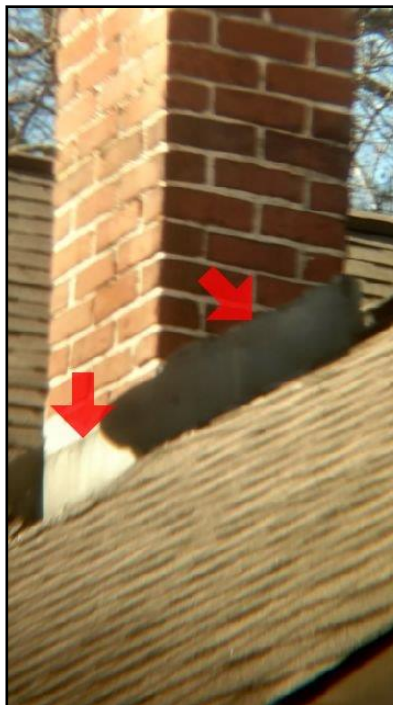
### **6. Condition:** • [Not let into mortar joints](#)

**Implication(s):** Chance of water damage to contents, finishes and/or structure

71. Not let into mortar joints

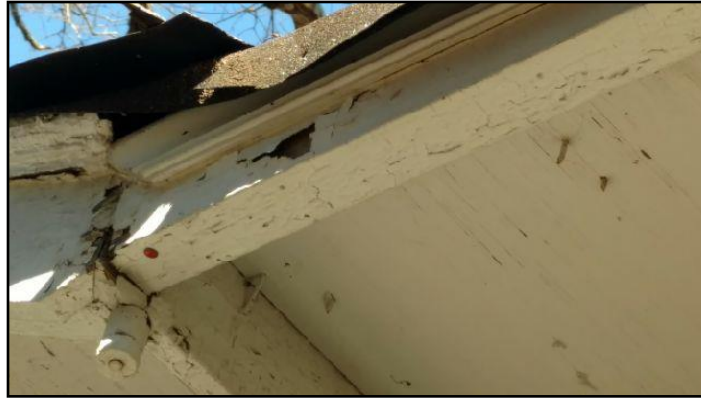
**10. Condition:** • Water Damaged

73. Water Damaged

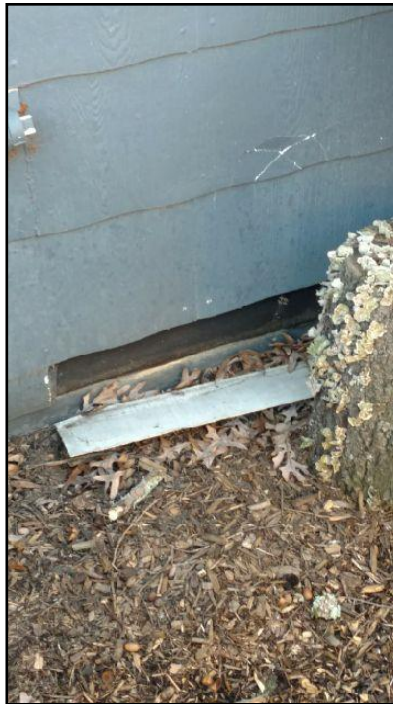
11. Condition: • [Mechanical damage](#)

Implication(s): Chance of water damage to contents, finishes and/or structure

74. Mechanical damage

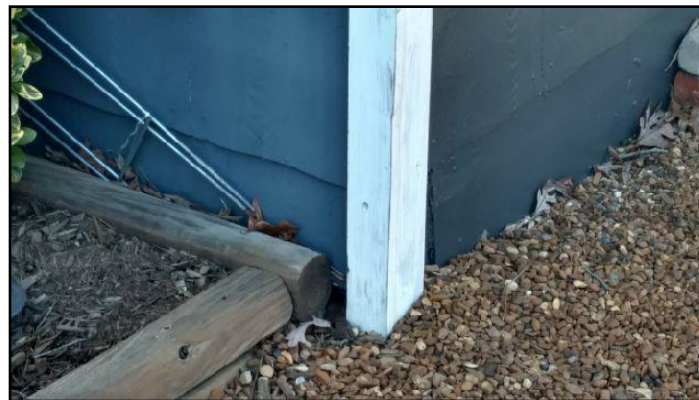
12. Condition: • [Too close to grade](#)

Implication(s): Chance of water damage to contents, finishes and/or structure | Rot

75. Too close to grade

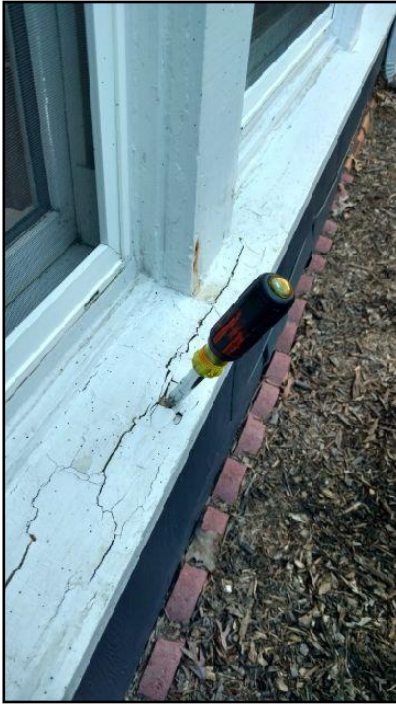
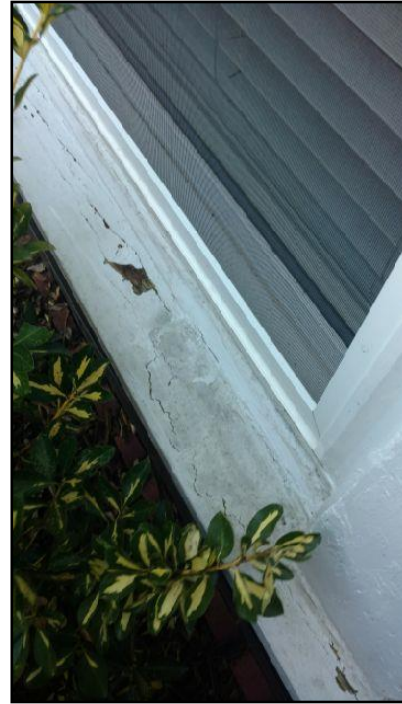
13. Condition: • [Rot](#)

Implication(s): Chance of water damage to contents, finishes and/or structure | Material deterioration

76. Rot

77. Rot

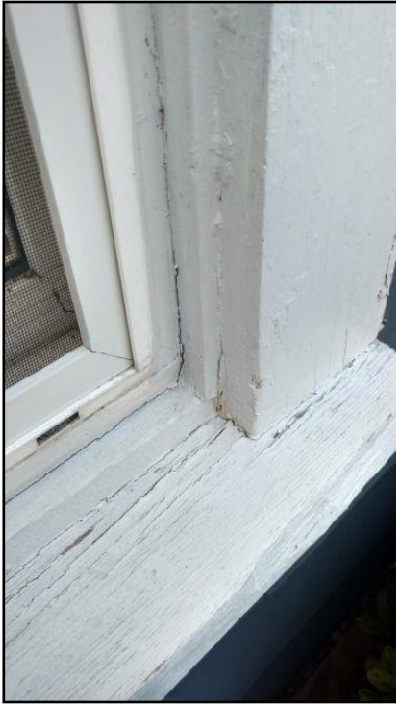
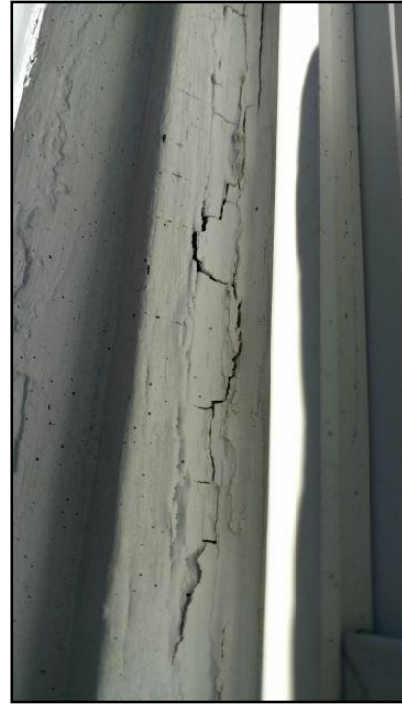
## 14. Condition: • [Paint or stain needed](#)

There is what appears to be some lead-based paint that is not secure that needs to be scraped and/or painted over. Any loose paint should be scraped loose. Anything that is well attached can be painted over and sealed and become a non issue.

78. Paint or stain needed

79. Paint or stain needed

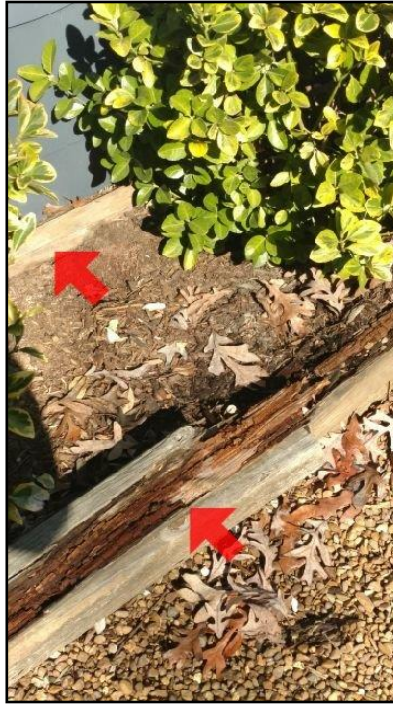
83. Wood touching foundation

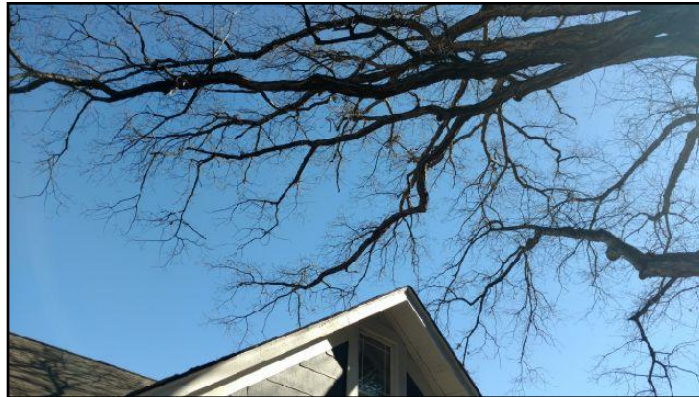
19. **Condition:** • Trees overhanging roof can speed roofing deterioration and fill gutters.

84. Trees overhanging roof can speed roofing...

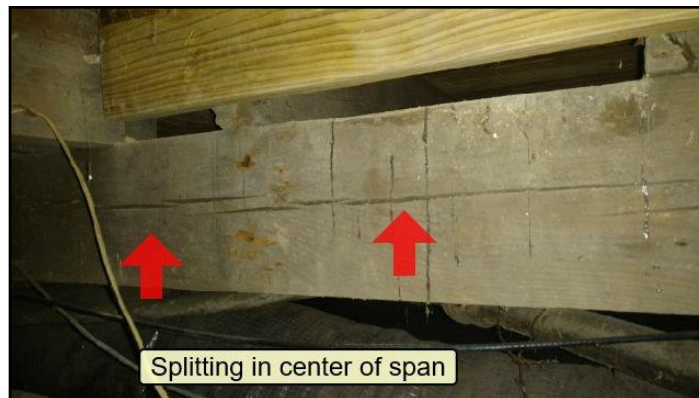
**Implication(s):** Weakened structure | Chance of structural movement

89. Rotated or twisted beams

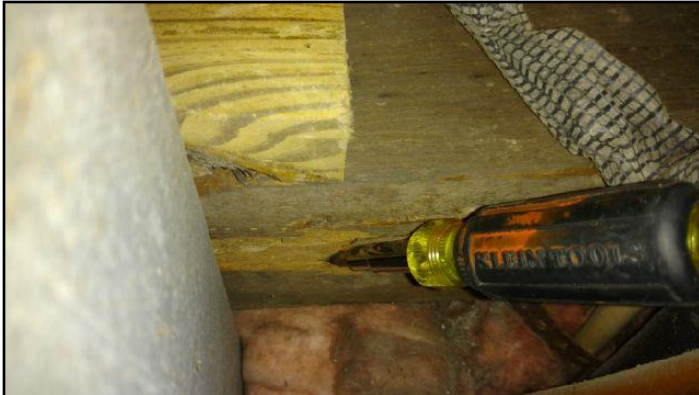
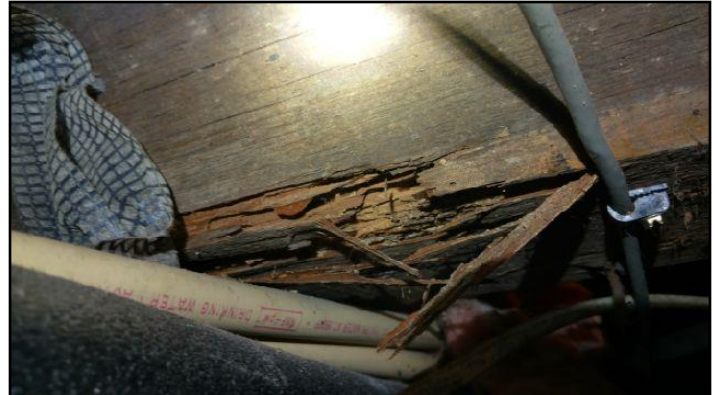
### 27. Condition: • [Prior repairs](#)

90. Prior repairs

91. Prior repairs

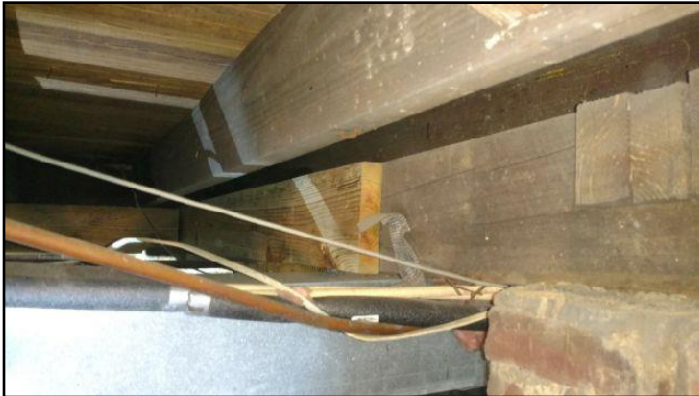
92. Prior repairs

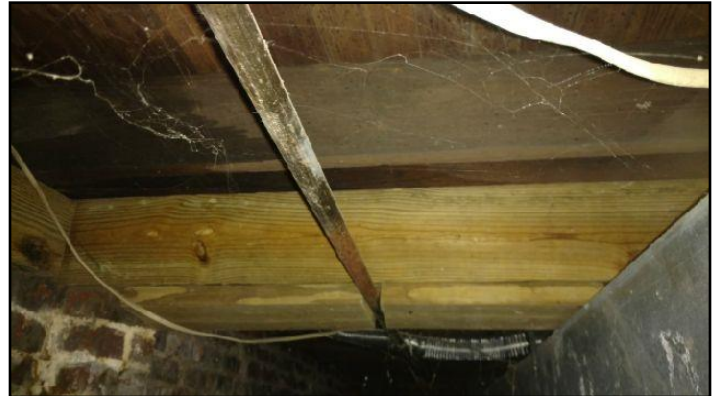
93. Prior repairs

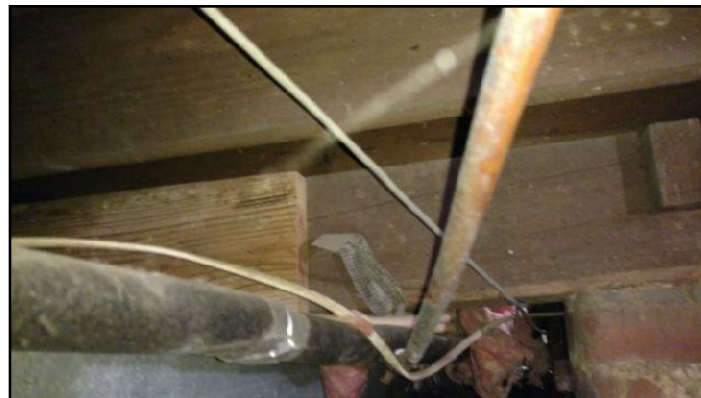
94. Prior repairs

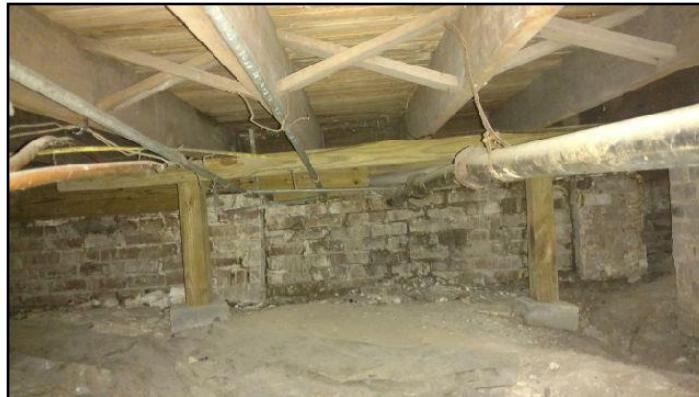
95. Prior repairs

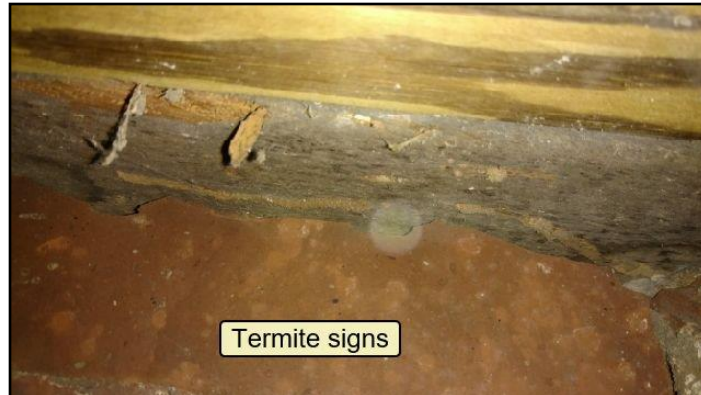
30. Condition: • [Insect damage](#)

Implication(s): Weakened structure

97. Insect damage

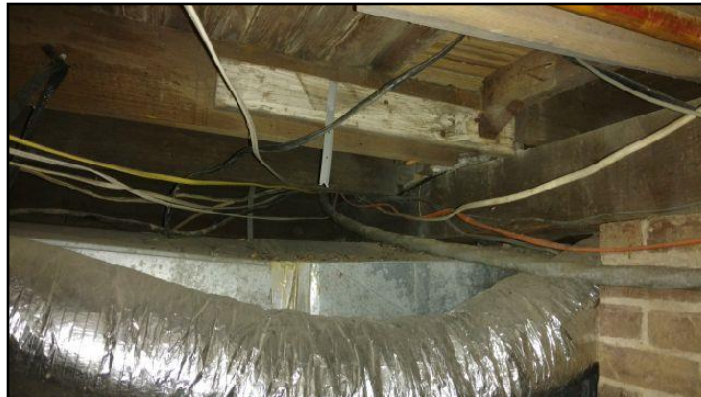
**36. Condition:** • [Not well secured](#)

**Implication(s):** Electric shock | Fire hazard

109. Not well secured

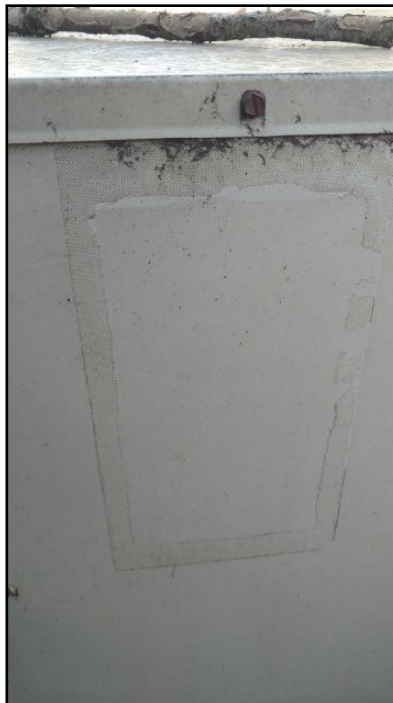
*Note:* It appears that the data plate has been removed. I recommend having the units serviced to gain information as to its age and capacity as well as operation.

113. Unknown

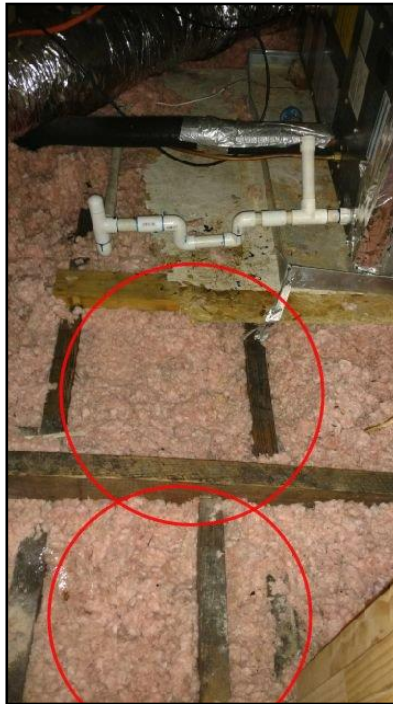
**40.** • Equipment placed in the attic over finished space is required to have a walk path to the unit where it can be accessed without the possibility of a technician stepping through the ceiling of damaging duct \* over it. This unit is placed where this is not possible. I recommend a path be installed and secured to protect ceilings/ducting.

*115. Equipment placed in the attic over finished...*

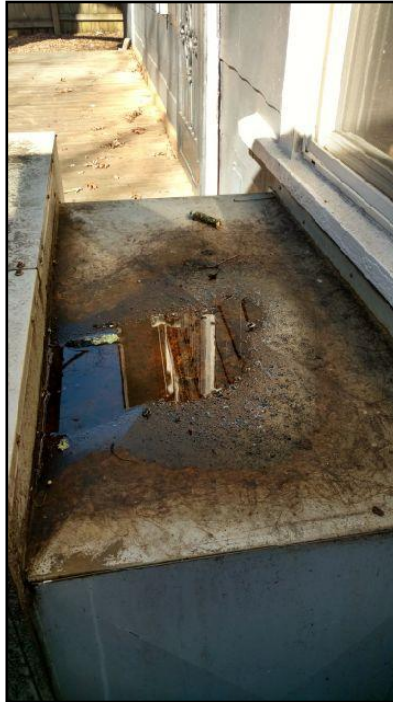
44. Condition: • Cowling is sagging and retaining water and debris.

120. Cowling is sagging and retaining water and...

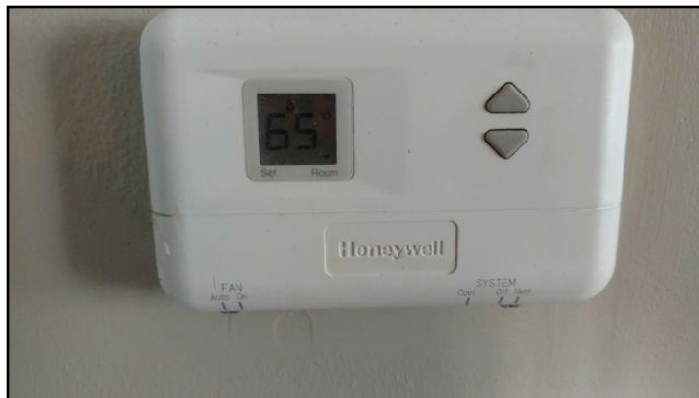
122.

**46. Condition:** • This inspector could not get the first floor thermostat to change temperature and was unable to test the downstairs unit. I highly recommend that a HVAC professional be consulted during the inspection period To evaluate this equipment. This inspector also placed the thermostat fan in the on position rather than the auto position and could not get the unit fan to come on.

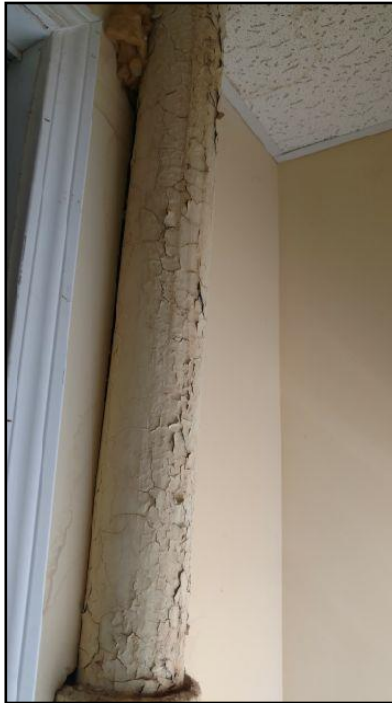
Cast iron piping is still in the venting system for the waste Plumbing. It is unknown if cast iron still has water running through it. Refer to other

124. Cast Iron

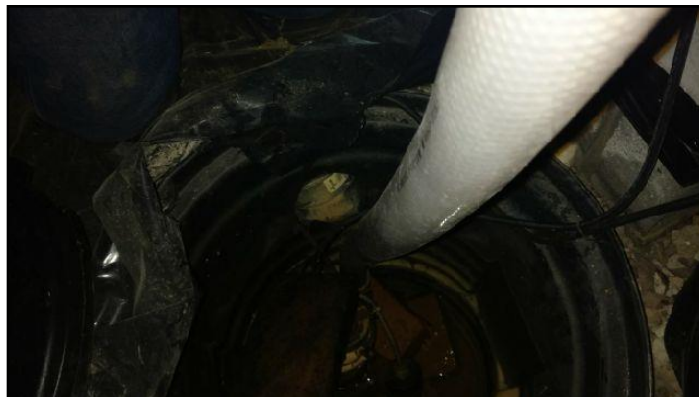
The sump pump was operating as expected during inspection

125. Sump pump

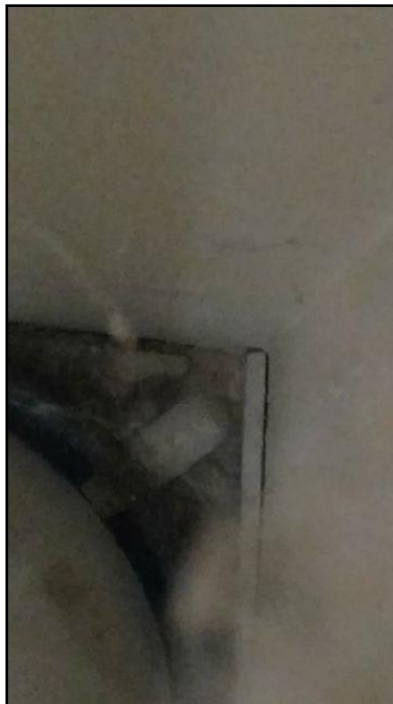
### **55. Condition:** • Drainline to exterior from water heater safety pan was missing

The drain line from the pan is emptying into the crawl space

**126.** Drainline to exterior from water heater...

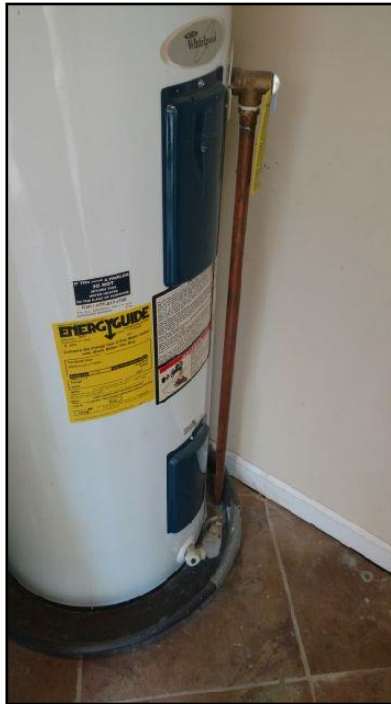
127. TPR Drainline draining in to pan instead of...

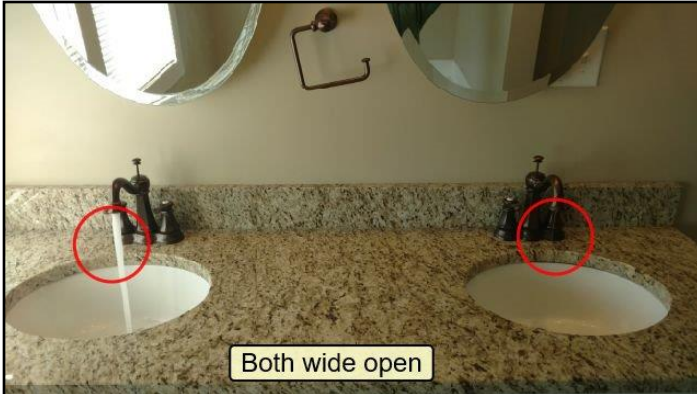
**59. Condition:** • Flow lower than balance of home

**129.** Flow lower than balance of home

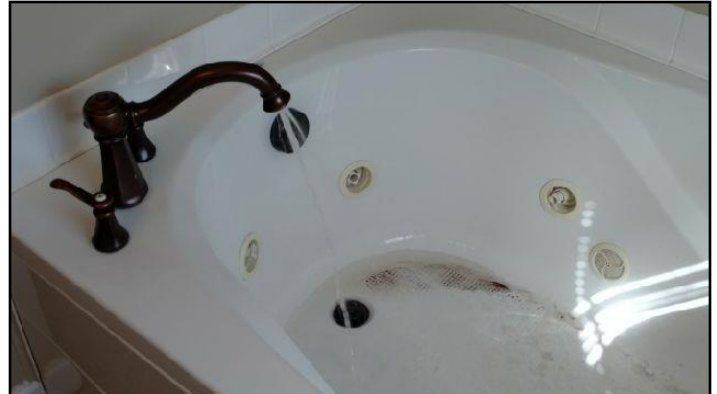
**130.** Flow lower than balance of home

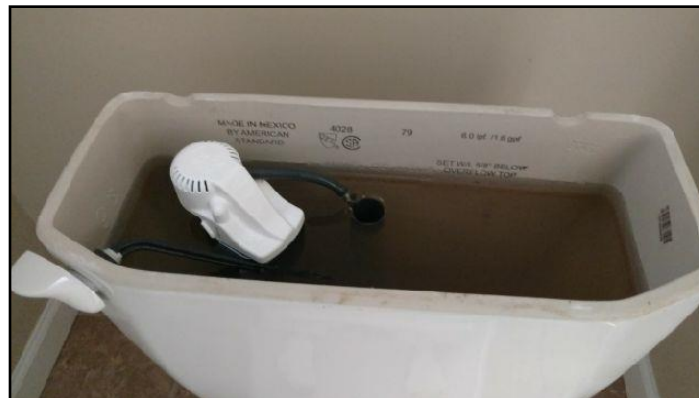
131. Running continuously

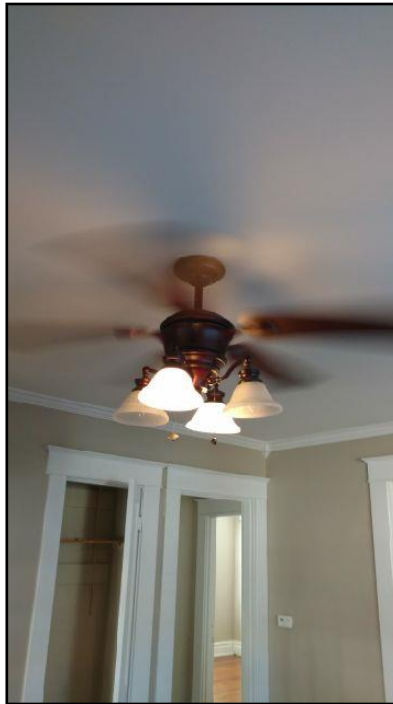
132. Noisy

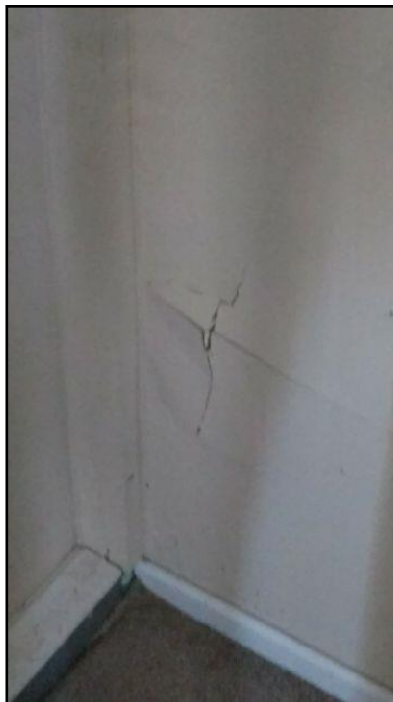
Implication(s): Damage or physical injury due to falling materials

133. Damaged

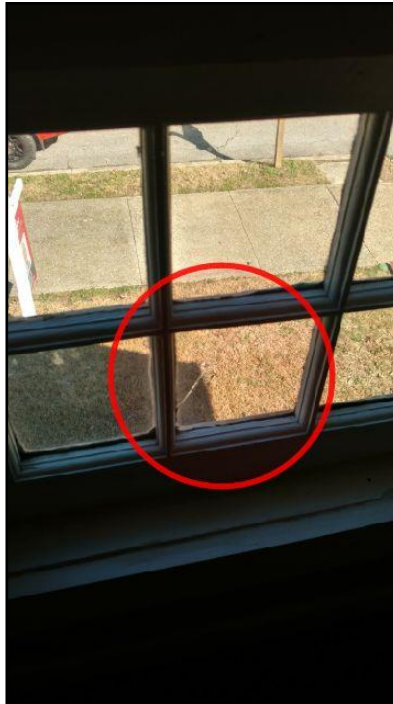
**Implication(s):** Physical injury

**134.** *Cracked*

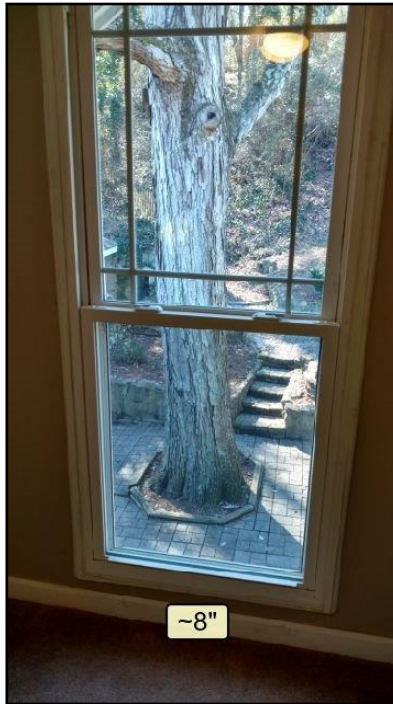
**66. Condition:** • Safety glass not installed

135. Safety glass not installed

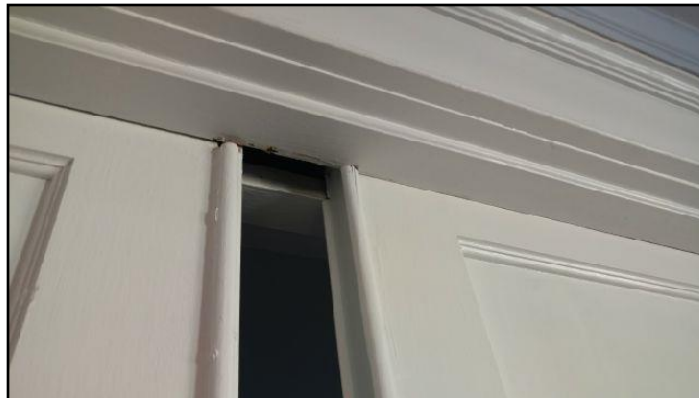
136.

**67. Condition:** • The right hand pocket door between the living room and dining room was hard to open and close. I recommend it be adjusted
