# INSPECTION REPORT

For the Property at:  
**123 ANY STREET**  
ANY TOWN, TN 12345

Prepared for: JOHN SMITH  
Inspection Date: Monday, February 19, 2018  
Prepared by: Melanie Moore

RE: Report No. 4176, v.5  
123 Any Street  
Any Town, TN  
12345

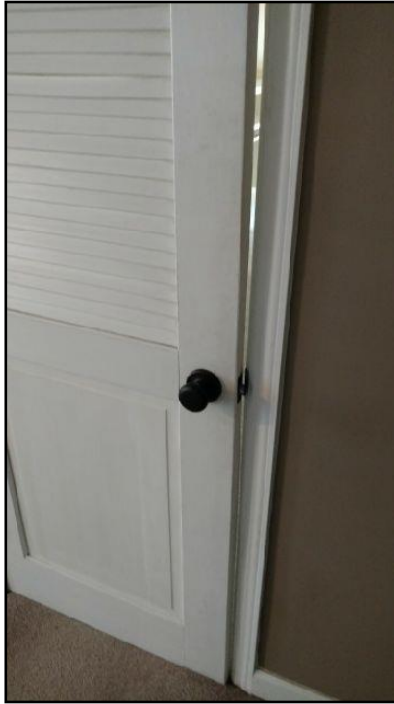
140. Ineffective

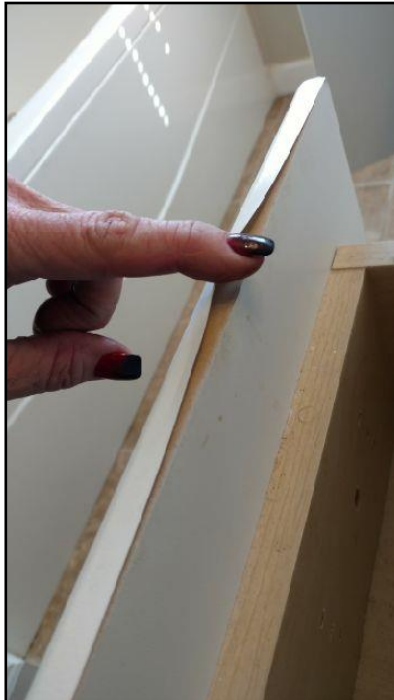
72. Condition: • Damage

141. Damage

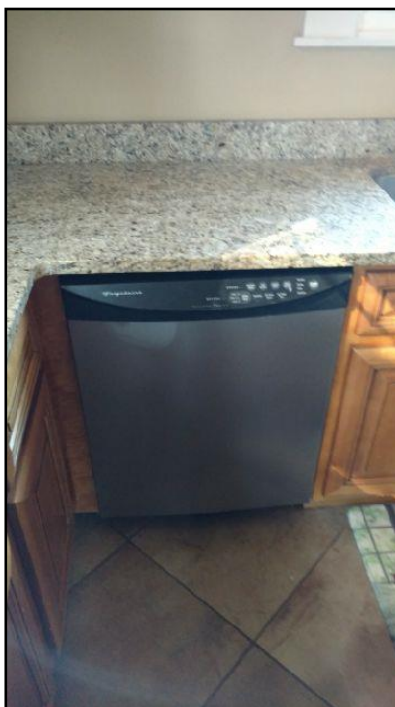
**144.** *Inoperative*
