Your Inspection Report

222 Sample Road, Suite B214
Tampa, FL 33619

INSPECTION DATE:
Friday, February 16, 2018

PREPARED BY:
Tom Frey

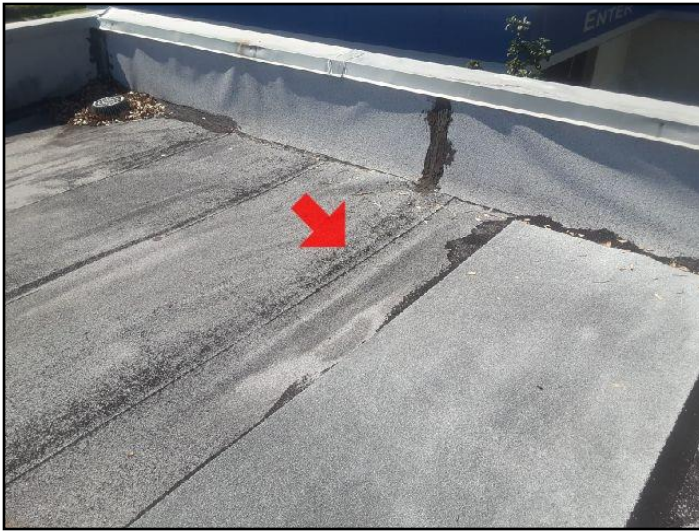
Condition: • Blistering

Blistering noted in numerous locations throughout the roof

12. Blistering

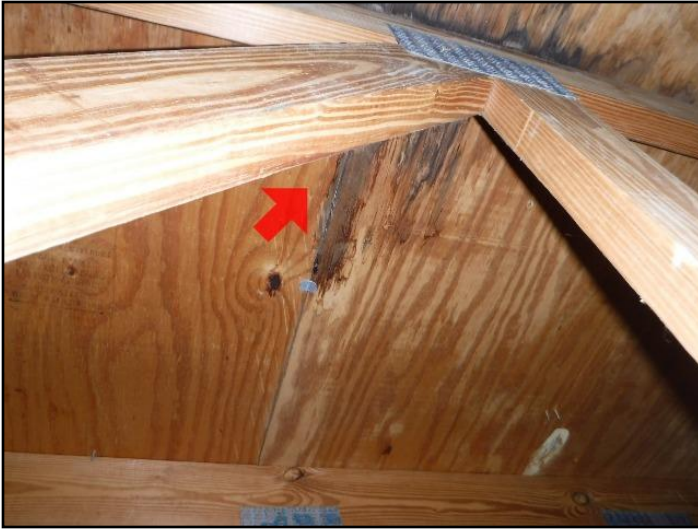
27.

Condition: • Water stains noted in several areas.

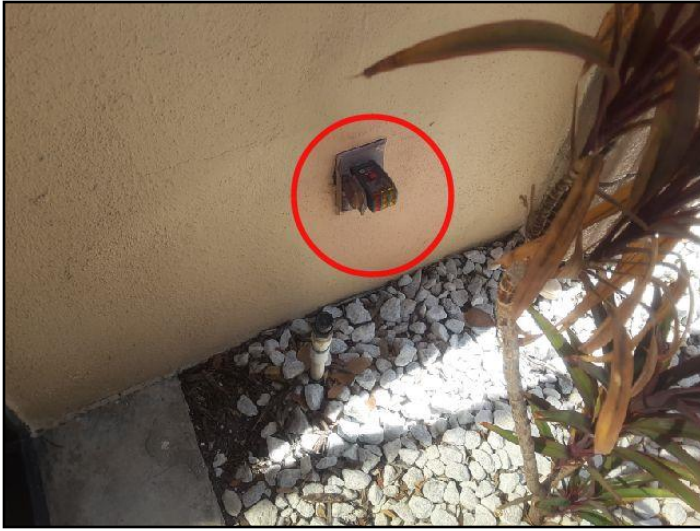
4. **Condition:** • Ungrounded three-prong receptacles
Several ungrounded exterior outlets noted

46. Ungrounded three-prong receptacles

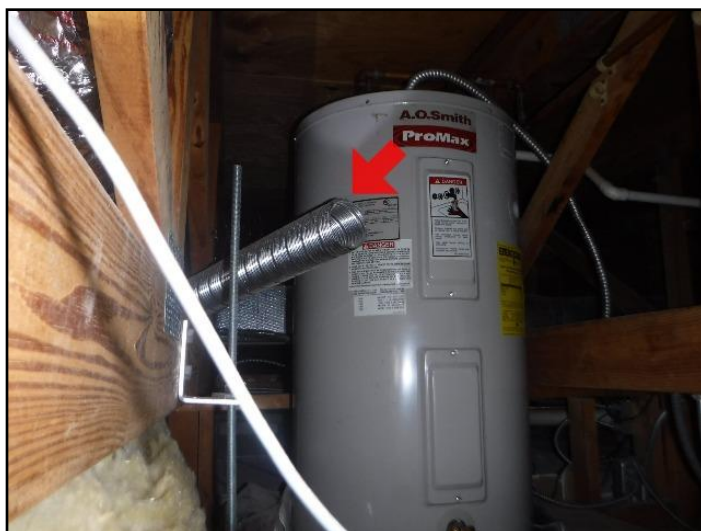
7. Condition: • Discharging into the attic / ceiling space

59. Discharging into the attic / ceiling space

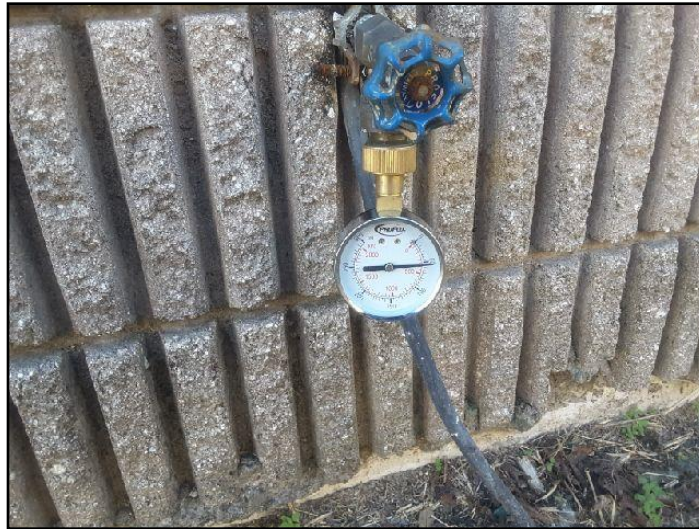
10. Condition: • No major deficiencies noted

69. No major deficiencies noted

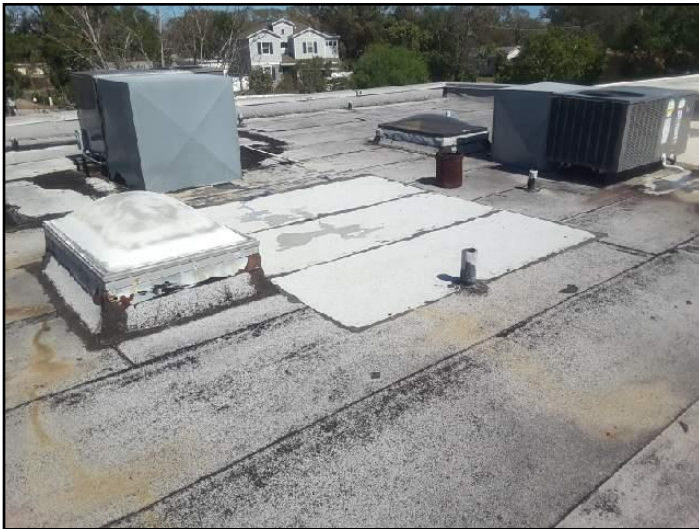
75. Building

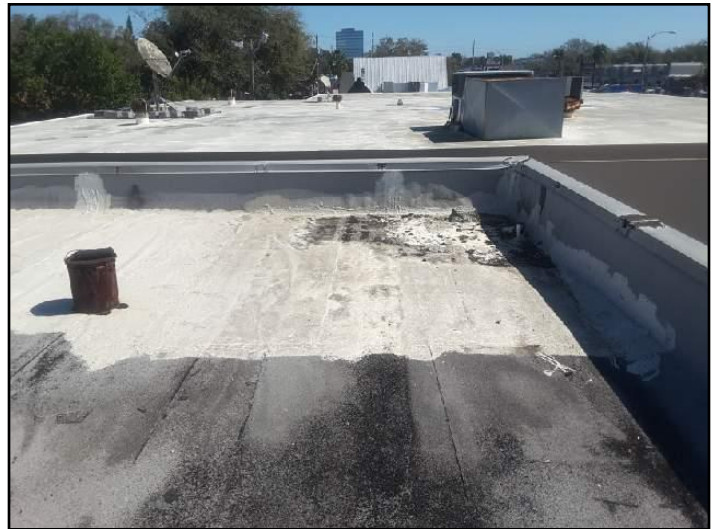
76. Building

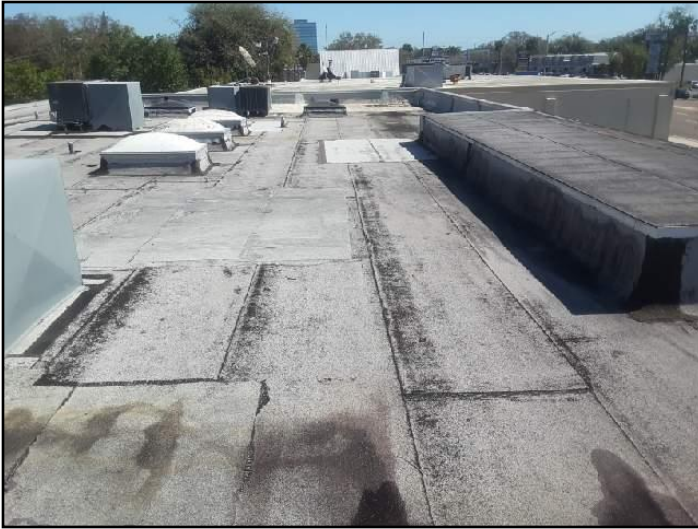
77. Building

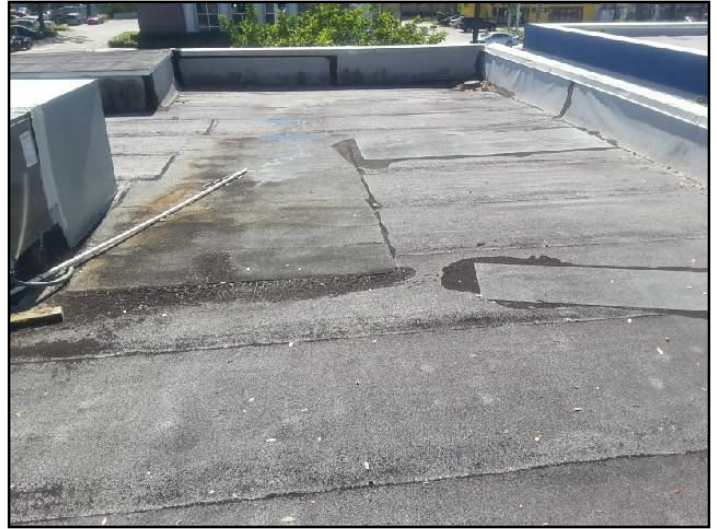
78. Building

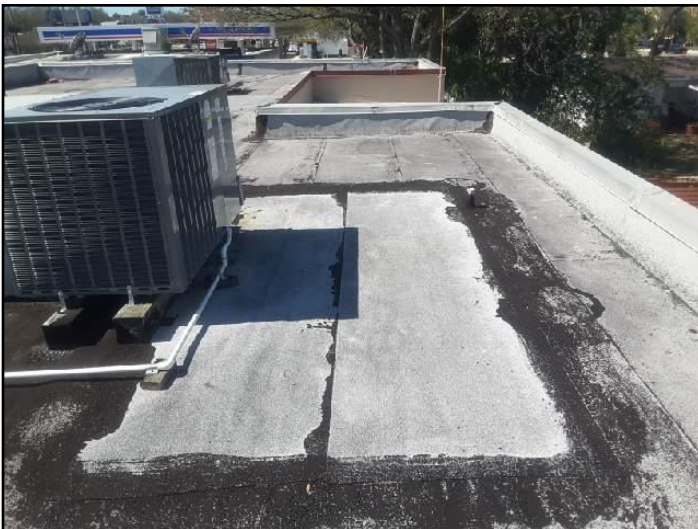
79. Building

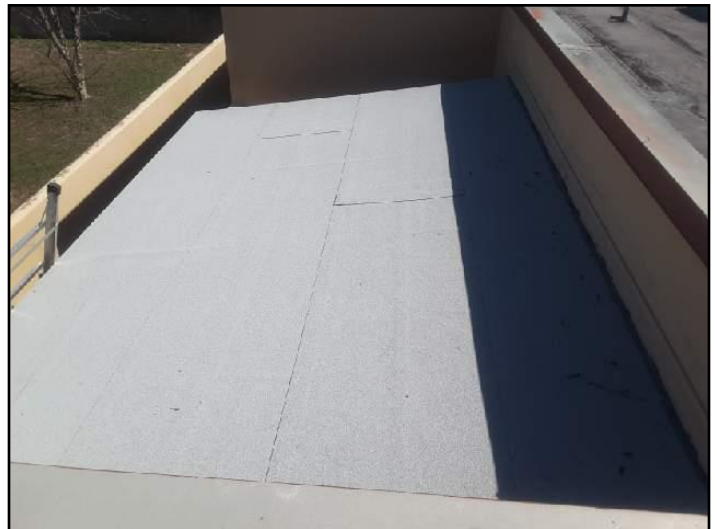
80. Building

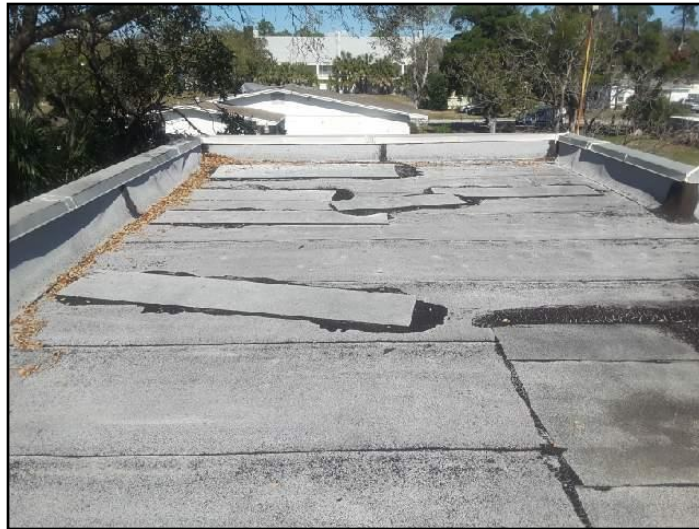
81. Building

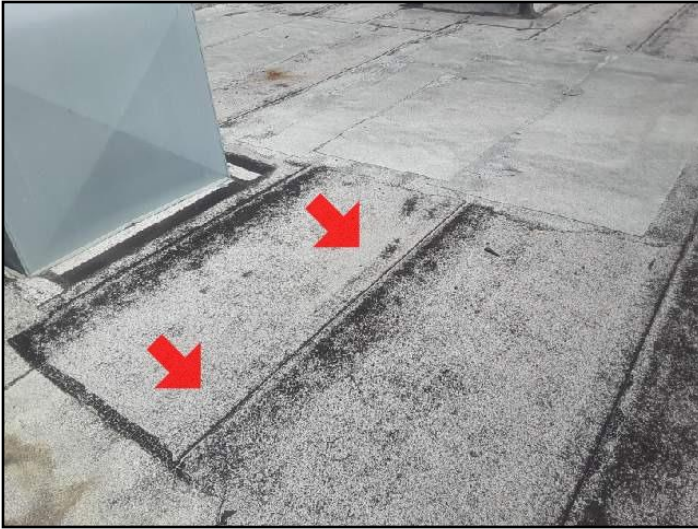
18. Condition: • Blistering

Blistering noted in numerous locations throughout the roof

82. Blistering

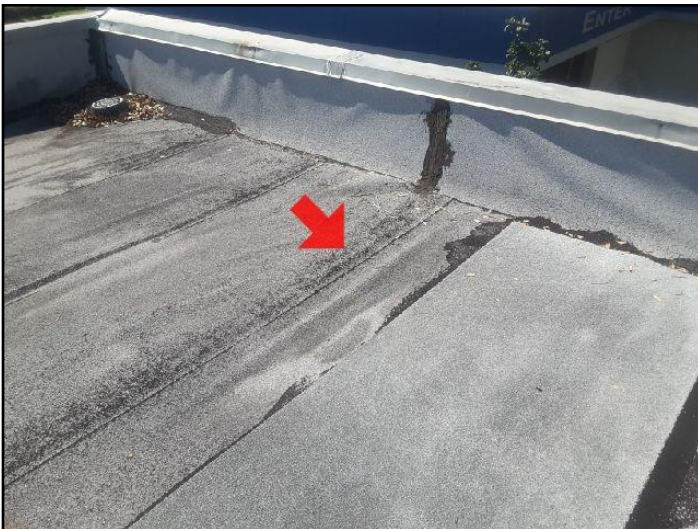
84. Blistering

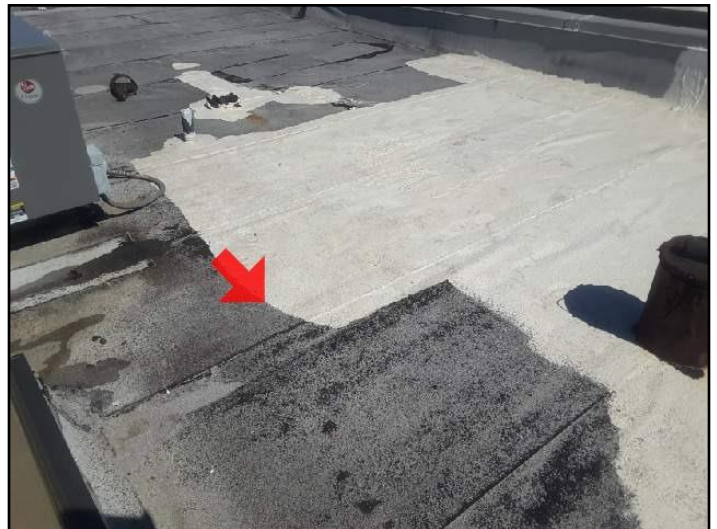
85. Blistering

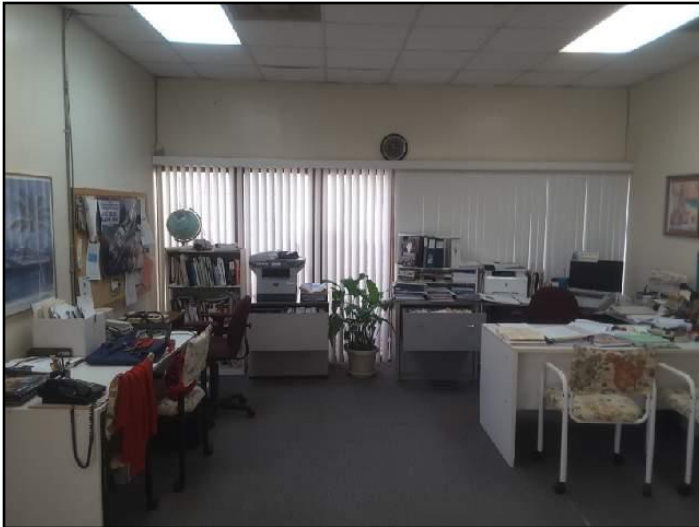
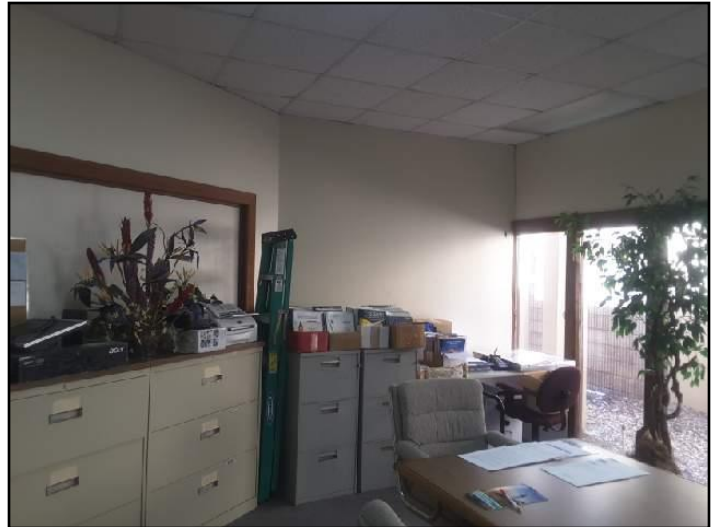
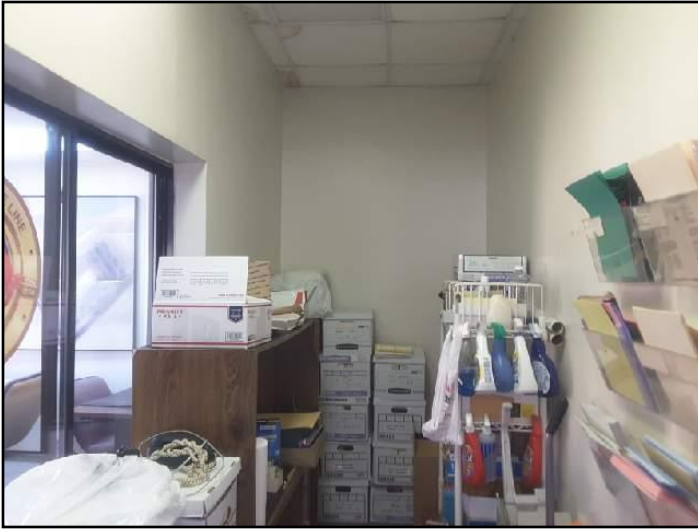
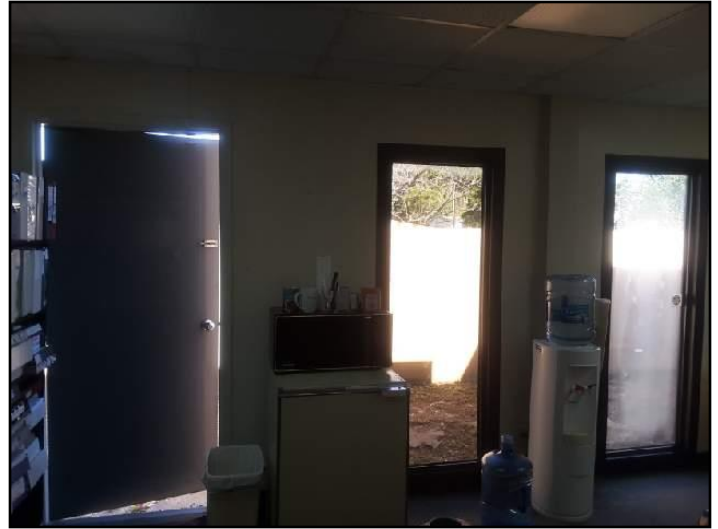
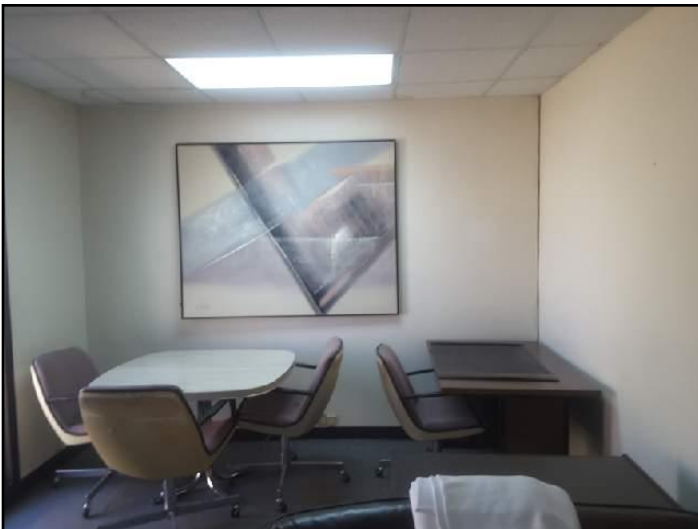
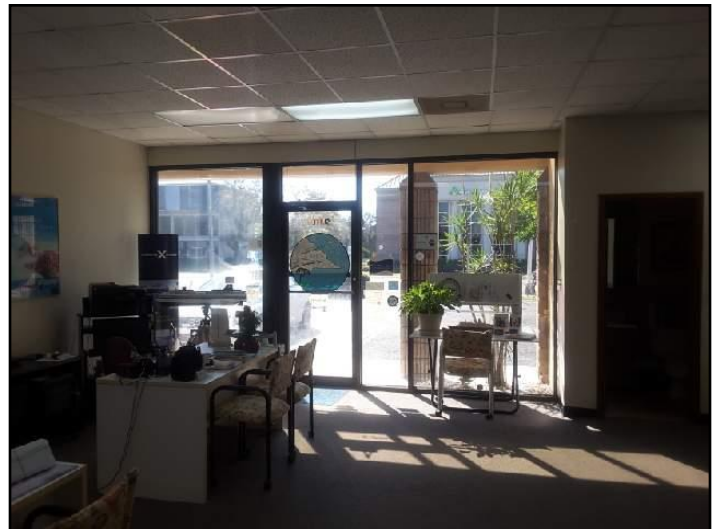
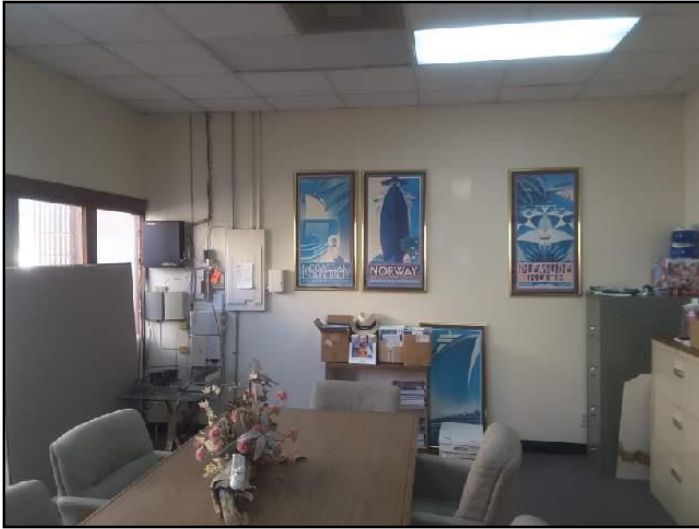
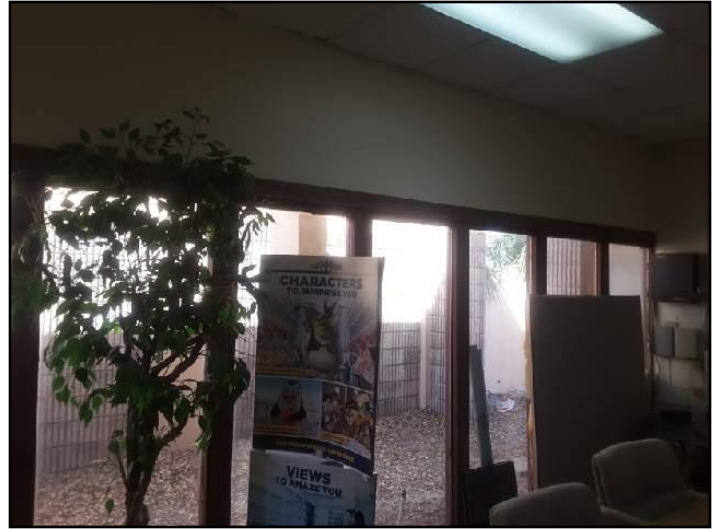
21. • General interior pictures unit #2

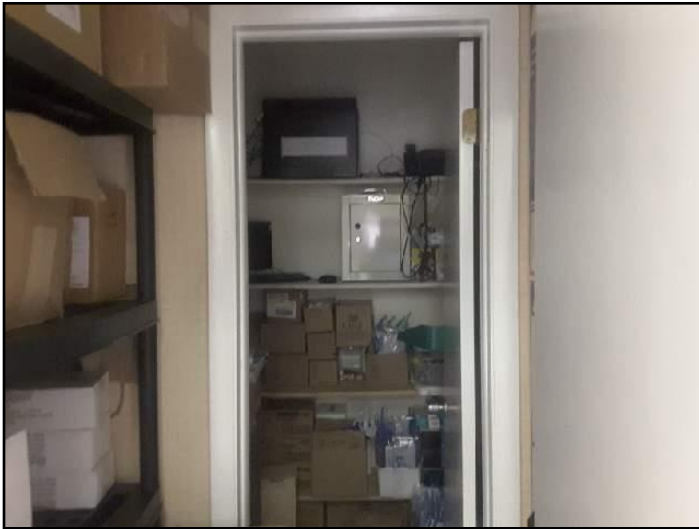
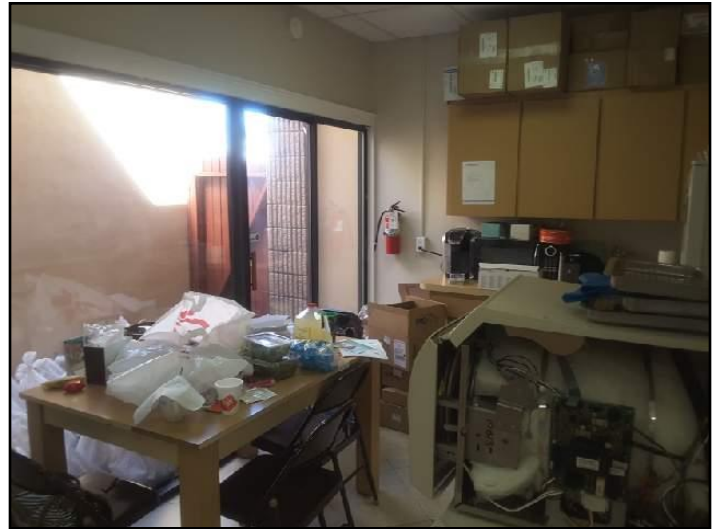
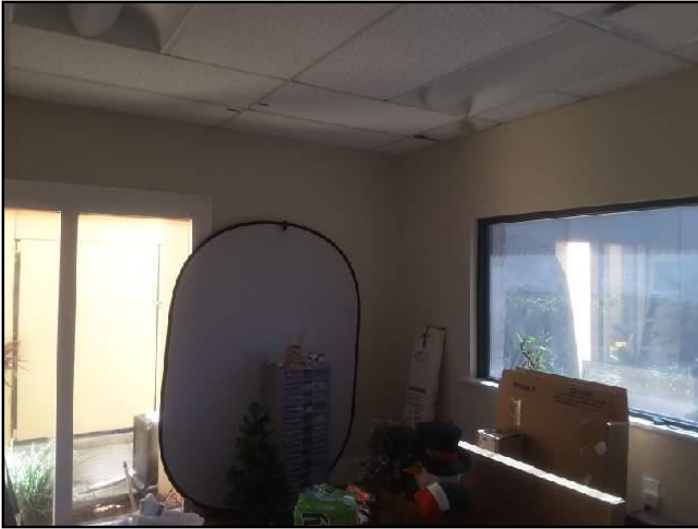
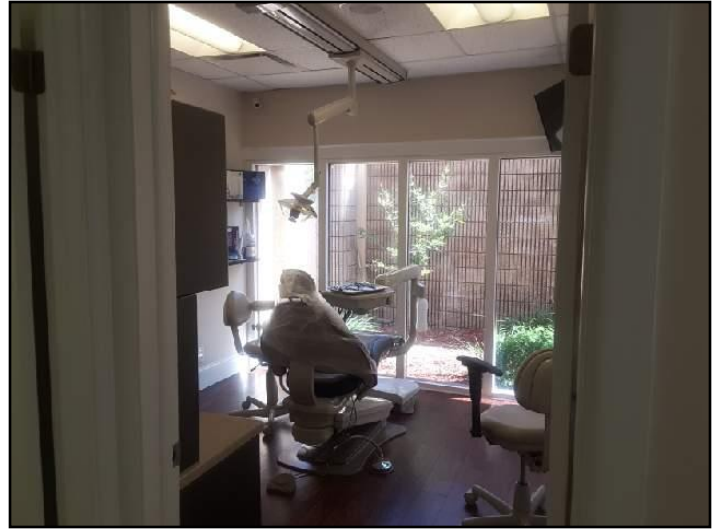
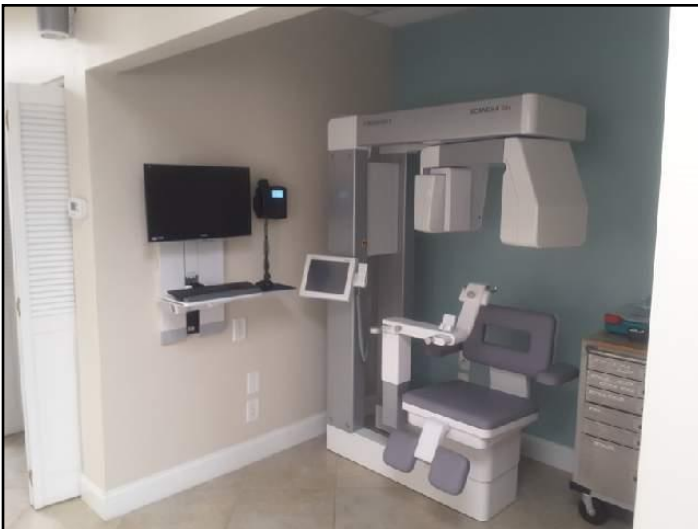
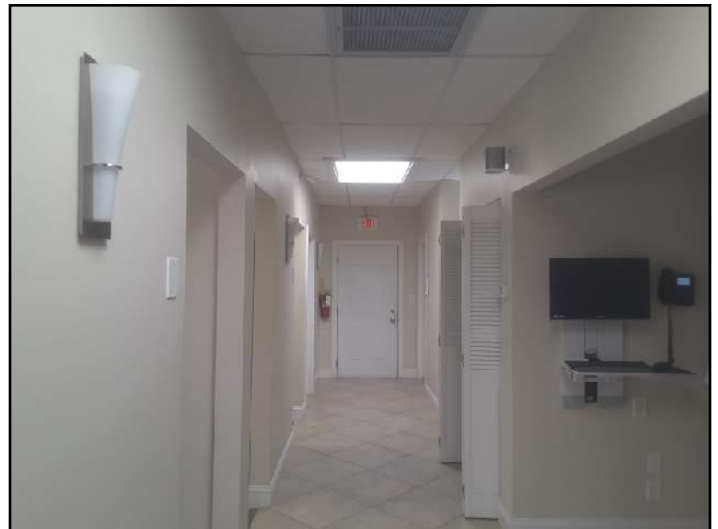
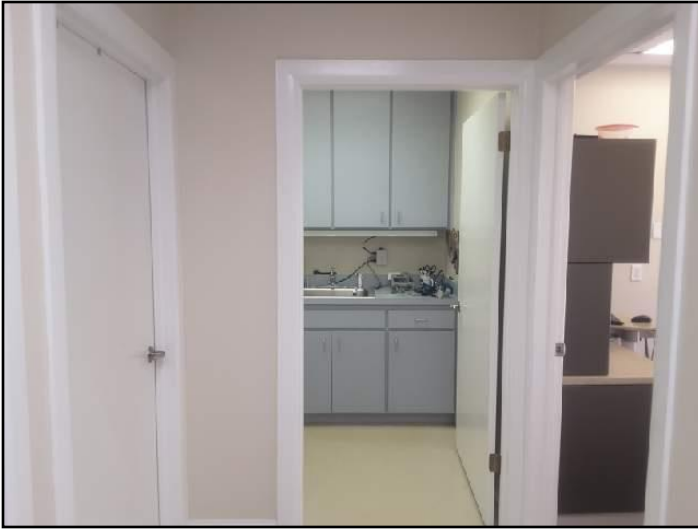
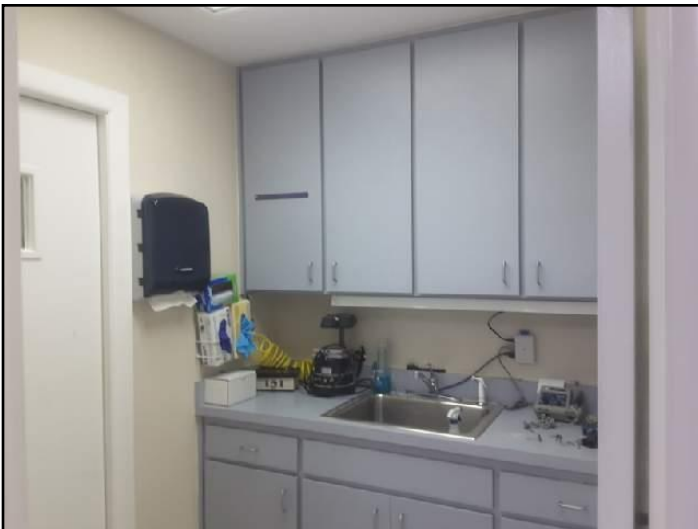
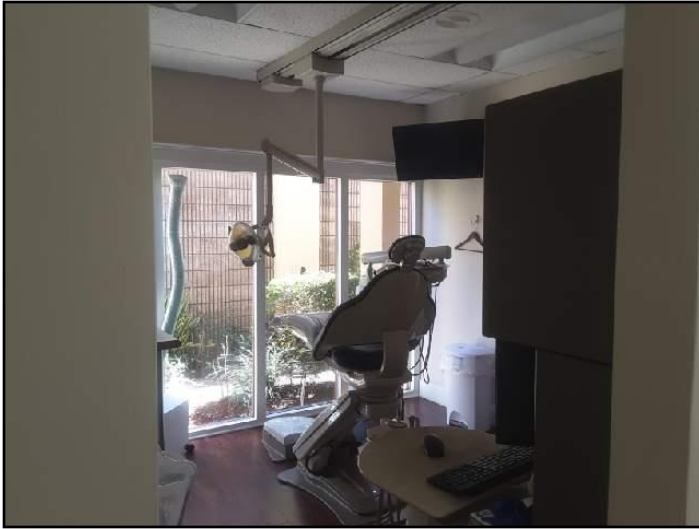
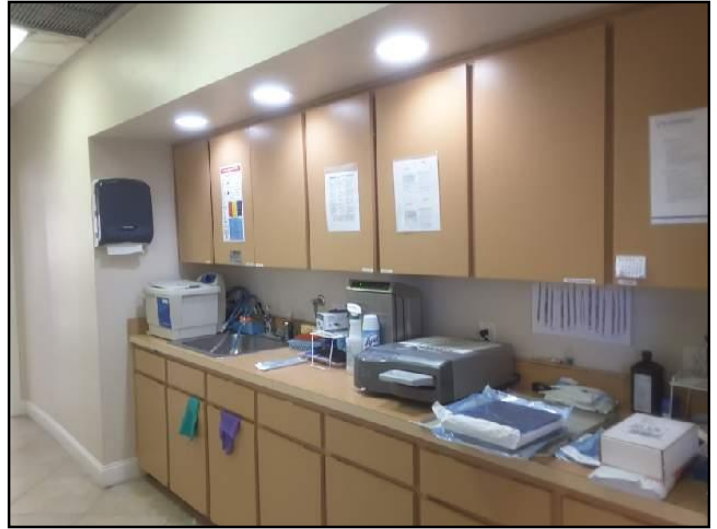
22. • General interior pictures unit #1

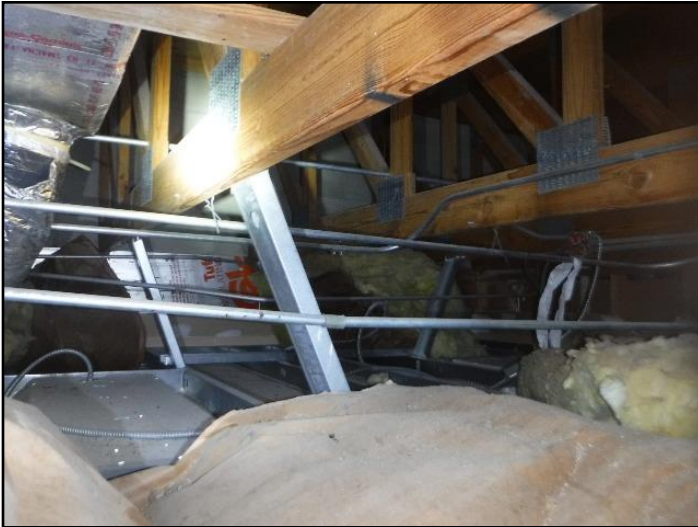
120. Fiberglass insulation

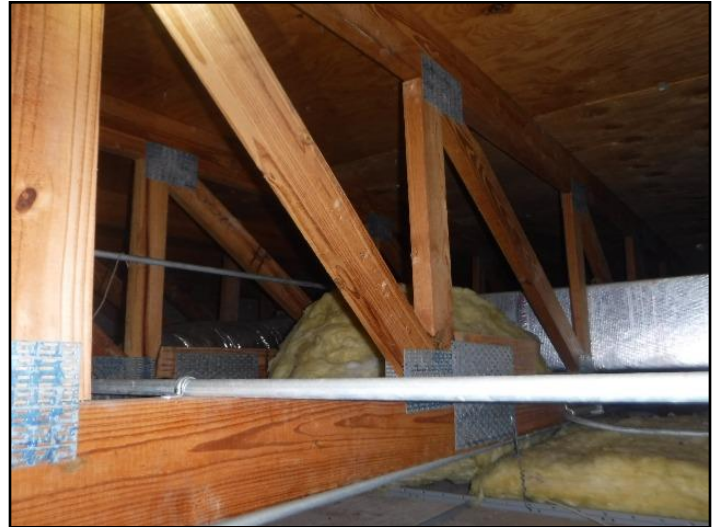
121. Fiberglass insulation

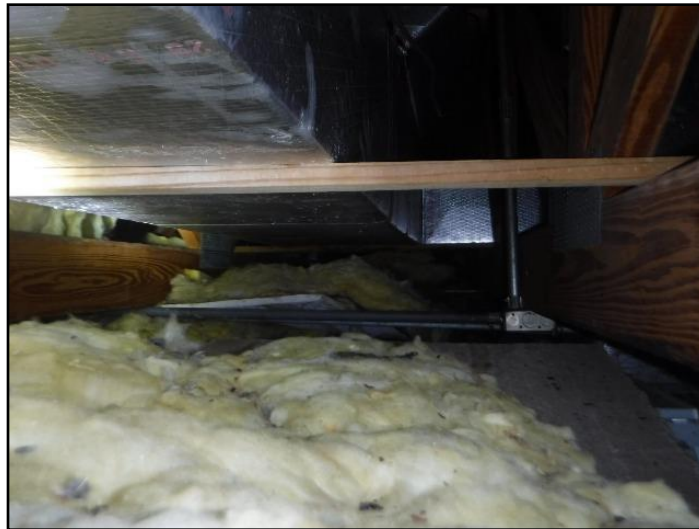
122. Fiberglass insulation

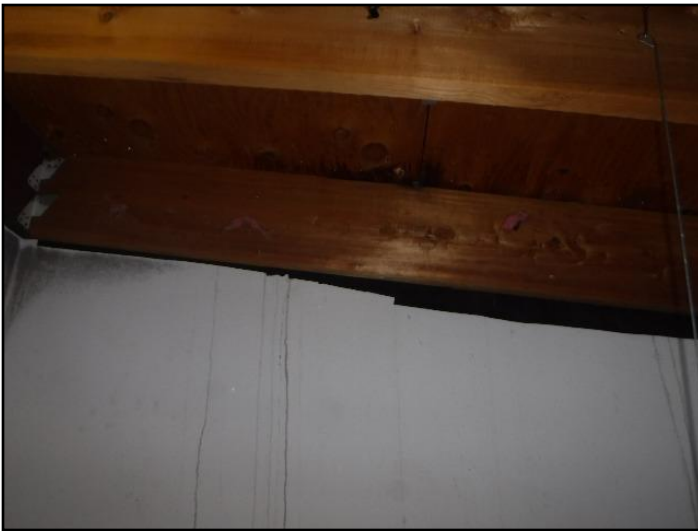
123. Wood deck

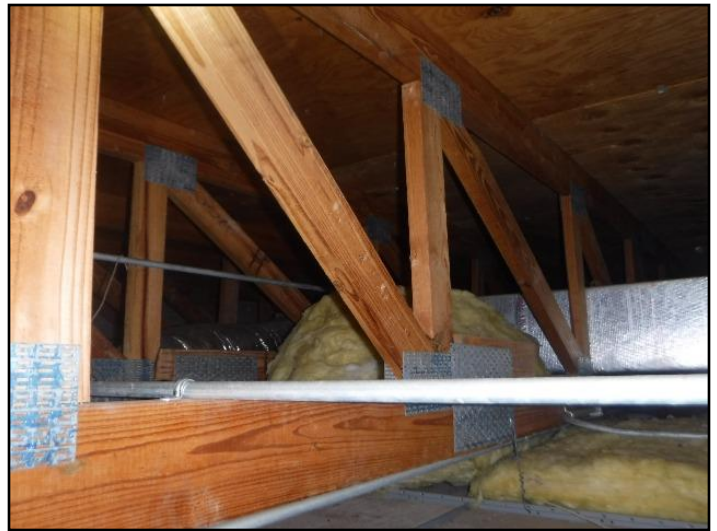
124. Wood deck

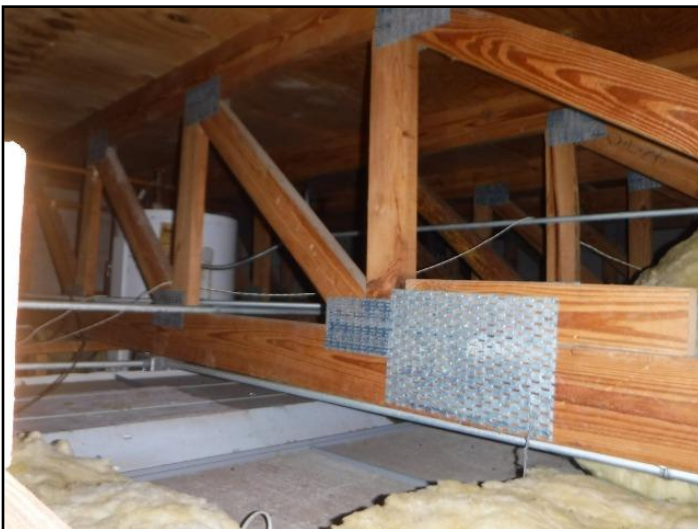
125. Supported by wood roof joists

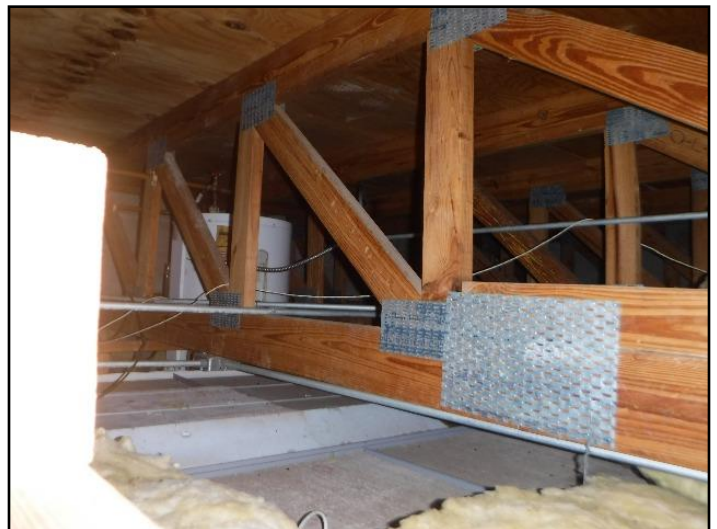
126. Supported by wood roof joists

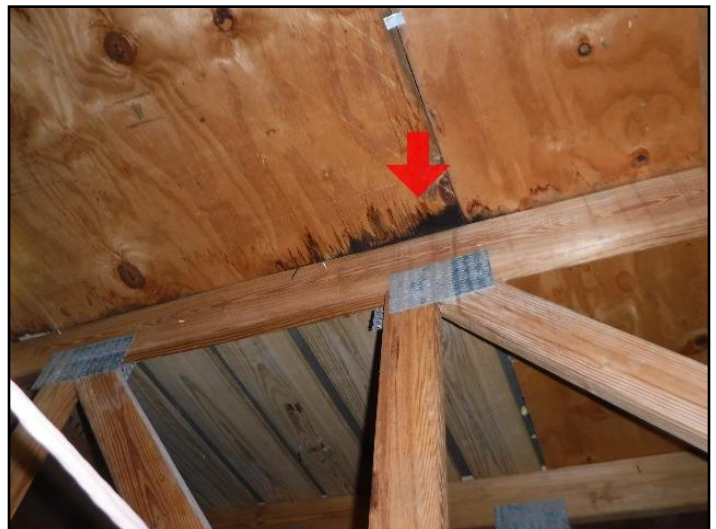
128.

34. Condition: • Water stains noted in several areas.

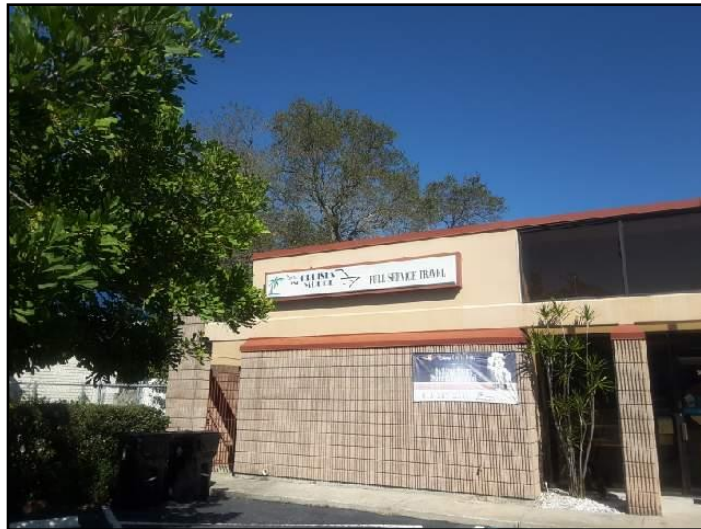
135. Lighted sign boxes on front façade

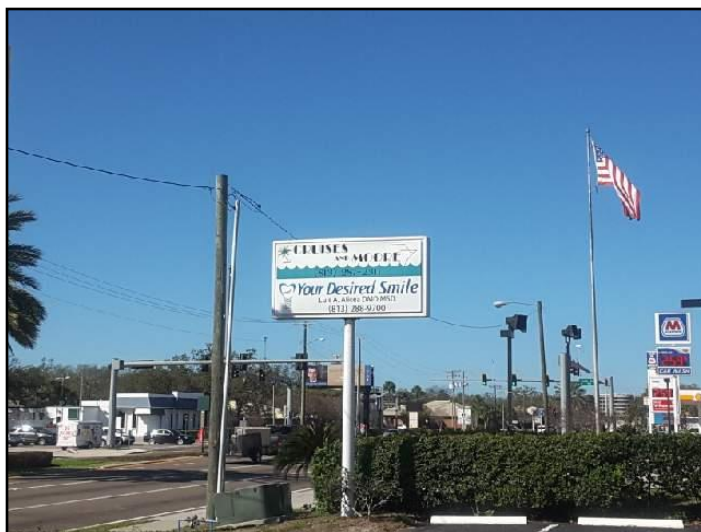
136. Pole-mounted marquee sign at front of...
