YOUR INSPECTION REPORT

Hou Dat Inspects
New Orleans, TX

Saturday, August 31, 2024

PROPERTY INSPECTION REPORT FORM

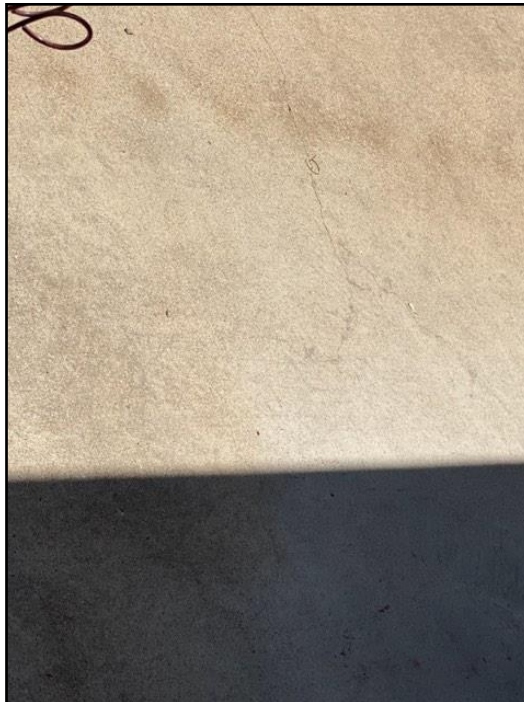
13. Concrete

- Concrete Crack

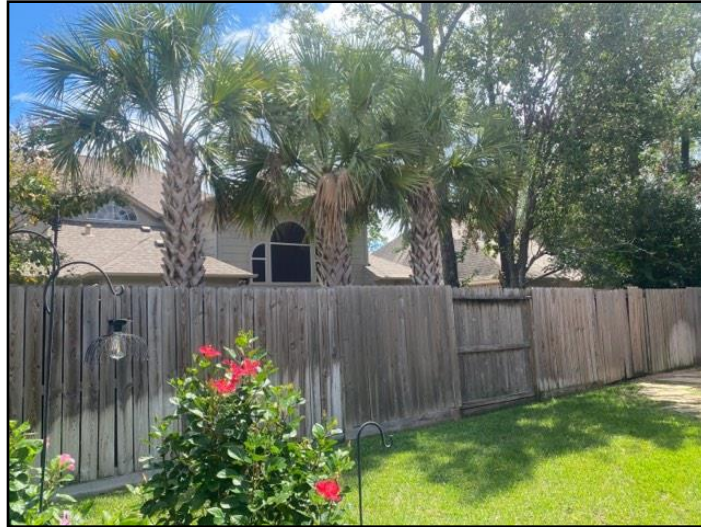
14. Wood

- Wood
- Missing board

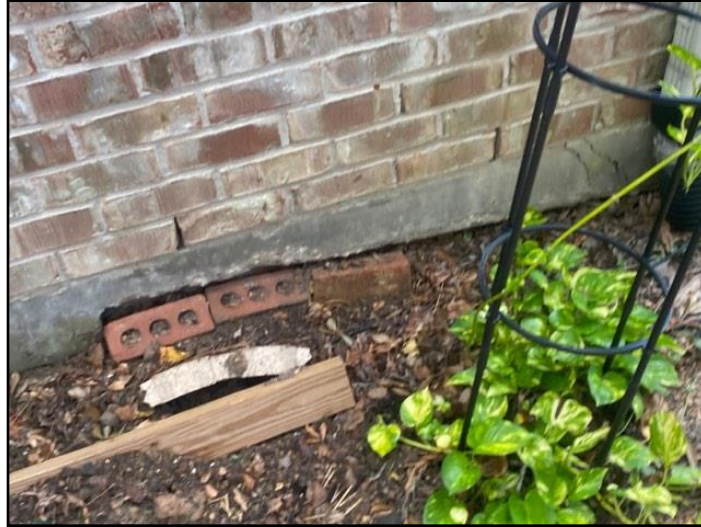
27.

General: • blank note

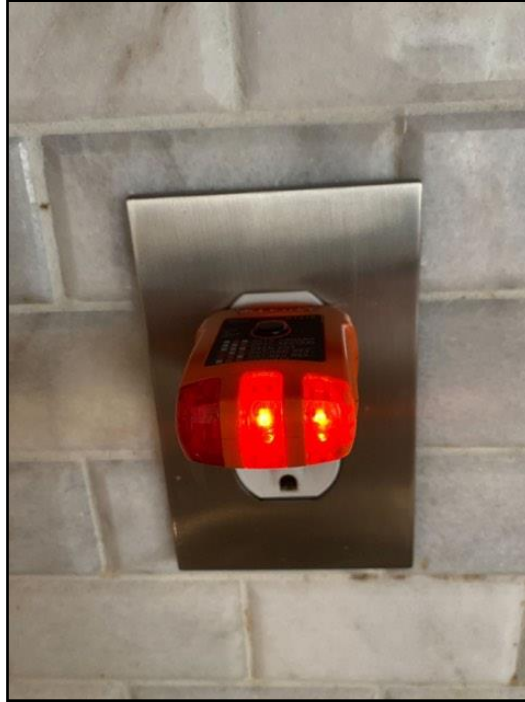
31.

General: • Functional

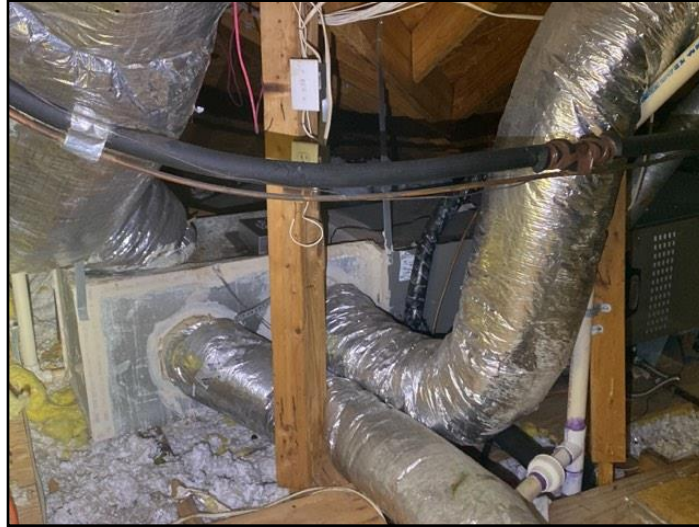
36. Furnace

10 years old

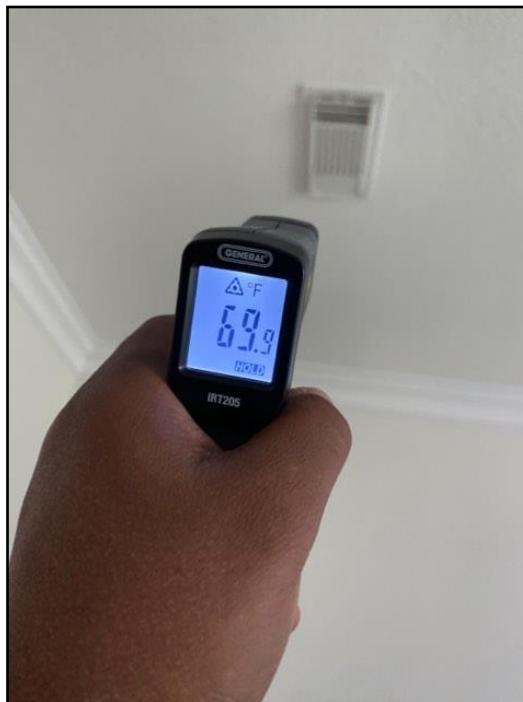
49.

Location of the thermostat for the cooling system: • By master Not cooling efficiently

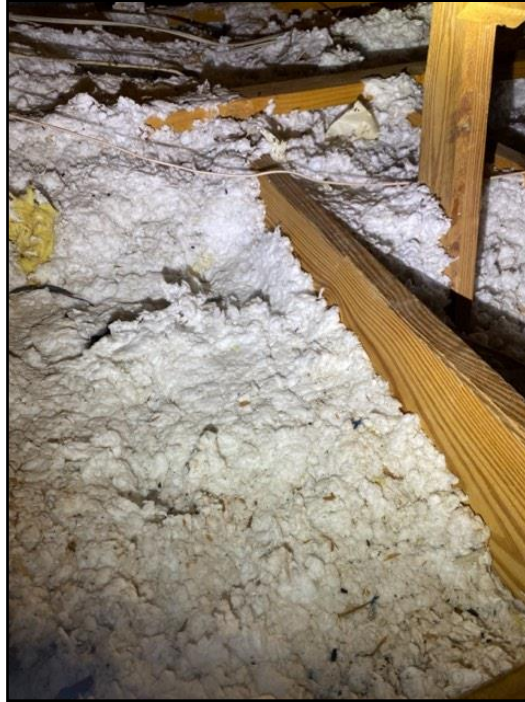
53.

General: • Low level

General: • Recommend insulation contractor evaluate

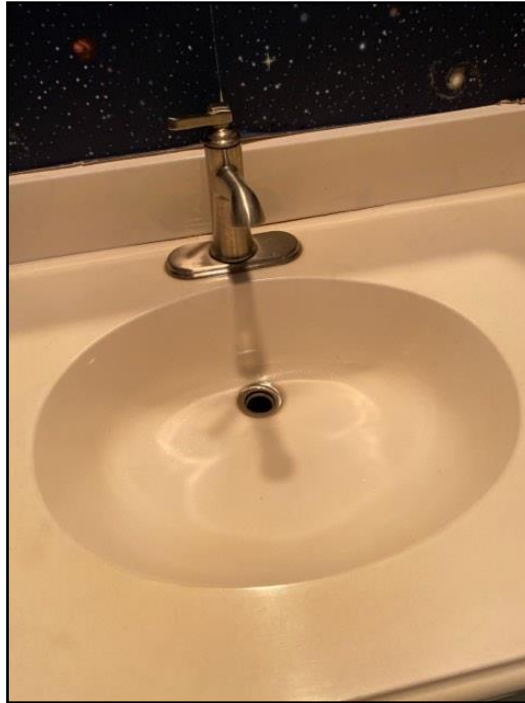
75. Clogged

28. Condition: • [Clogged](#)

Upstairs left sink slow drain

Implication(s): Sewage entering the building
