INSPECTION REPORT

12345 ADDRESS

Inspection Date: Tuesday, July 4, 2023

RE: Report No. 1498, v.2
12345 Address
Denver and all metro areas, CO

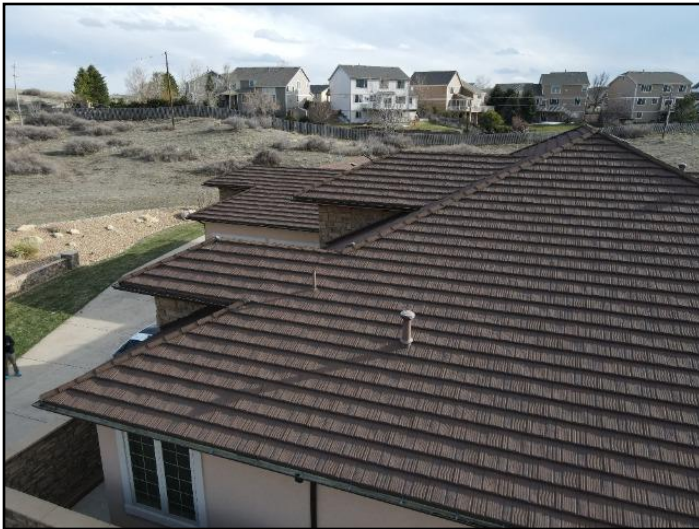
14. Good condition

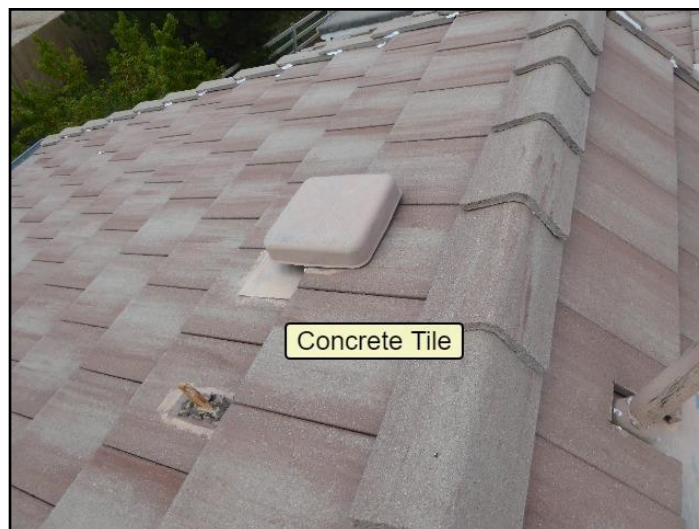
16. CONCRETE TILE:

2. Condition: • The general condition of the main roof appears to be in serviceable condition. I recommend regular maintenance and inspection. I recommend requesting the sellers to disclose if the roof warranty is transferrable or obtaining a five (5) year roof certification by a qualified roofing contractor before closing on the property. The roofing has evidence of weathering and possible hail damage. We recommend having a qualified roofing contractor inspect and provide recommendations.

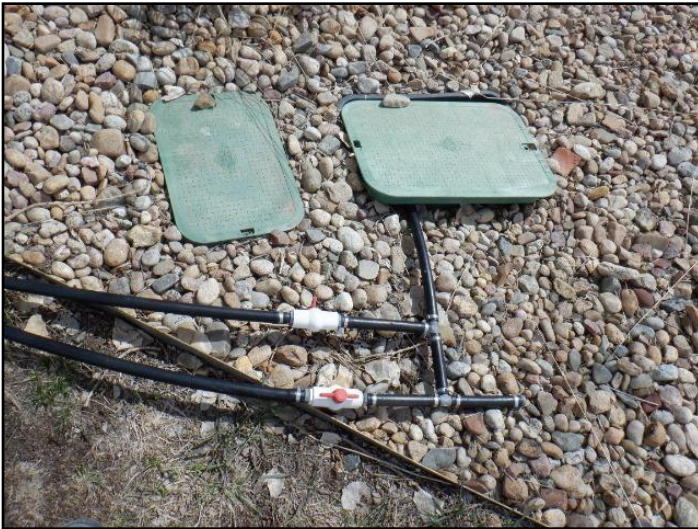
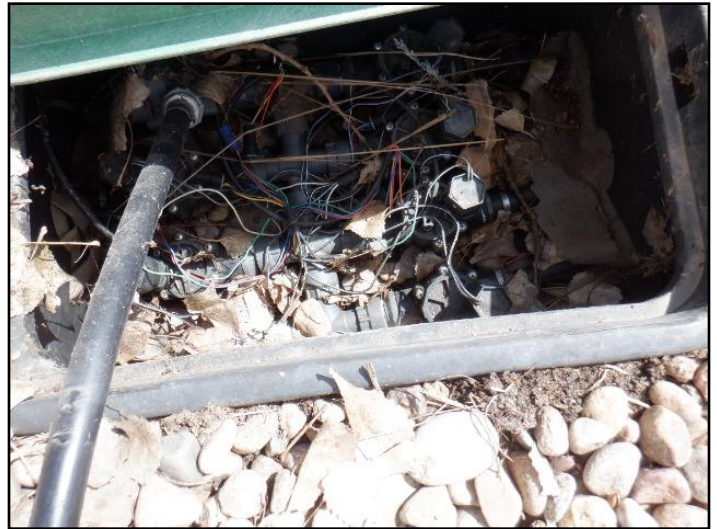
- Testing of lawn sprinkler systems is outside the scope of a standard home inspection. As a courtesy, we run and test sprinkler systems, when possible, and if the system is currently turned on and operational. The testing is minor and limited in nature, and consists of running the system one zone at a time, to look for any broken heads, or obvious leaks in the system, and general operation and performance issues. The integrity of the buried lines cannot be assessed or determined. Annual maintenance is recommended, and proper winterization of the system is recommended each fall.

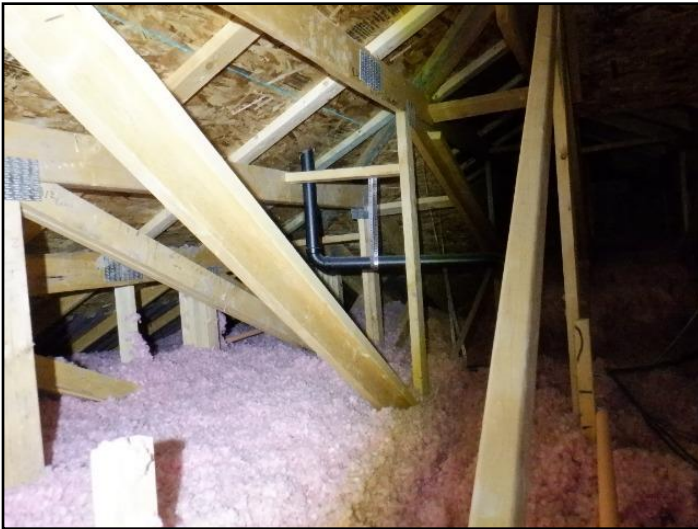
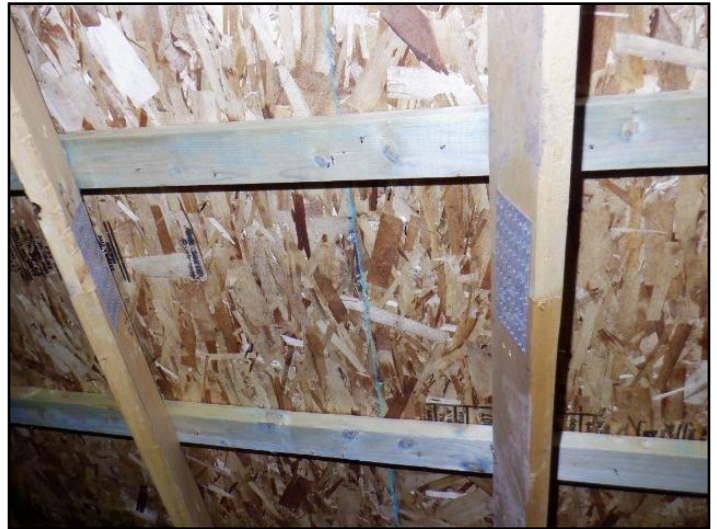
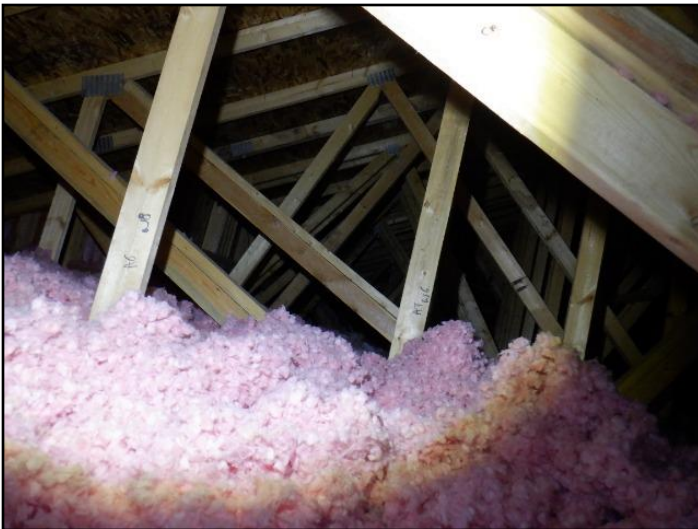
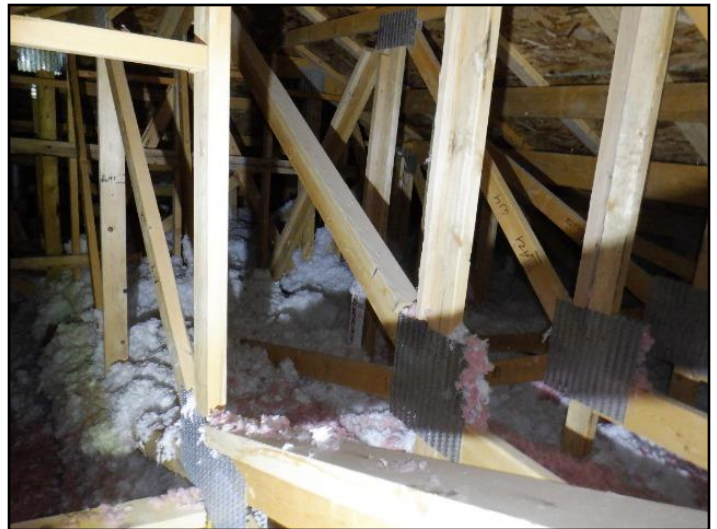
- Engineered Trusses appeared to be in good condition

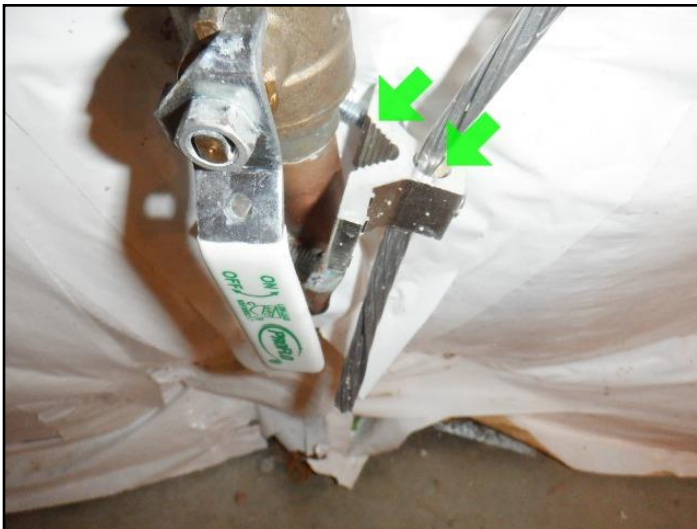
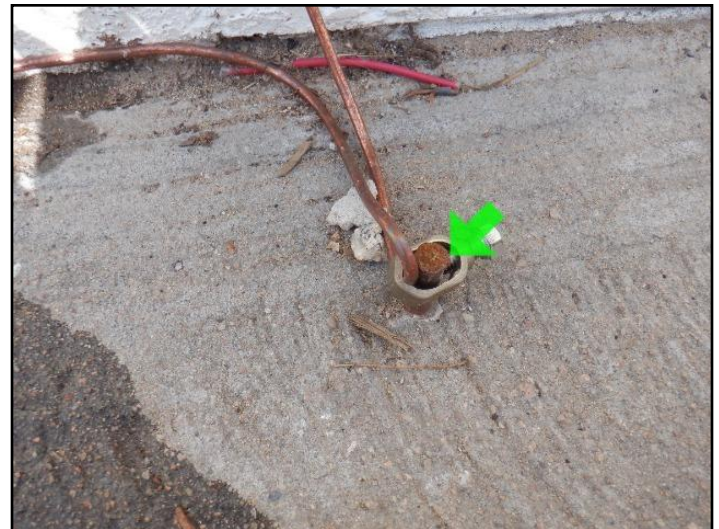
48. Copper - water pipe and ground rod

49. Copper - water pipe and ground rod

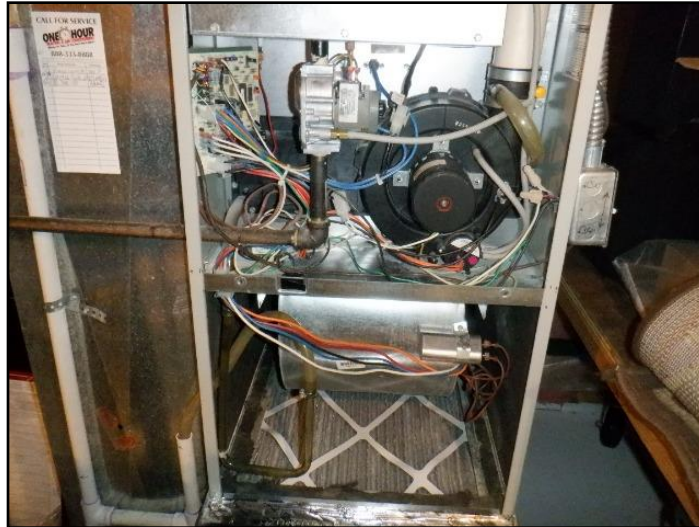
53. Furnace System operated as designed. The...

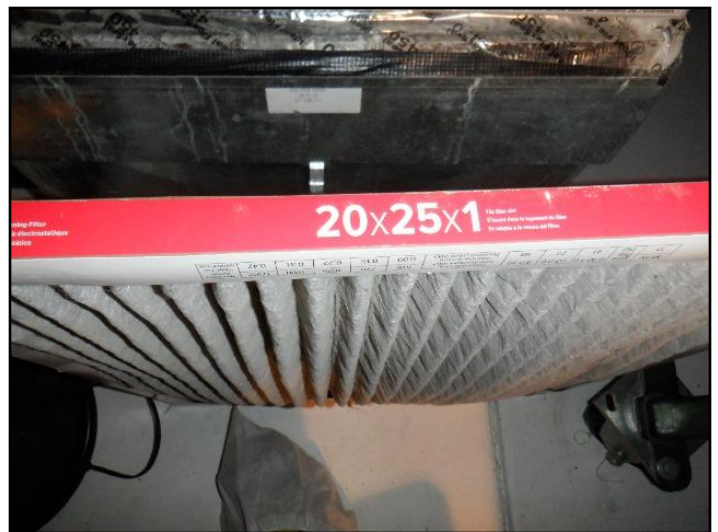
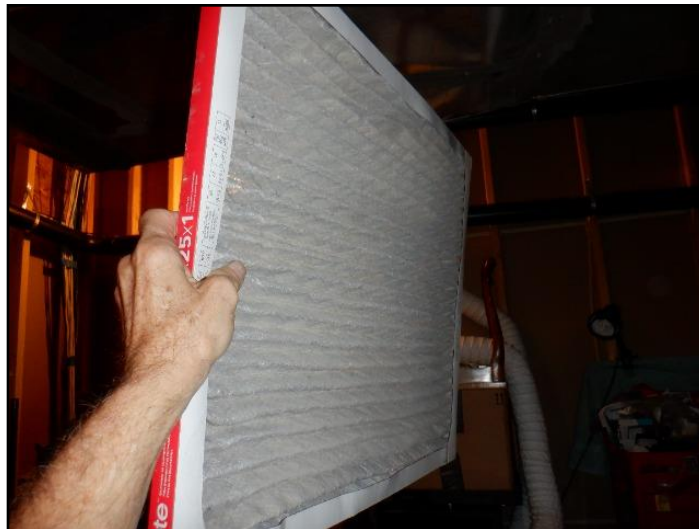
38. Condition: • MAINTENANCE (Don't Forget!): The air filter(s) should be inspected at least monthly and cleaned or replaced as required. There are two types of filters commonly used: (1) Washable filters, (constructed of aluminum mesh, foam, or reinforced fibers) these may be cleaned by soaking in mild detergent and rinsing with water. Or (2) Fiberglass disposable filters that must be REPLACED before they become clogged. Remember that dirty filters are the most common cause of inadequate heating or cooling performance. A clogged filter will cause premature failure of your furnace system and or unnecessary/preventable costly repairs or replacement of the HVAC system.

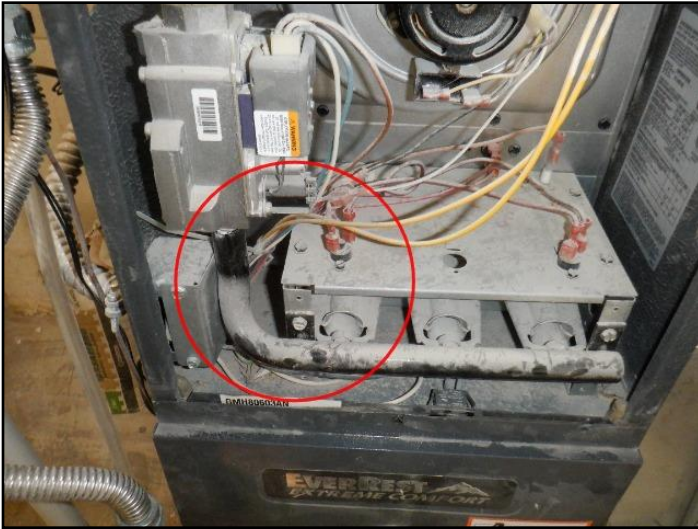
39. Condition: • Excessive construction dust

This is a typical issue with new and remodeled homes

64. Excessive construction dust

65. Excessive construction dust

Task: Have an HVAC tech service/clean

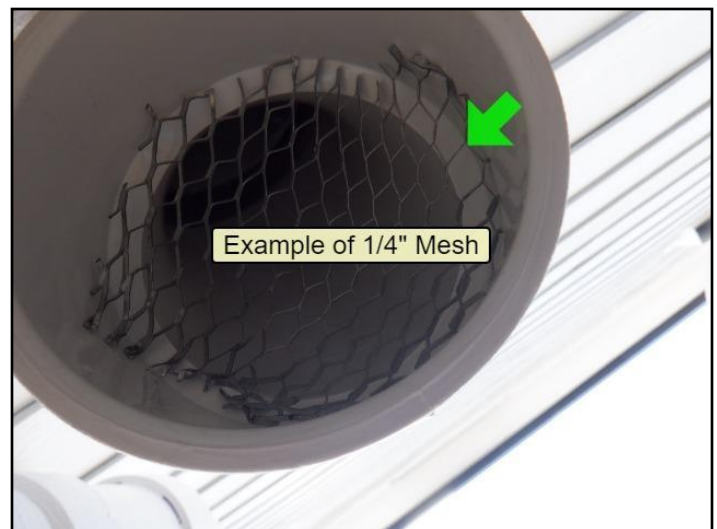
45. Condition: • Exterior HVAC PVC intake & exhaust vents needs a 1/4" mesh pest/bug screen . This is recommended to prevent pests, Miller Moths, from entering the furnace system and preventing children from inserting rocks or balls into the vents especially for vents reachable by small children.

67. Example of 1/4" Mesh

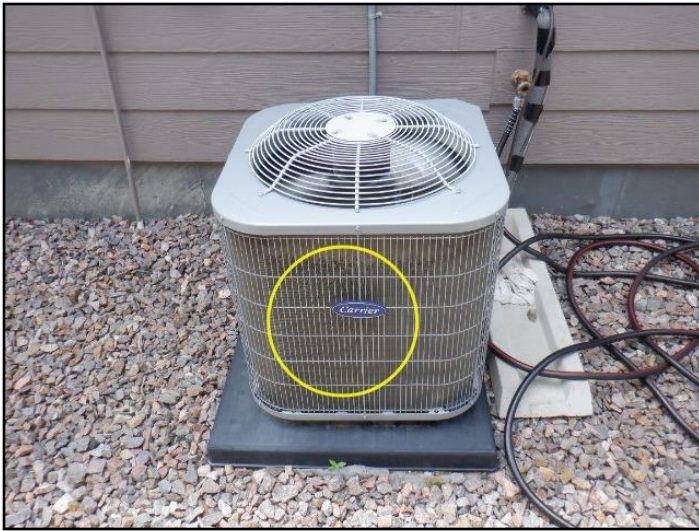
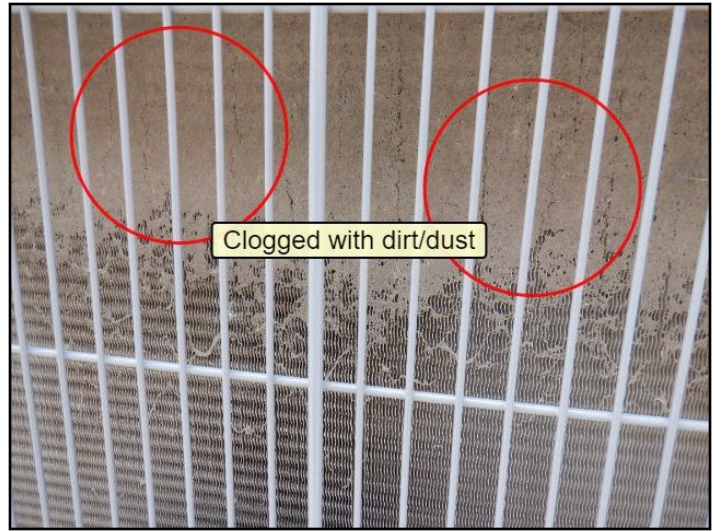
70. Dust/Debris in cooling fins, reduced...

71. Dust/Debris in cooling fins, reduced...

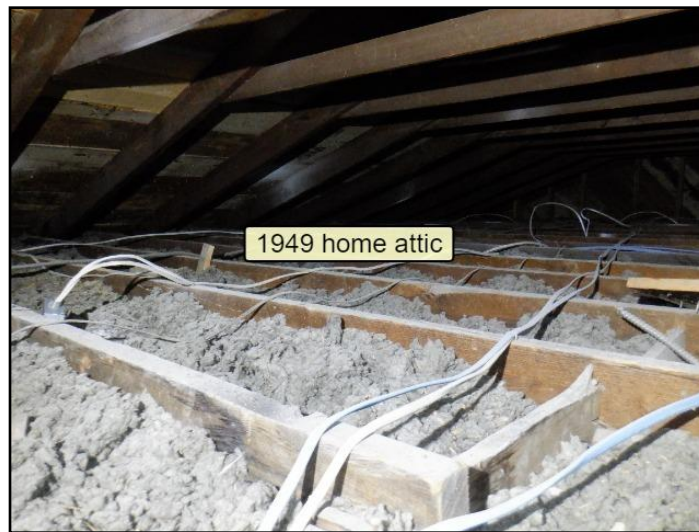
1949 home attic

Implication(s): Increased heating and cooling costs

73. Amount less than current standards

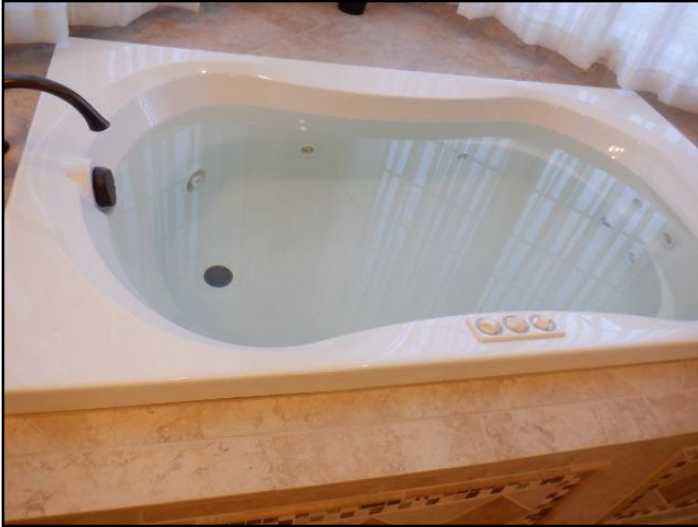
74. Filled tub(s) sinks and checked overflow(s)

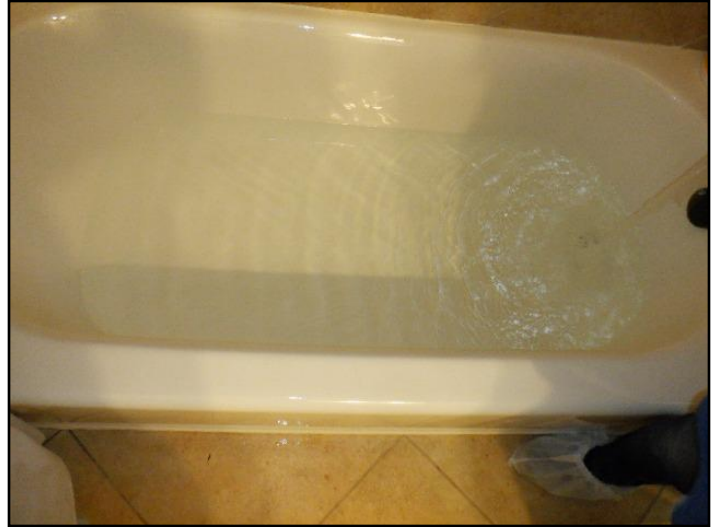
75. Filled tub(s) sinks and checked overflow(s)

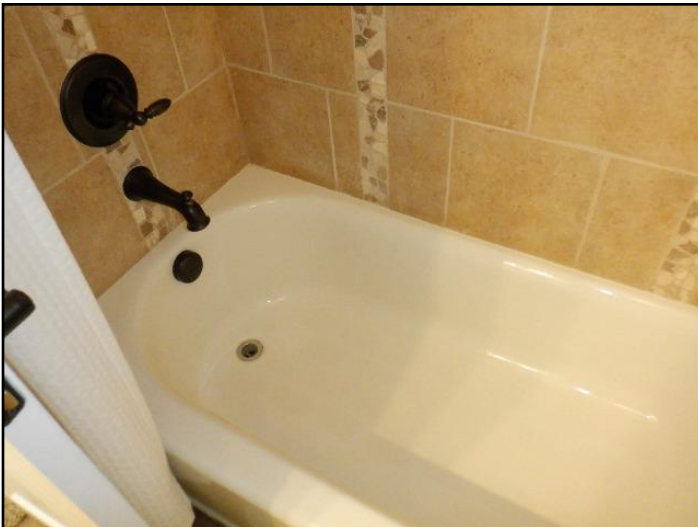
76. Filled tub(s) sinks and checked overflow(s)

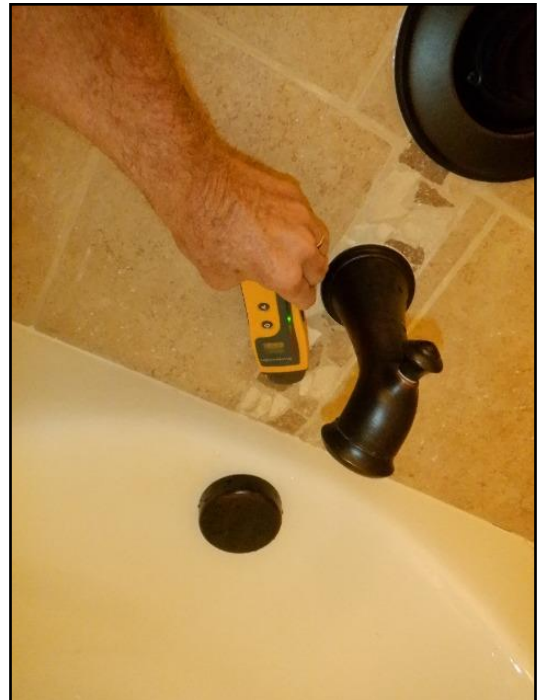
77. Filled tub(s) sinks and checked overflow(s)

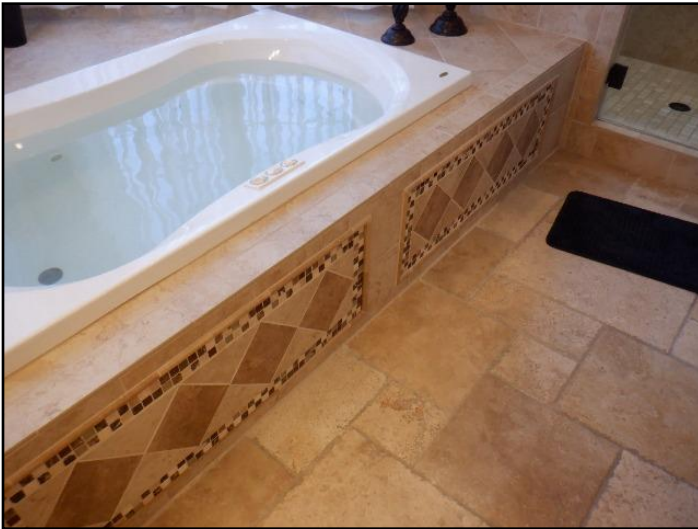
78. All shower/tub tile surfaces are in good...

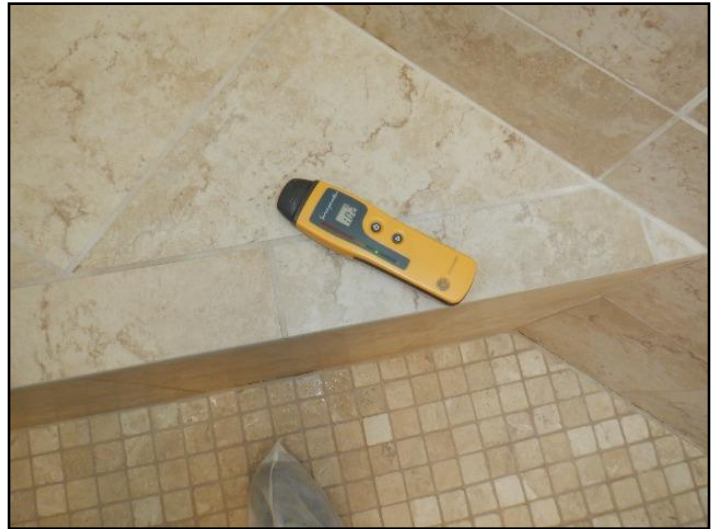
79. All shower/tub tile surfaces are in good...

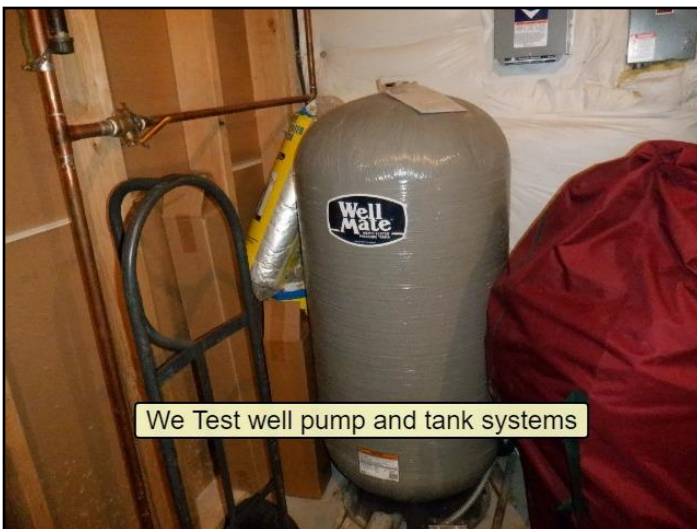
83. Well pump and tank test

- Kitchen sink no leaks were observed. Monitor sink drains and under sink components, this area is most prone to leaks resulting in potential damage to the base cabinet and potential mold issues.
- Well pump flow and tank were inspected per specifications, operated pump for two hours no drop in pressure or fluctuation in flow were noted, flow and pressure are at or above minimum standards. Flow rate was at 8-10 gallons per minute. Electrical load was within manufacture specifications.

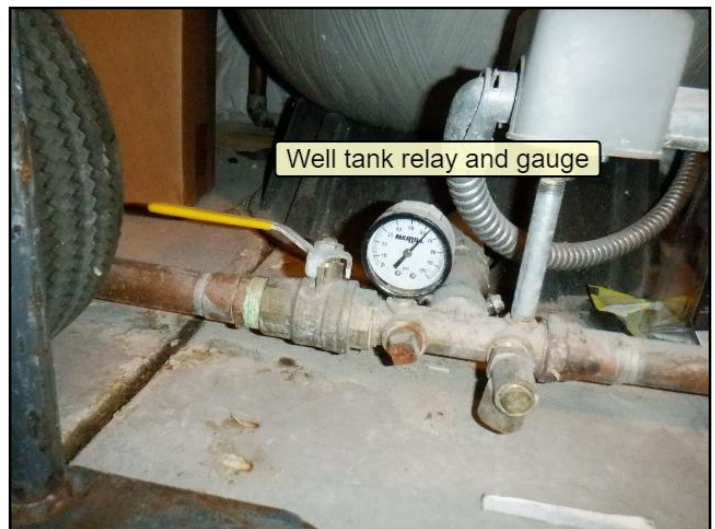
84. Well pump flow and tank were inspected per...

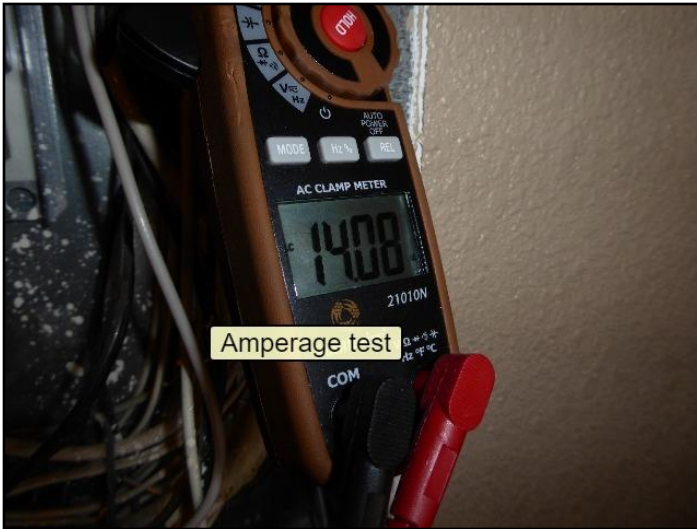
85. Well Pump circuit test

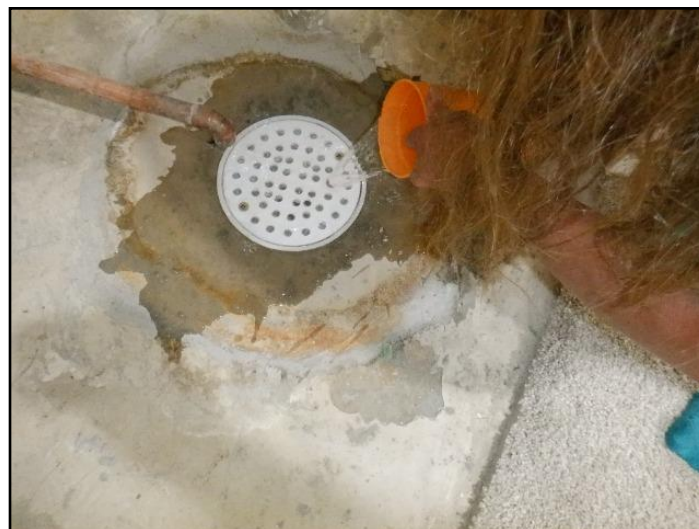
90. Near heating system

- Near heating system
- Tested, no issues

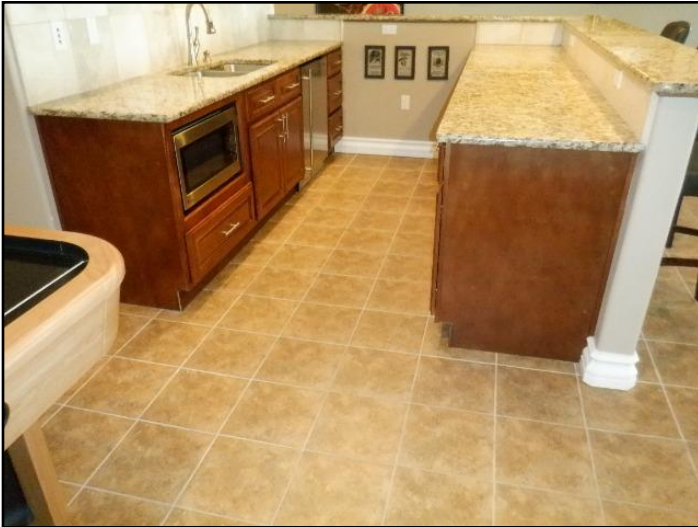
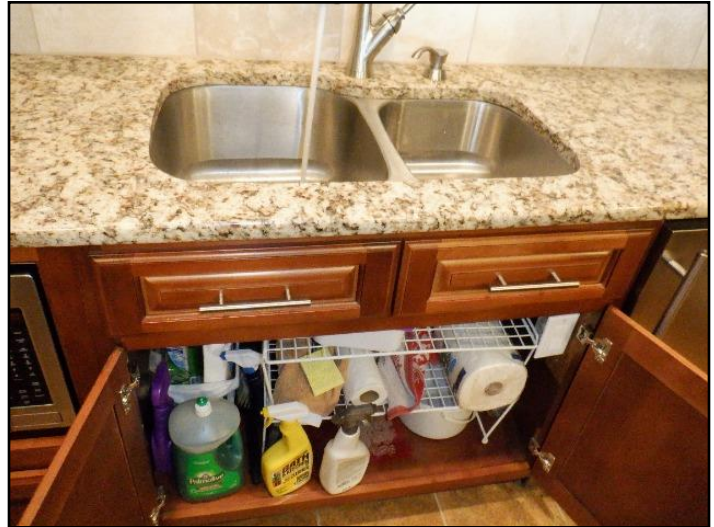
96. Kitchen counter tops are newer high quality

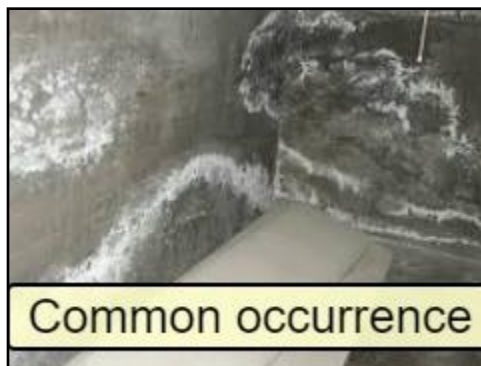
Efflorescence is a chalky white salt residue that can occur with any product containing cement. As moisture migrates up to the surface of the concrete, it carries along with it calcium salts from within the concrete. When the salts reach the surface, they react with CO₂ in the air and form insoluble calcium carbonate.

100. Efflorescence

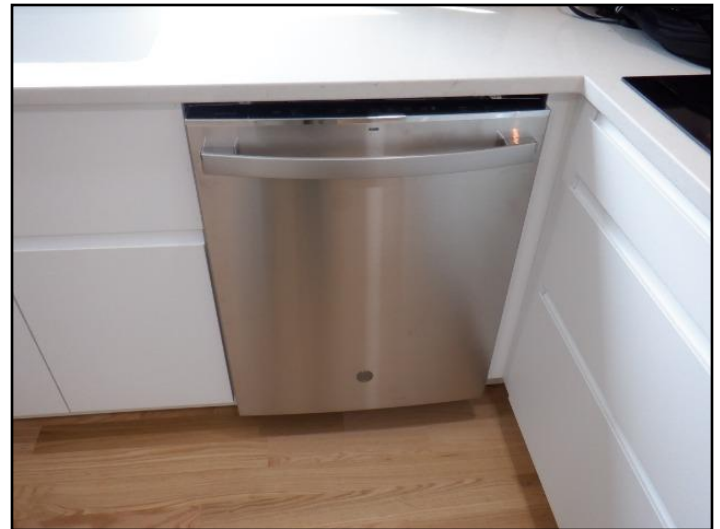
103. Operates

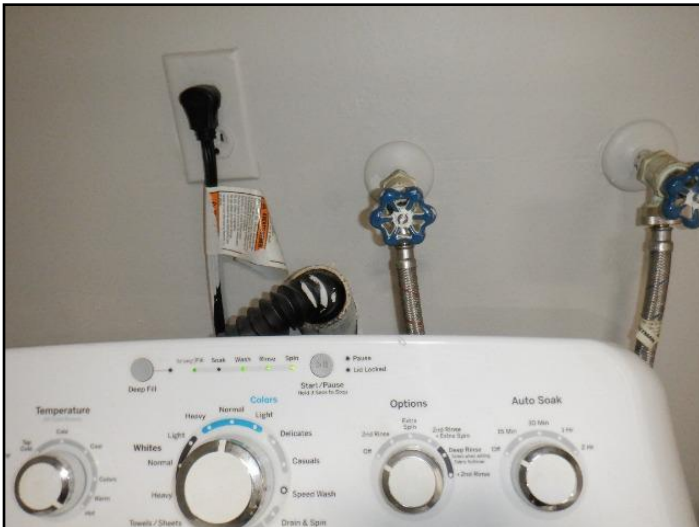
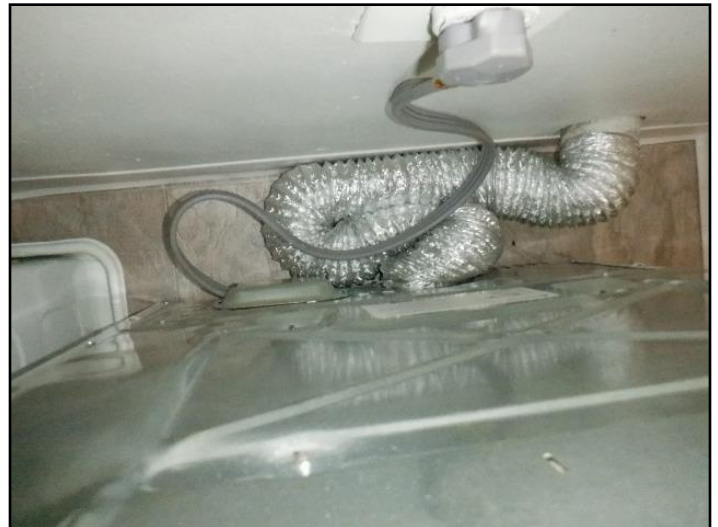
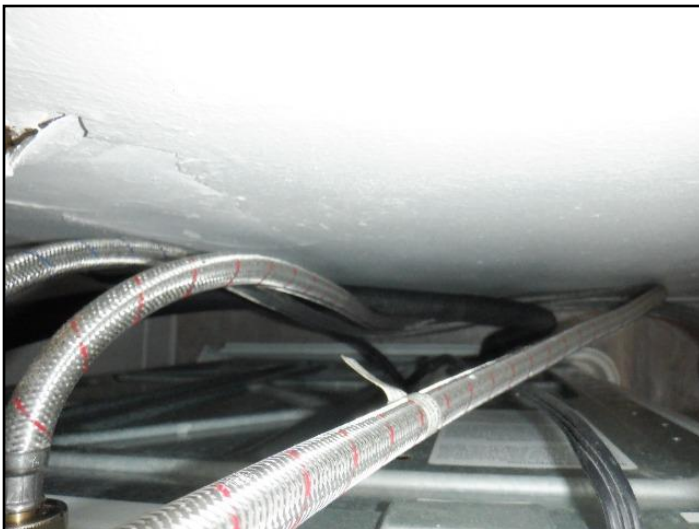
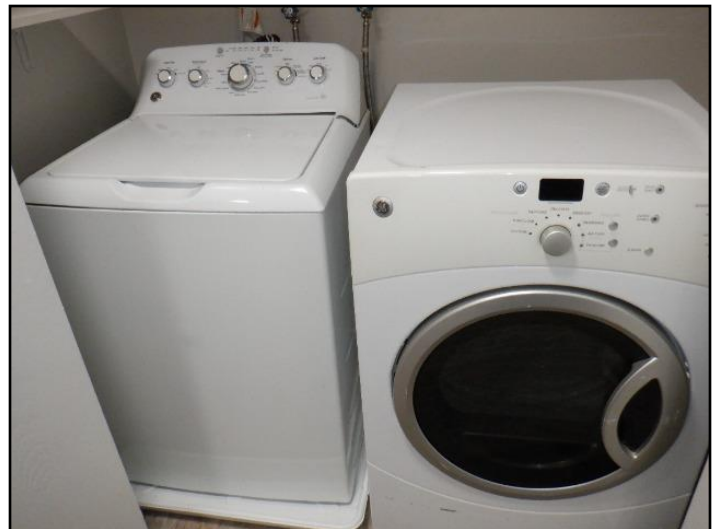
106. Tested washer and dryer, operated.

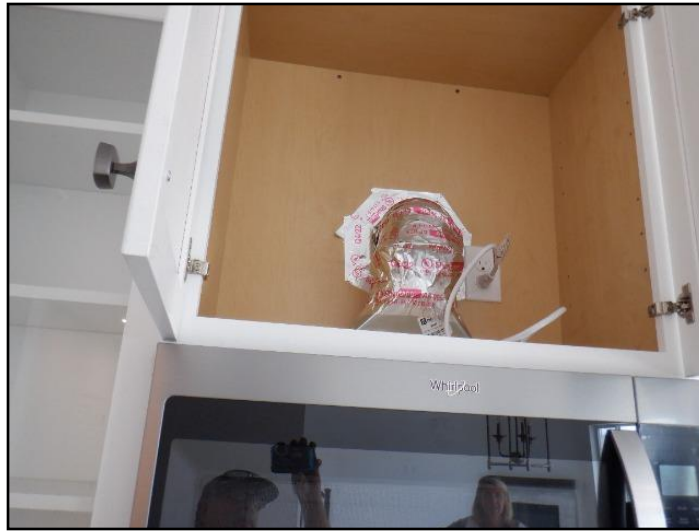
110. Exhaust fan discharges to the exterior

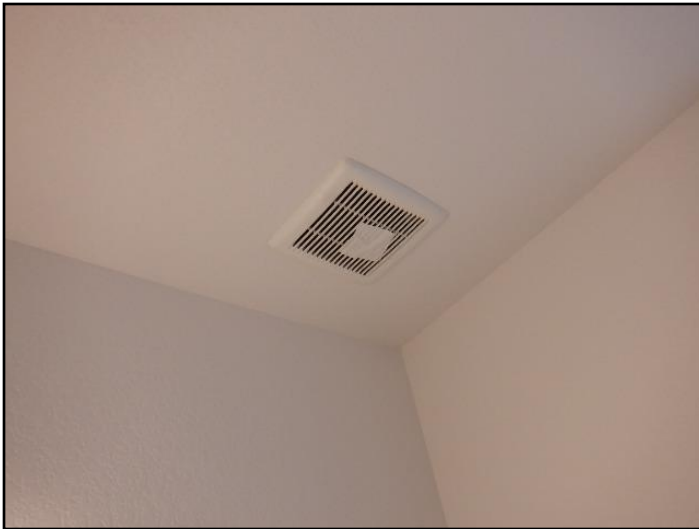
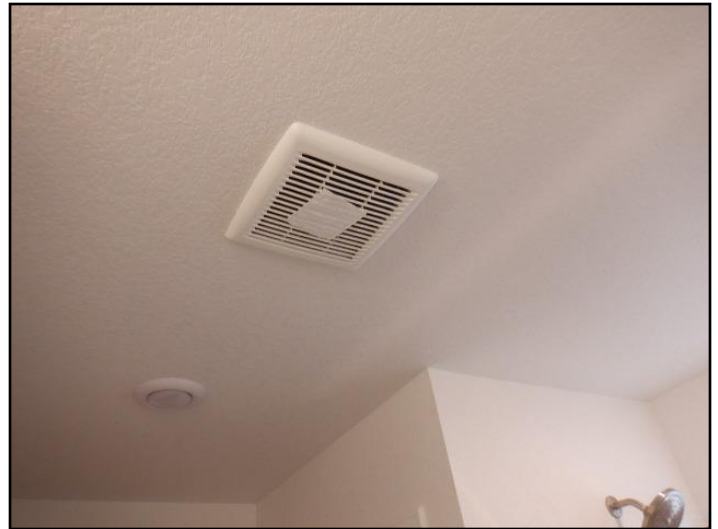
111. Bathroom fan(s) operated and have good air...

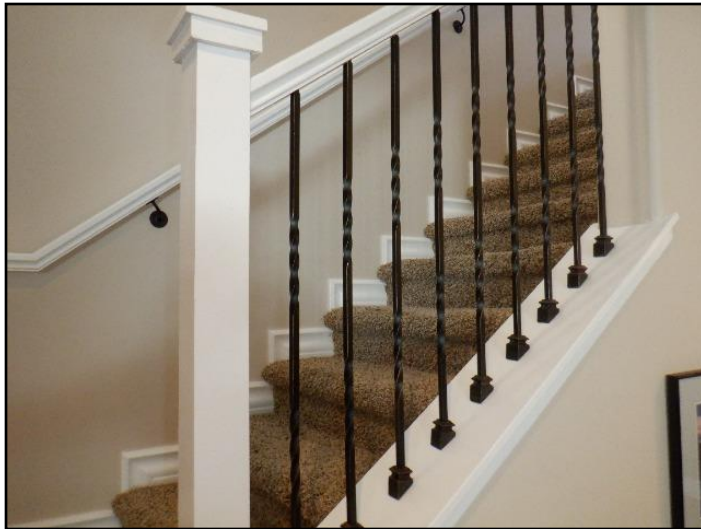
113. The general condition of the interior stair...

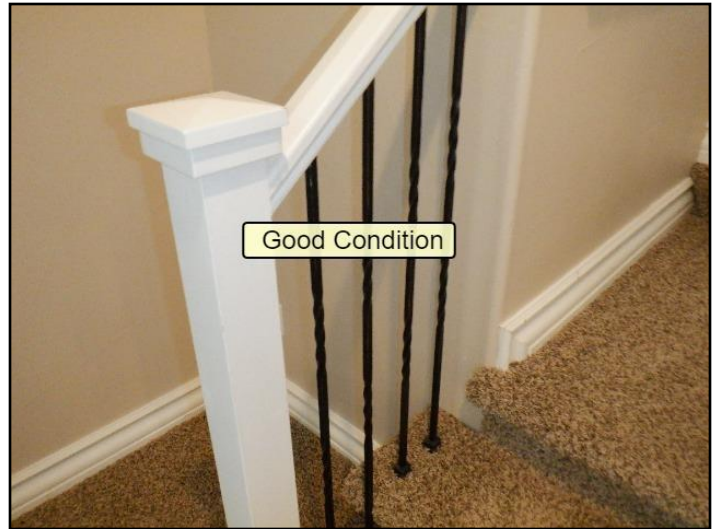
114. Good Condition

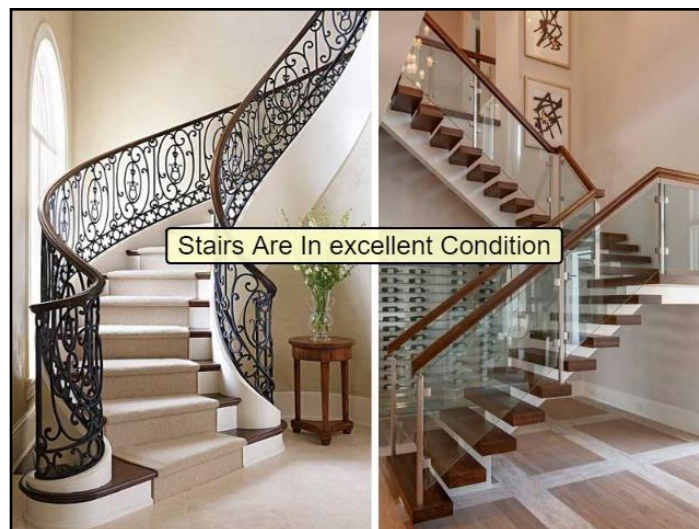
115. Stairs Are In excellent Condition

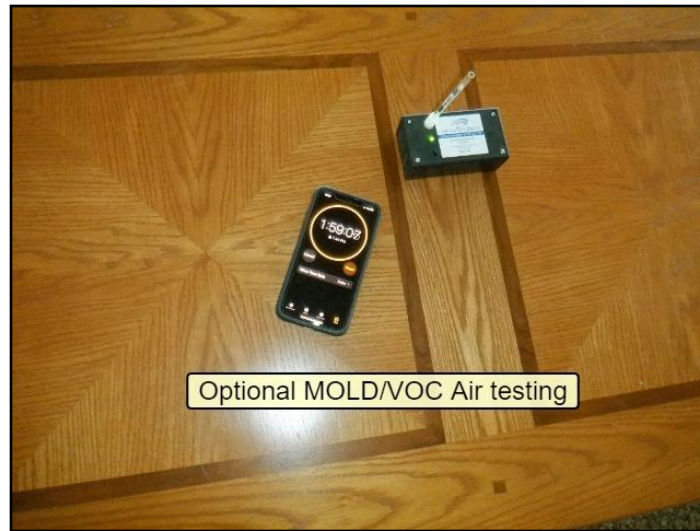
116. A PRISM MOLD/VOC Air Quality test was...

72. Condition: • ENTHALPY MOLD/VOC Air Quality test was performed

(This is an add-on) Results pending (Example)
