# YOUR INSPECTION REPORT

FOR THE PROPERTY AT:  
30 Edwalter Ave  
Toronto, ON

INSPECTION DATE:  
Friday, April 21, 2017

RE: Report No. 2108  
30 Edwalter Ave  
Toronto, ON

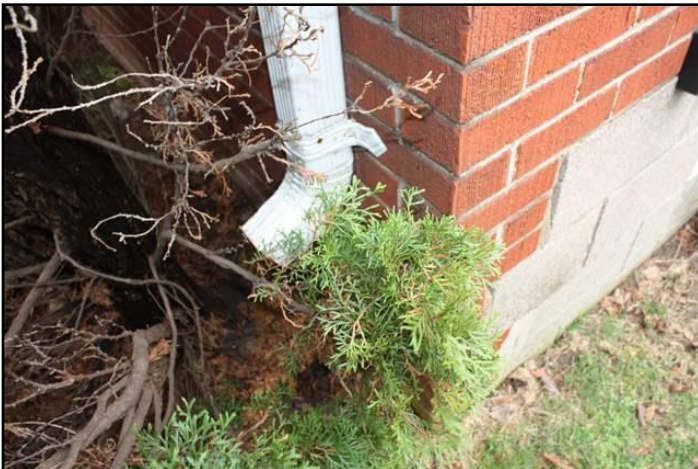
1. Should discharge 6 feet from building
