# Your Inspection Report

1204 Walker Line Road  
Algonquin Highlands, ON P1H 0K1

RE: Report No. 3126, v.2  
1204 Walker Line Road  
Algonquin Highlands, ON  
P1H 0K1

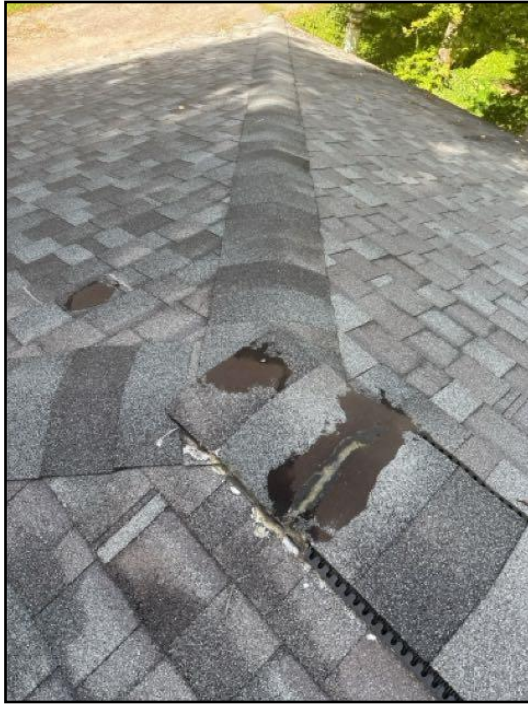
**Condition:** • Patched

9. Patched

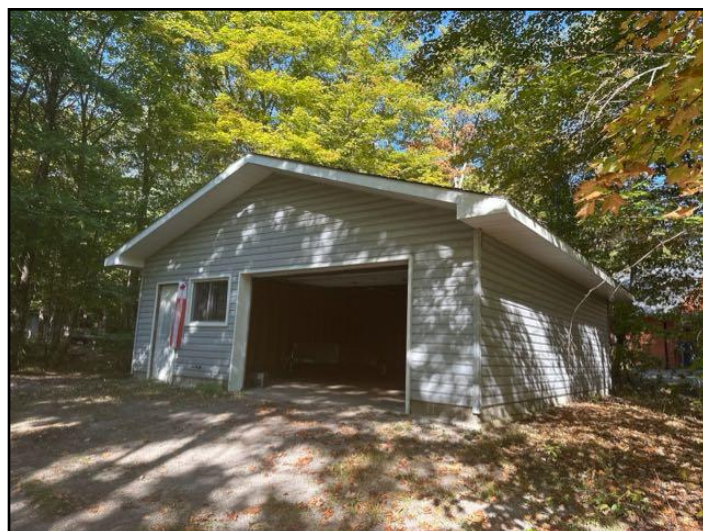
39. Detached

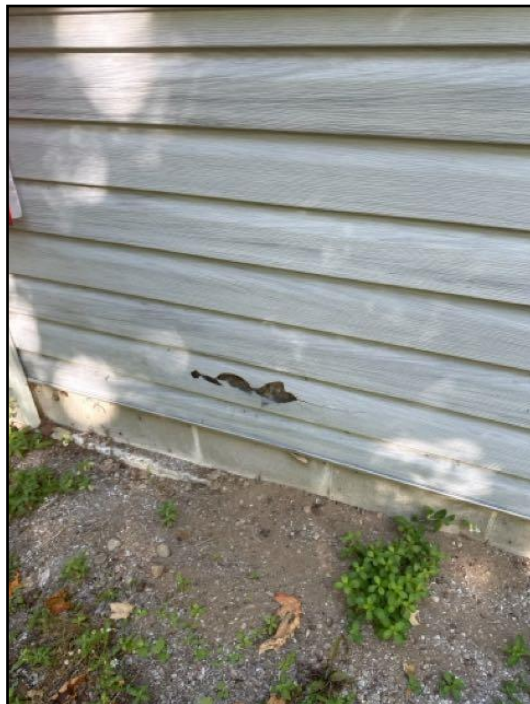
40. Detached

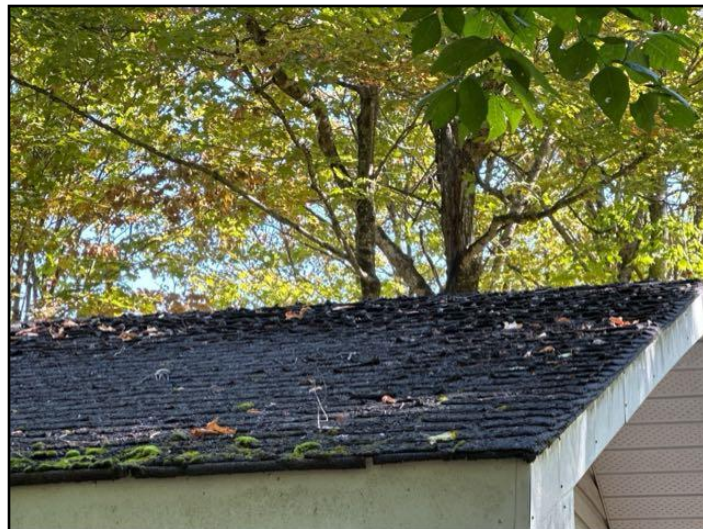
41. Detached

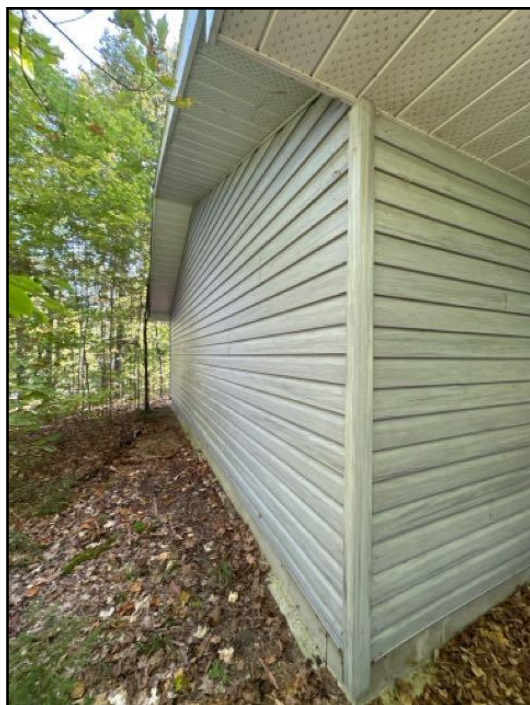
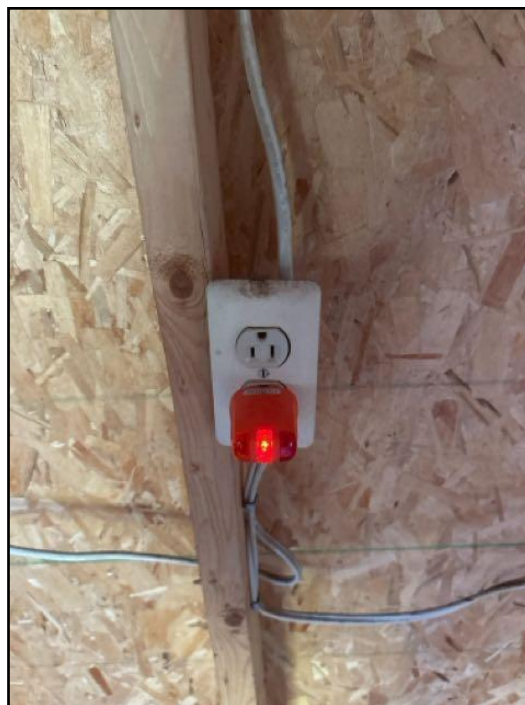
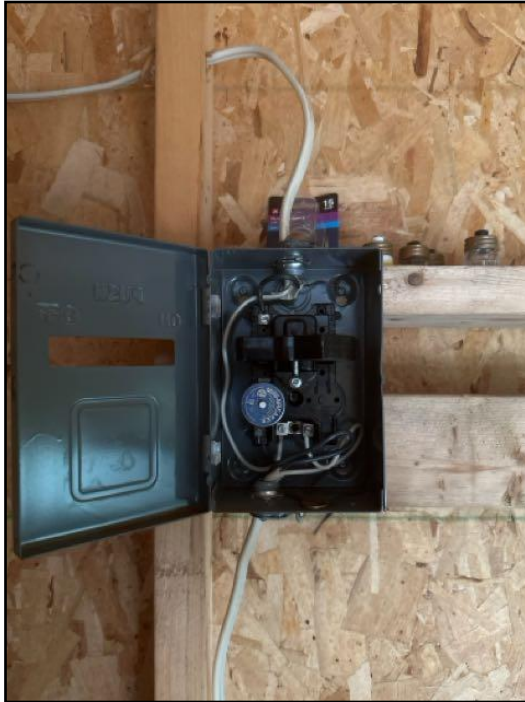
Detached garage conditions

1. Roof shingles have past their life expectancy, recommend replacing soon. Water appears to be entering on the left side above water stains in the garage.
2. Mechanical damage to vinyl siding at the front wall.
3. Ungrounded outlets, recommend further investigation suspect a loose wire.

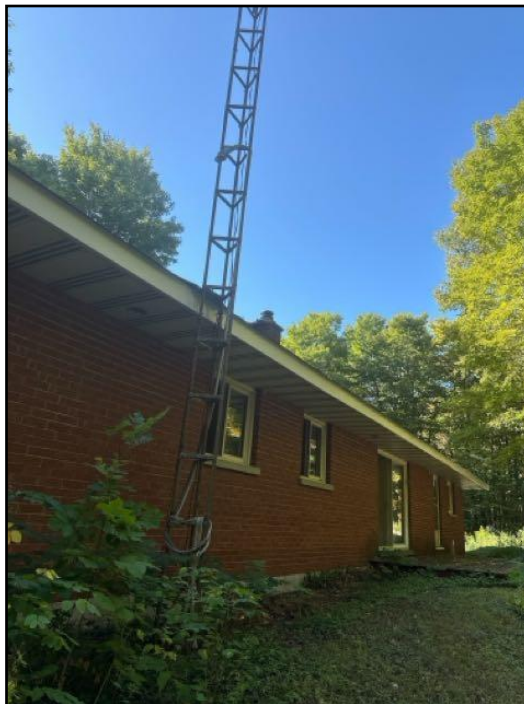
46. Missing

**4. Condition:** • Missing

Missing gutters, recommend installing to control water drainage around foundation and prevent water splashing on exterior wall. Recommend installing slightly lower to prevent snow or ice from damaging them.

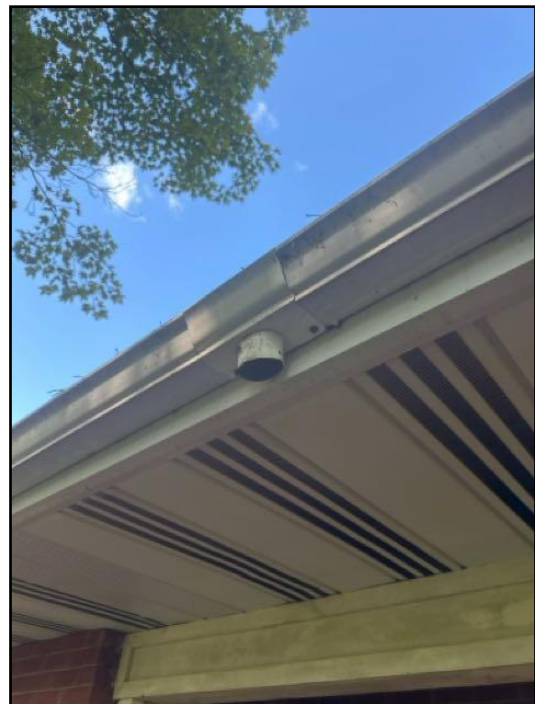
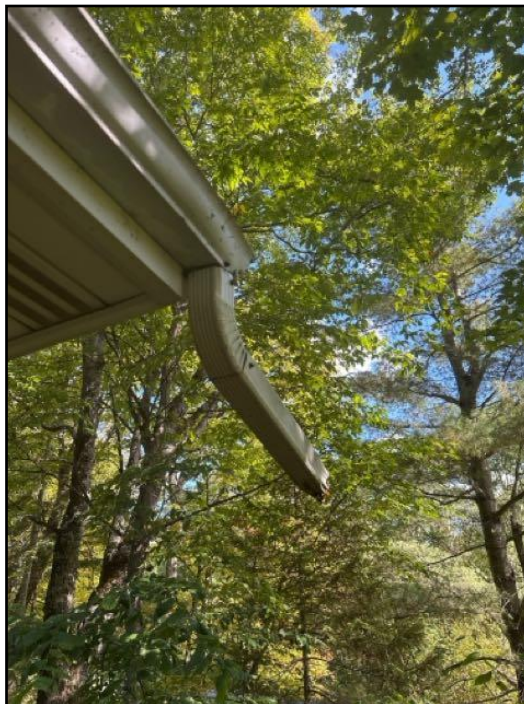
## 6. Condition: • Missing

Missing downspouts, consider installing a plastic chain from gutter to the ground to prevent splashing of water on walls or adding downspouts.

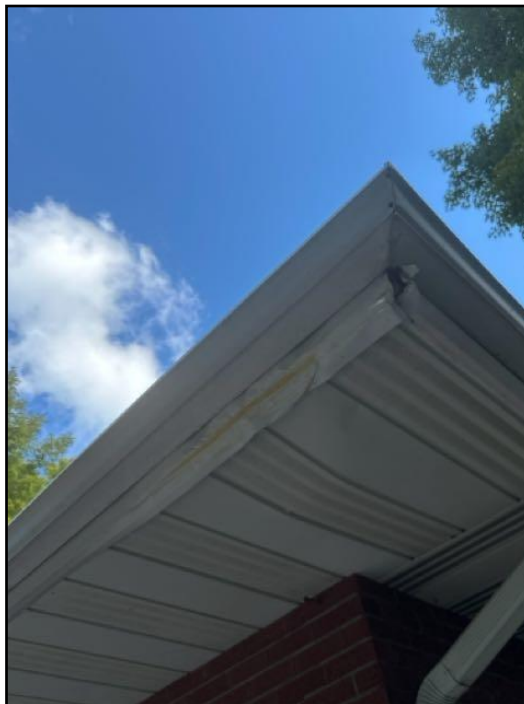
51. Damage

### 7. Condition: • Damage

Damaged fascia trim, recommend replacing soon to prevent weather and rodents from entering.

**Implication(s):** Chance of water damage to structure, finishes and contents

**Task:** Repair or replace

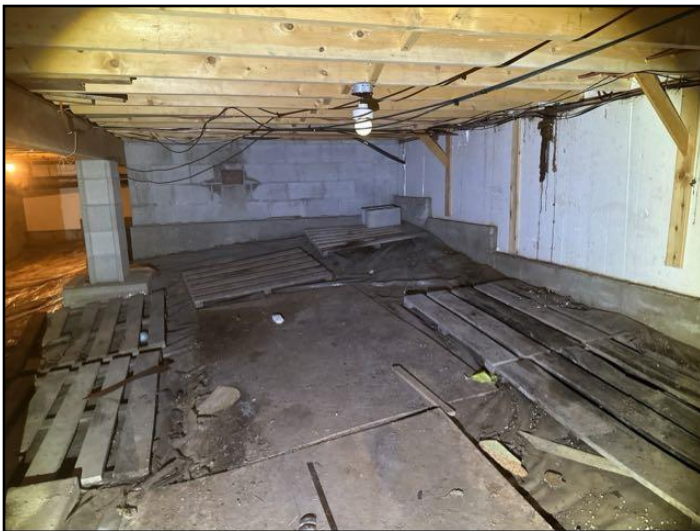
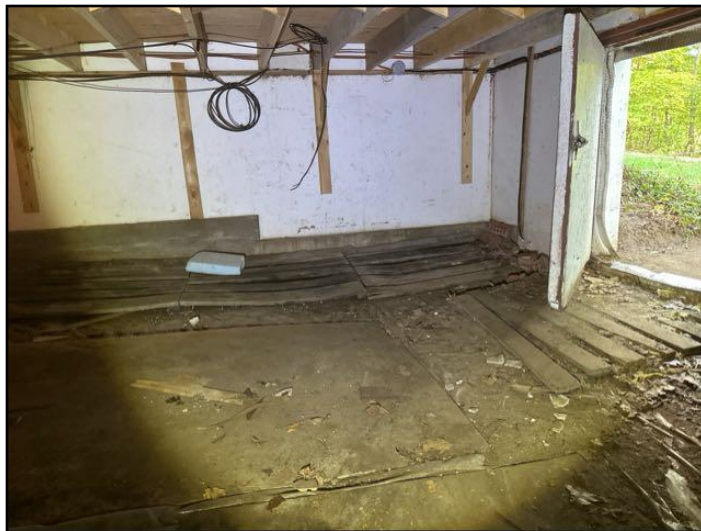
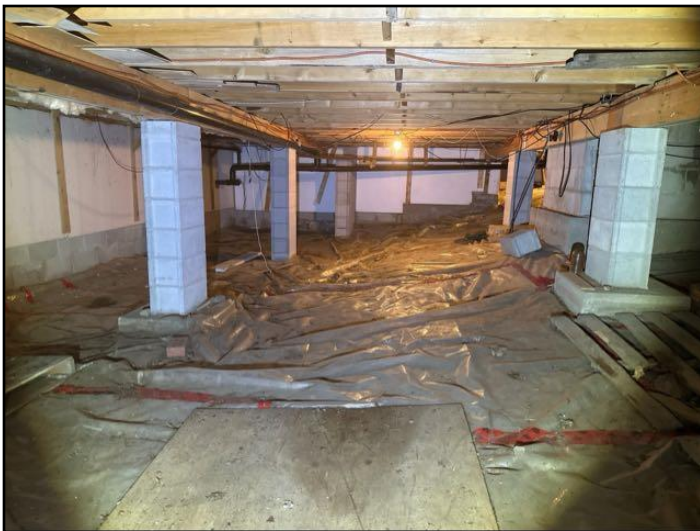
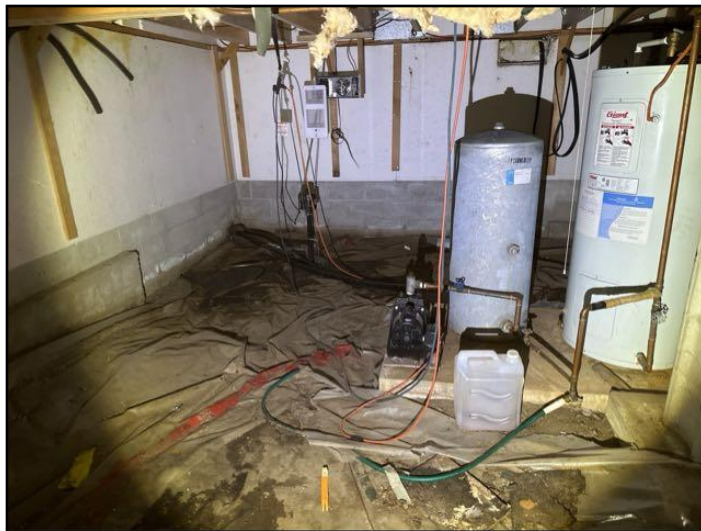
Crawlspace in very good condition, recommend improving water drainage at the crawlspace exterior access hatch to prevent water from entering crawlspace.

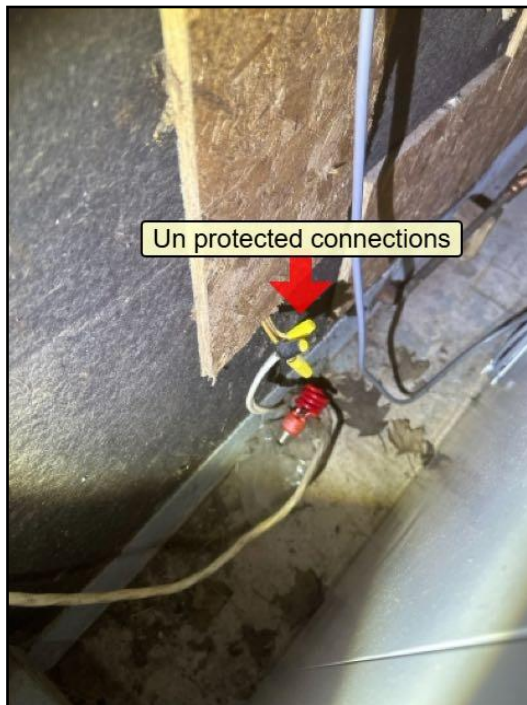
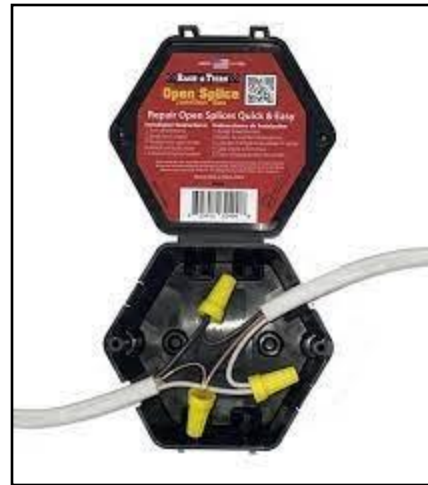
**12. Condition:** • All wire connections must be protected in a metal box with a cover plate for safety.

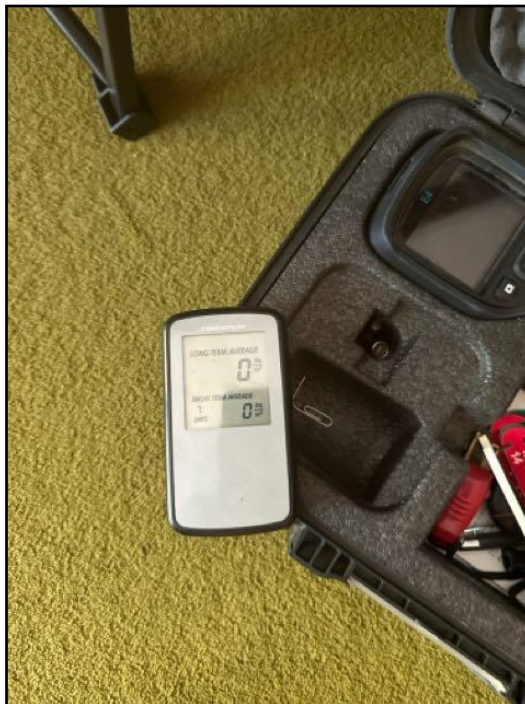
80. Radon

Radon levels measured 0 Bq/m<sup>3</sup> during the time of inspection, safe levels in Canada are below 200 Bq/m<sup>3</sup>.

For a more accurate reading, testing should be done over a 3 month period or more.

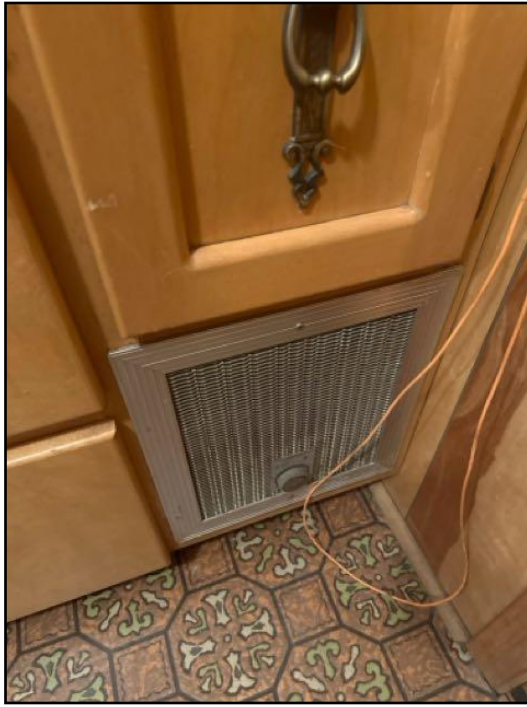
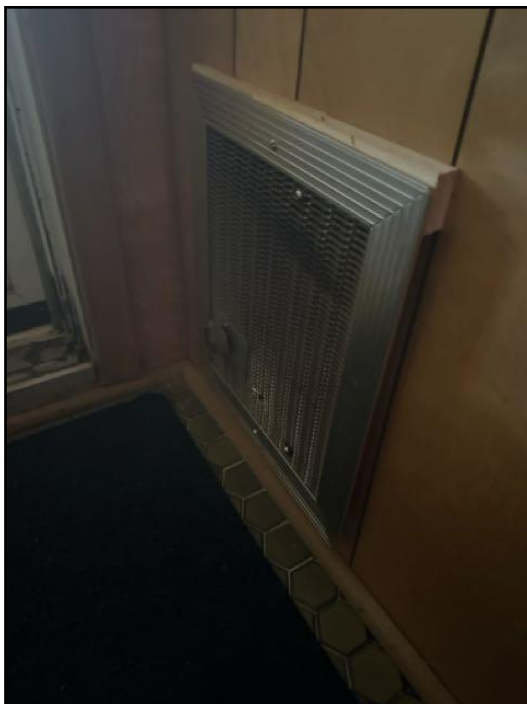
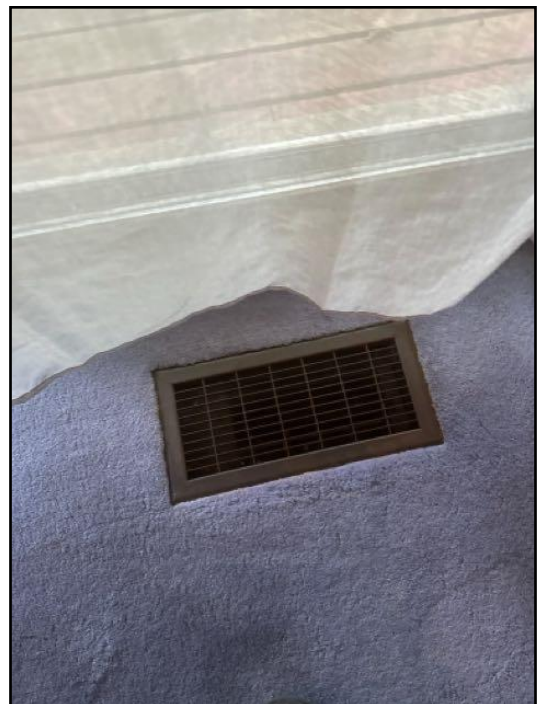
All space heaters tested fine except two, one in the dining area and the second in the floor of the living room.

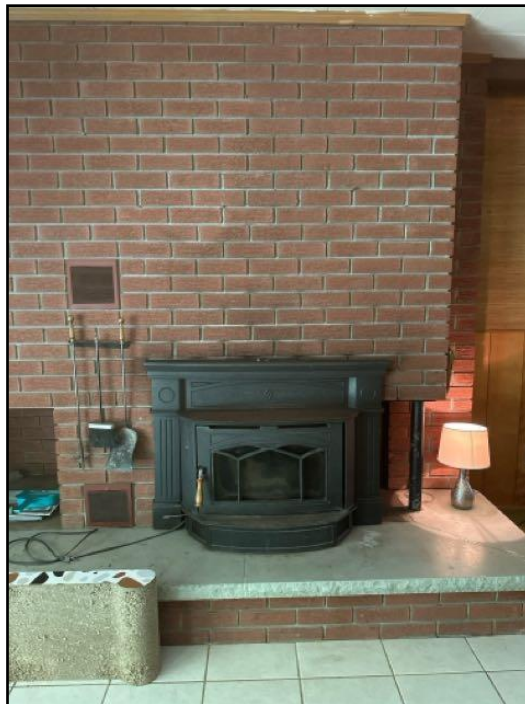
108. Wood stove

Woodstove appears to meet combustible clearances.

FYI- Prior to lighting wood stove during the heating season, prepare wood in chamber open damper valve to full, crack open a window and prior to lighting, heat chamber opening with a hair dryer to ensure draft is going up the chimney and then proceed to light to ensure no smoke enters the home. When the fire is roaring hot after several minutes the damper can be closed fully or to the desired setting, closing fully will have logs in the wood stove last longer. And chimney should be cleaned before and after each heating season.

Also, provide an ash pail with a lid for the safe removal of ashes.

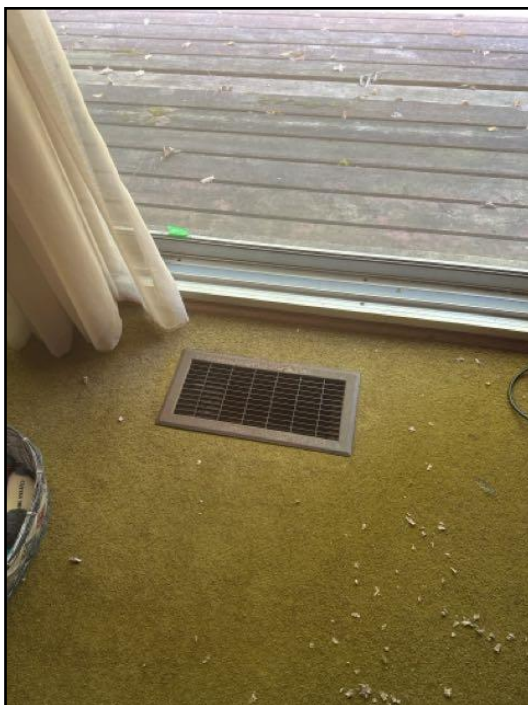
**16. Condition:** • Inoperative heaters

Inoperative heaters in the living room and dining room, recommend further investigation, suspect a loose wire.

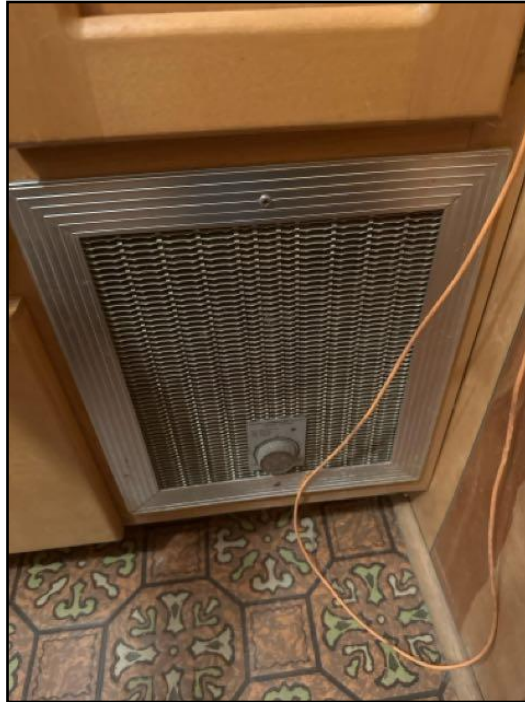
117. Noisy

**18. Condition:** • Noisy

Kitchen space heater fan is noisy, recommend cleaning fan.

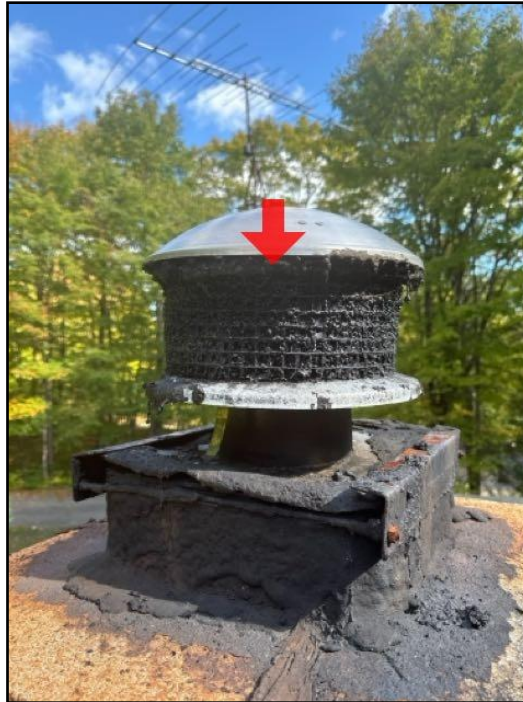
**119.** *Creosote buildup*

#### **20. Condition:** • Creosote buildup

Chimney cap is completely clogged with creosote, recommend cleaning prior to use. Ensure to use seasoned fire wood prior to burning to reduce the amount of creosote buildup.

**Implication(s):** Hazardous combustion products entering home | Increased fire hazard

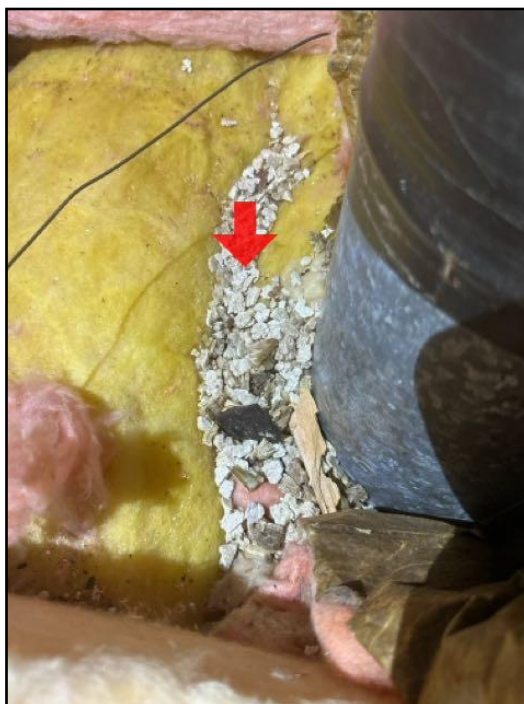
**126.** Vermiculite

**21. Condition:** • Possible Zonolite (vermiculite)

Vermiculite is safe as long as its left alone and not disturbed. Recommend testing for asbestos. And or sealing the attic space, some vermiculite noted around duct pipes and a few voids of insulation.

**Implication(s):** Environmental contamination

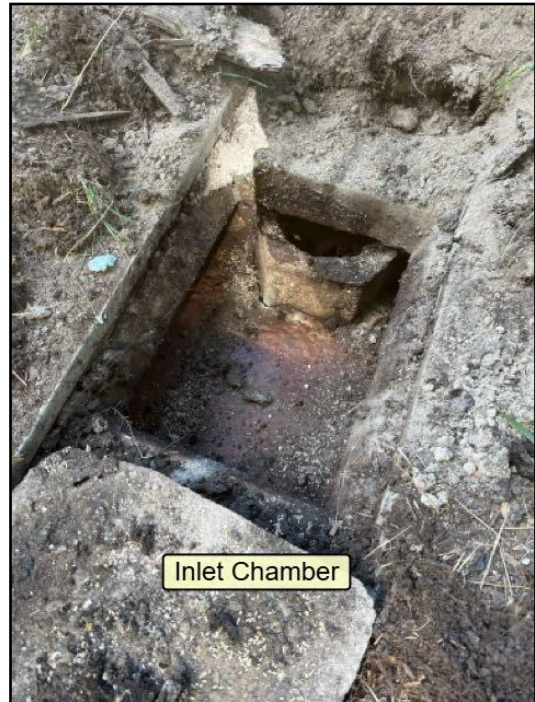
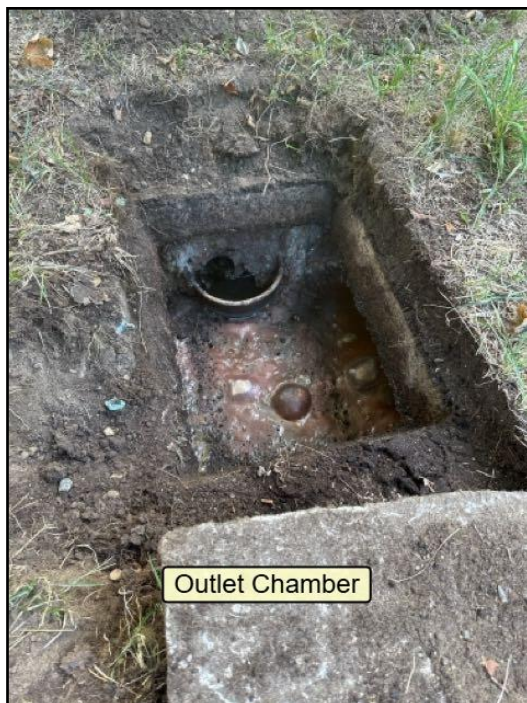
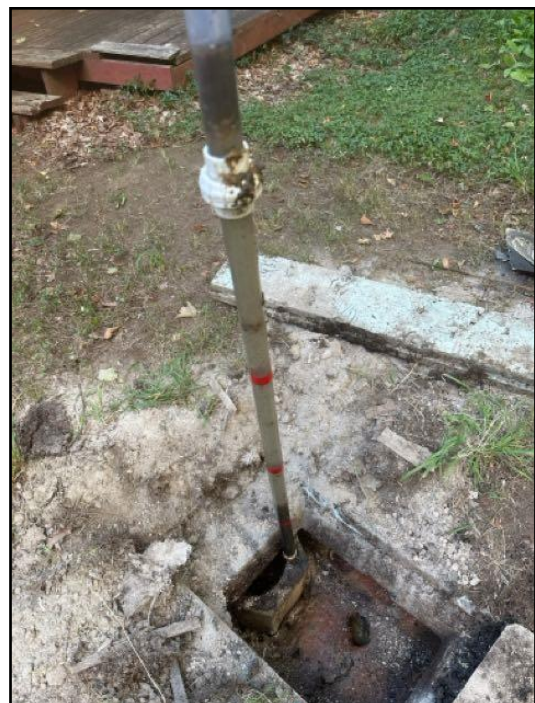
Onsite sewage system is good condition and functioning fine. Flow test conducted for 15 minutes and leaching bed tested fine. Recommend pumping in summer of 2026 and then pumped every 3-5 years afterwards, avoid pumping in the fall or winter whenever possible, chance of freezing and cracking tank. (Sewage generates heat and does not allow tank to freeze) Recommend dumping yogurt once a month or every few visits to promote good bacteria and avoid using harsh chemicals that could kill the bacteria.

Outlet baffle has been repaired, monitor during each pump out and replace when necessary.

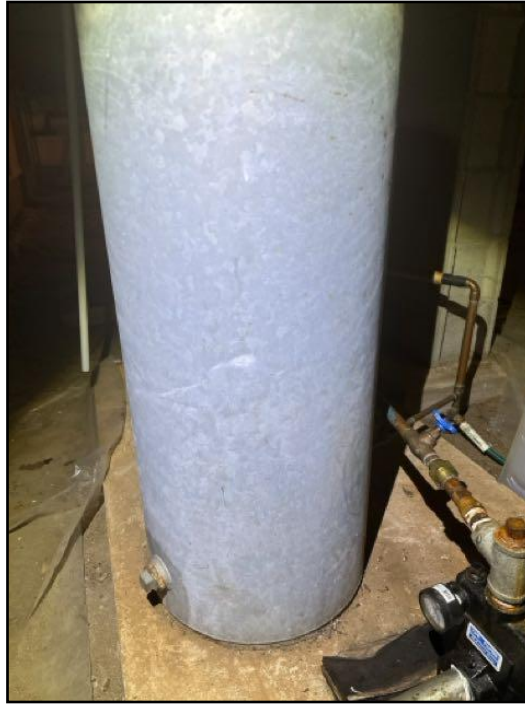
144. Waterlogged

**22. Condition:** • Waterlogged

Water pump runs continuously, suspect pressure tank is water logged, recommend replacing pressure tank.
