INSPECTION REPORT

5300 South 108th Street, Hales Corners WI
53130

July 15, 2025

4 Site Building Inspections Inc

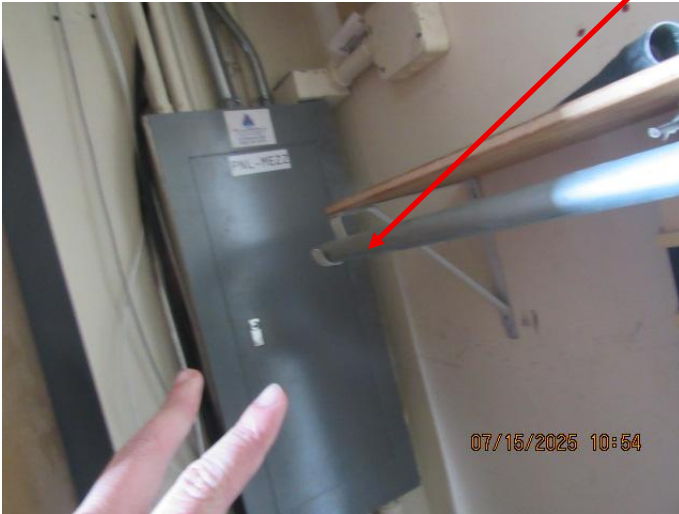
22. Electrical panel face covers should be better secured.

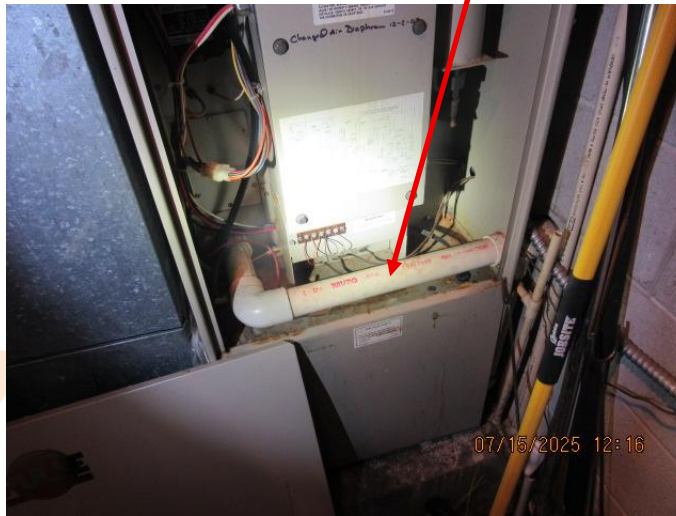
37. PVC flue pipe configuration should be improved by a HVAC contractor.
