# INSPECTION REPORT

For the Property at:  
**WELCOME HOME**  
NEW ORLEANS, LA 70115

Prepared for: MIKE SMITH  
Inspection Date: Wednesday, November 14, 2018  
Prepared by: Turk Schexnayder LHI Lic.10679

RE: Report No. 1848, v.2  
Welcome Home  
New Orleans, LA  
70115

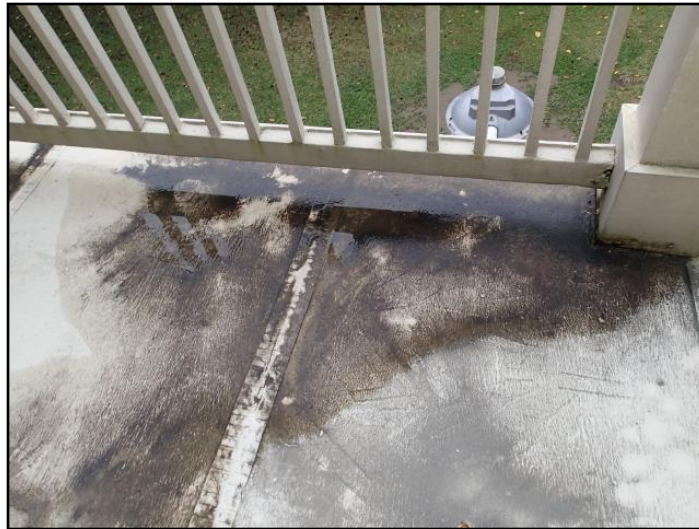
Ponding or standing water on rear balcony was noted. It rained the night before the inspection. However, staining pictured appeared to be from water sitting for some time. No leaks were noted in the area.

9. The roof appeared functional at the time of...

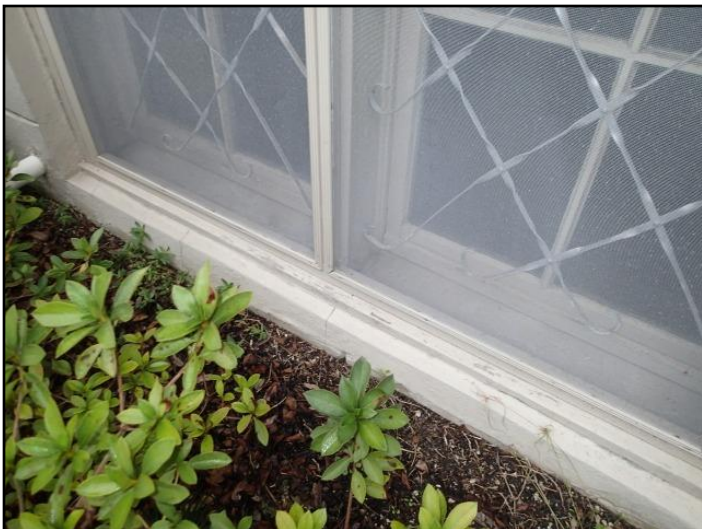
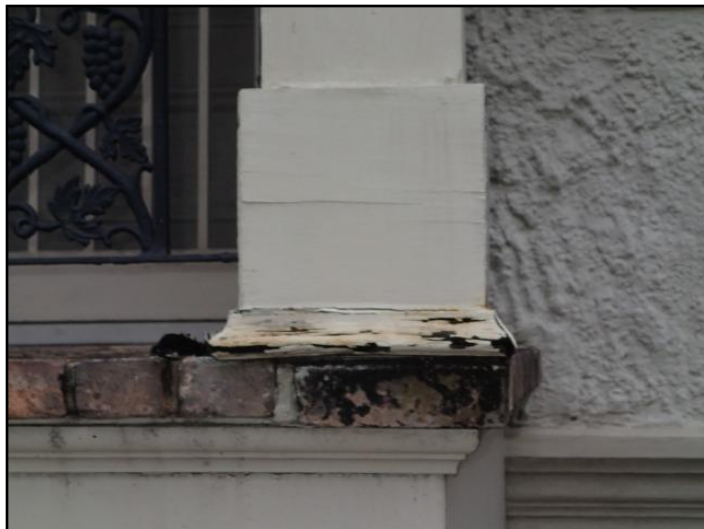
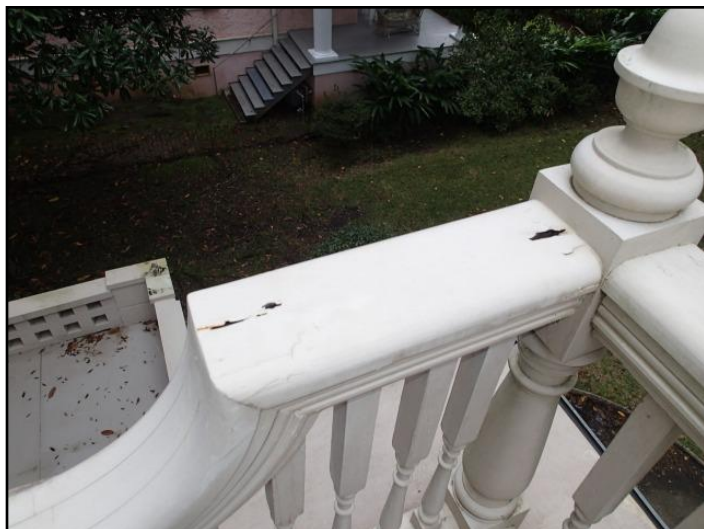
**5. Condition:** • Peeling paint on exterior wood surfaces. Including, but not limited to, windows, trim, shutters, soffit, fascia, and weather boards. Moisture intrusion through openings will cause exterior wood damage. Peeling paint and open seams should be addressed before material deterioration occurs. Due to limitations on photos only a few areas of peeling paint or exterior wood damage are pictured.

10. Peeling paint on exterior wood surfaces....

11. Peeling paint on exterior wood surfaces....

12. Peeling paint on exterior wood surfaces....

13. Peeling paint on exterior wood surfaces....

**Task:** Replace any damaged wood, seal open seams and paint as needed.

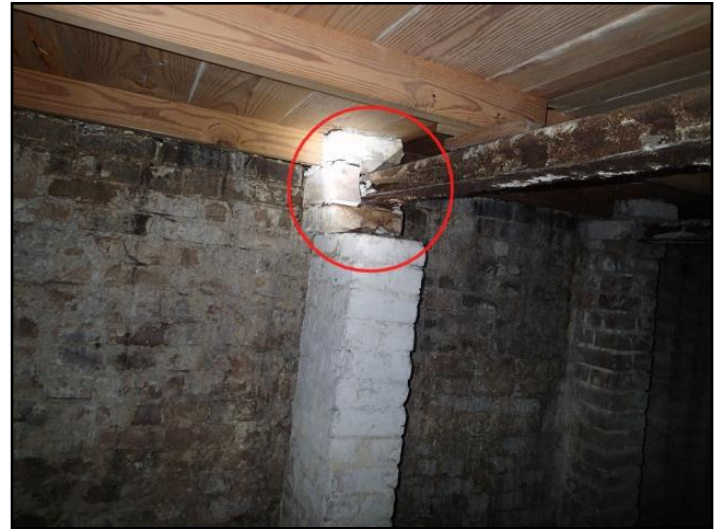
**14. Condition:** • It appears the front porch has been reworked. Existing rail road tracks and brick piers were still in place. Newer wood framing and planks were used as form boards. However, poor bearing and missing mortar was noted on piers under front porch. These items found should be addressed and corrected by a reputable contractor.

20. Poor bearing on pier

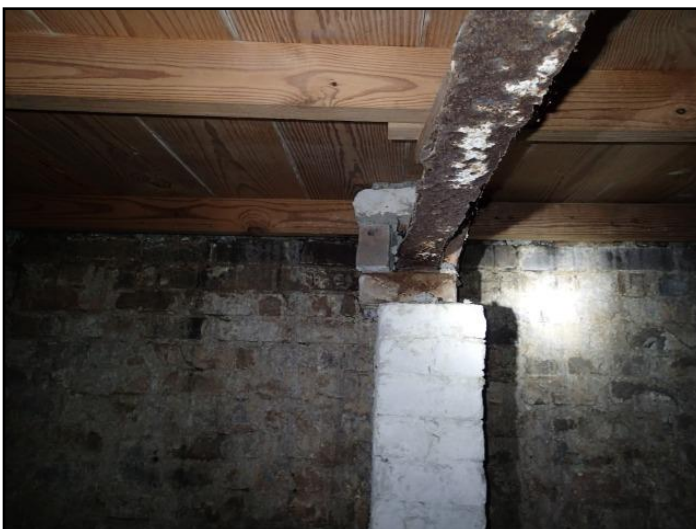
21. Poor bearing on pier

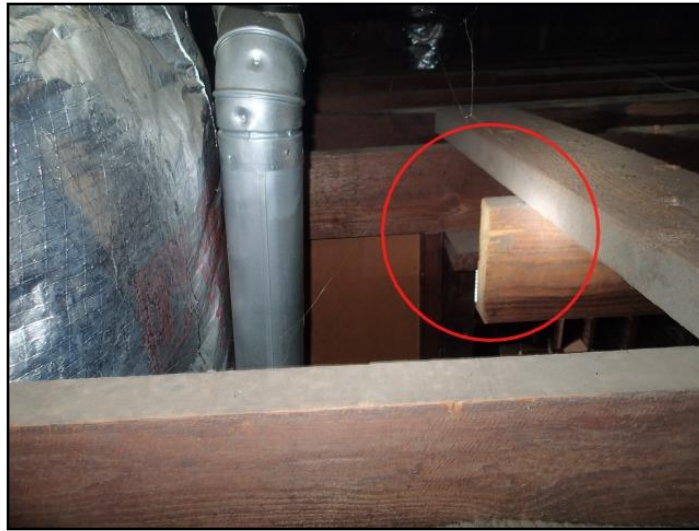
35. Cut joist

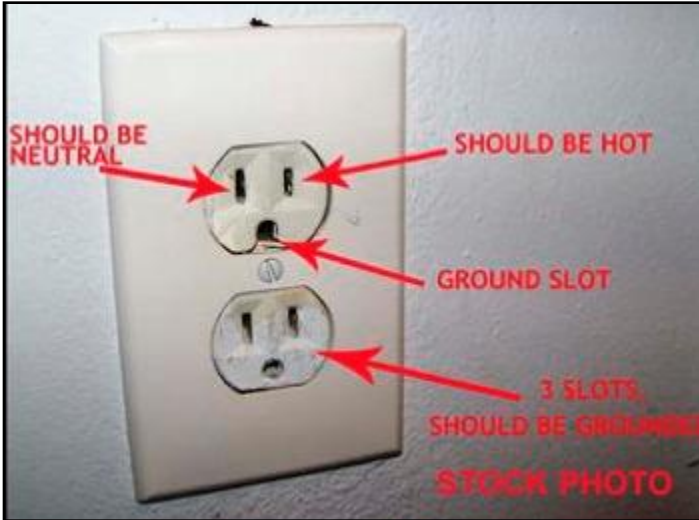
While some of the electrical system has been upgraded to grounded three slot outlets, there are still many ungrounded, two slot outlets. While these are SAFE to use for items not requiring a ground. An appliance requiring a ground (3 pronged plug) cannot be used in these outlets. An adapter should NEVER be used in these outlets to override the designed safety features, nor should a 3 slot receptacle ever be installed without proper grounding. Stock photos are used for illustration purposes.

38. Ungrounded 3 slot outlet

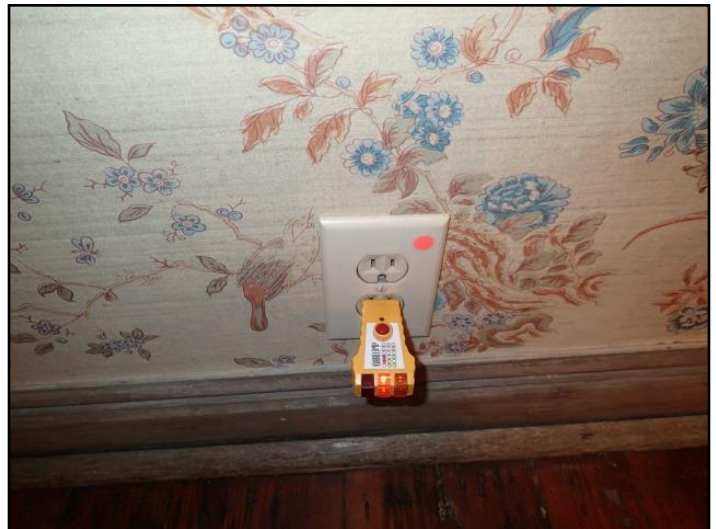
51. Ground needed for 3-slot outlet

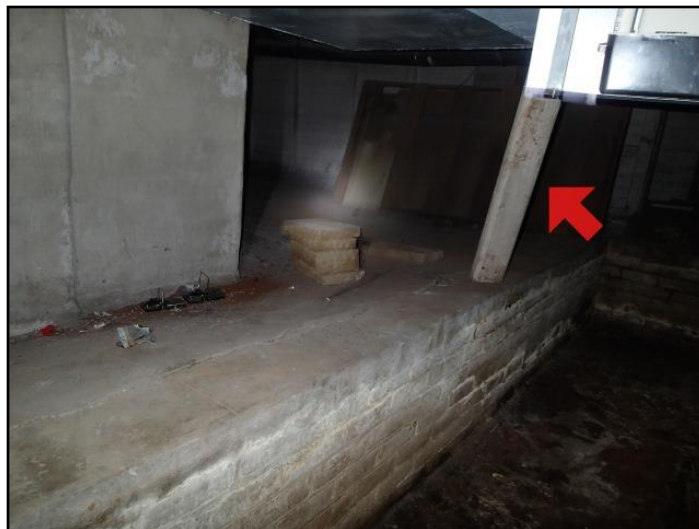
**57.** Board wedged under furnace.

**Task:** Provide proper support for basement furnace.

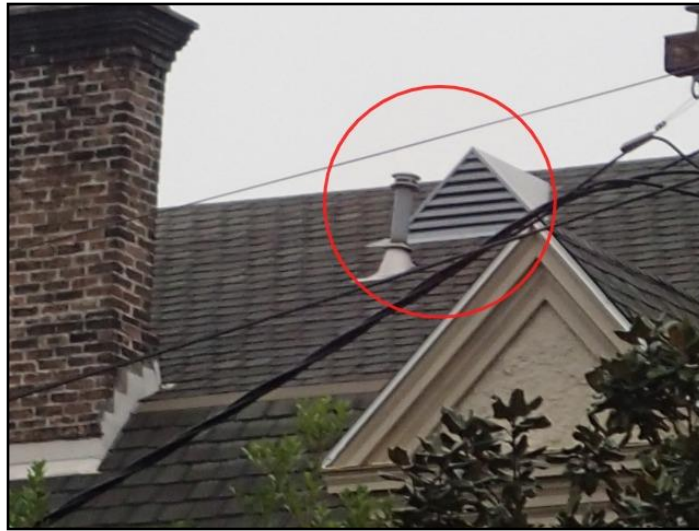
58. Vent location

**Task:** Improve / Correct venting.

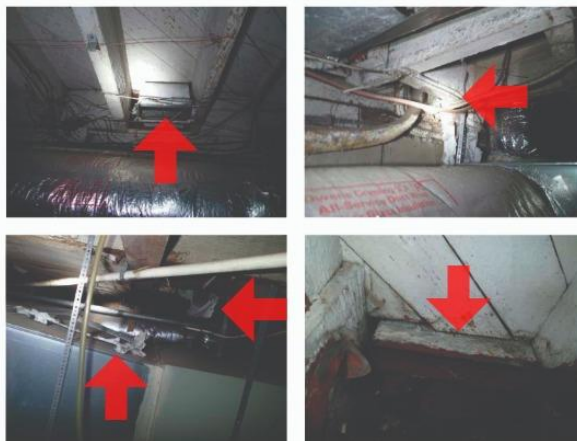
Possible Asbestos Duct Wrap

59. Suspect material

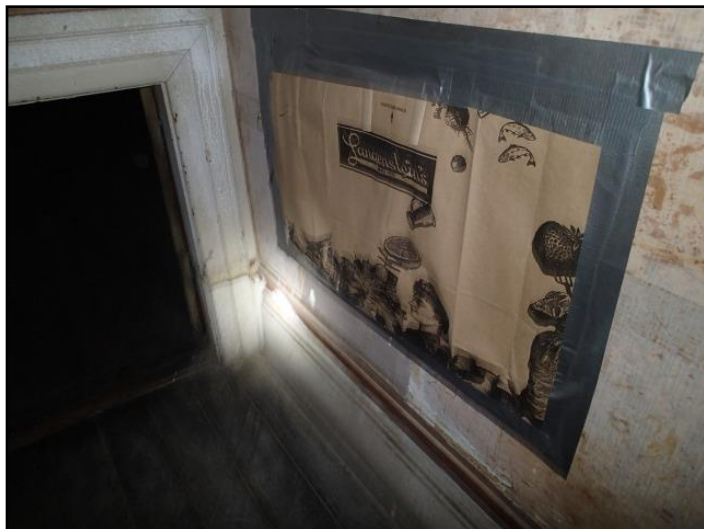
61. Carboard covering possible opening in chimney

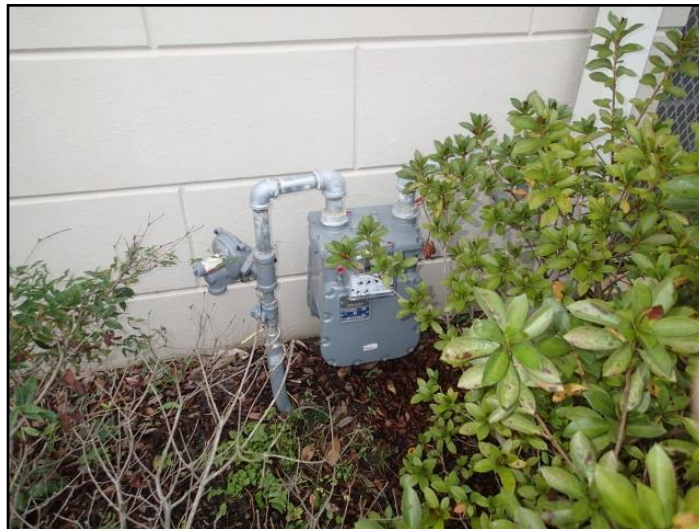
69. Location of gas meter

- Steel
  - Location of gas meter and main gas supply shut-off device.
- Left side of house.

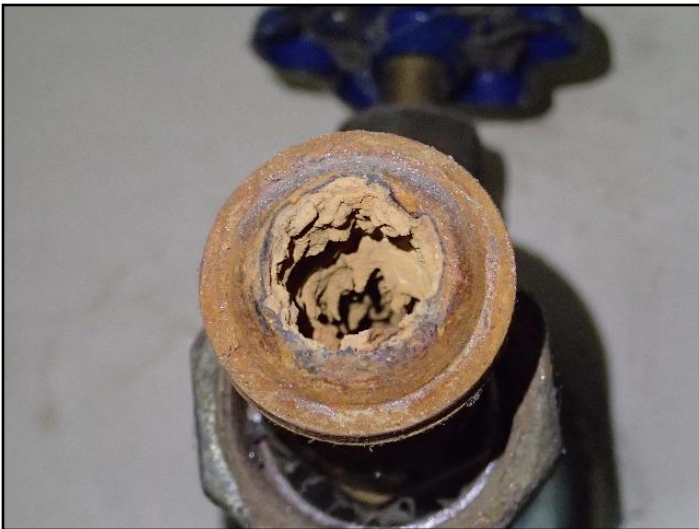
70. Galvanized steel - Stock Photo

### **49. Condition:** • Galvanized steel

Galvanized steel piping will often leak first at the joints. Steel pipe has threads cut into it where it joins a fitting. The pipe wall is thinner at the threaded connections. As the piping rusts from the inside, the pipe rusts through first at the threaded connections, where the pipe wall is thinner. (Refer to illustration) As steel piping corrodes, it may rust through at one spot and begin to leak; however, the rust may form a scab over the leak and the leak may be intermittent as the rust progresses. This scabbing means the pipe is close to the end of its useful life, even though it may not be actively leaking. Poor pressure and flow may be noted before the pipe leaks. The rust inside reduces the diameter, restricting flow. When leaks become prevalent or decreased water pressure is noted, it may be time to replace the galvanized supply lines with copper or PEX. Upgrades should be referred to a licensed plumbing contractor for a complete evaluation and written estimates of work needed.

**Implication(s):** Reduced water pressure and volume

**Task:** Monitor. When issues arise, further evaluation is recommended.

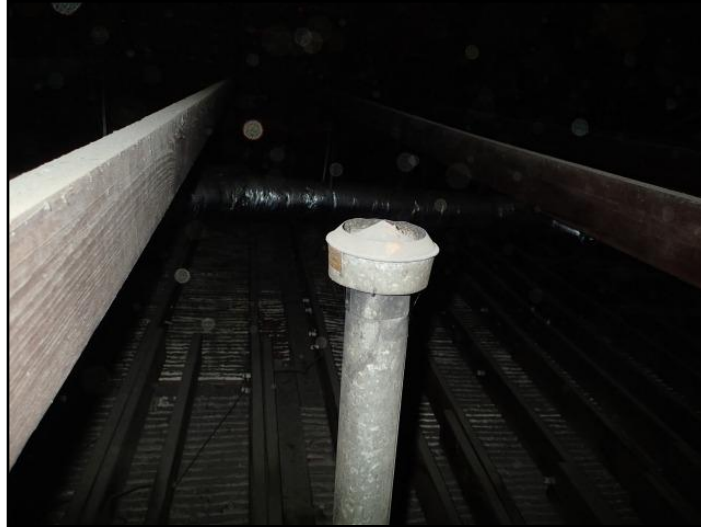
73. Possible water heater vent in attic

Possible water heater vent terminating in attic. It was not determined if the vent hood pictured was an active water heater vent, but should be checked, verified, and/or corrected as needed.

**Task:** Checked and/or corrected by a licensed plumber.
